Investigation report

Death of a worker at West Wyalong Quarry

February 2023

Published by the Department of Regional NSW

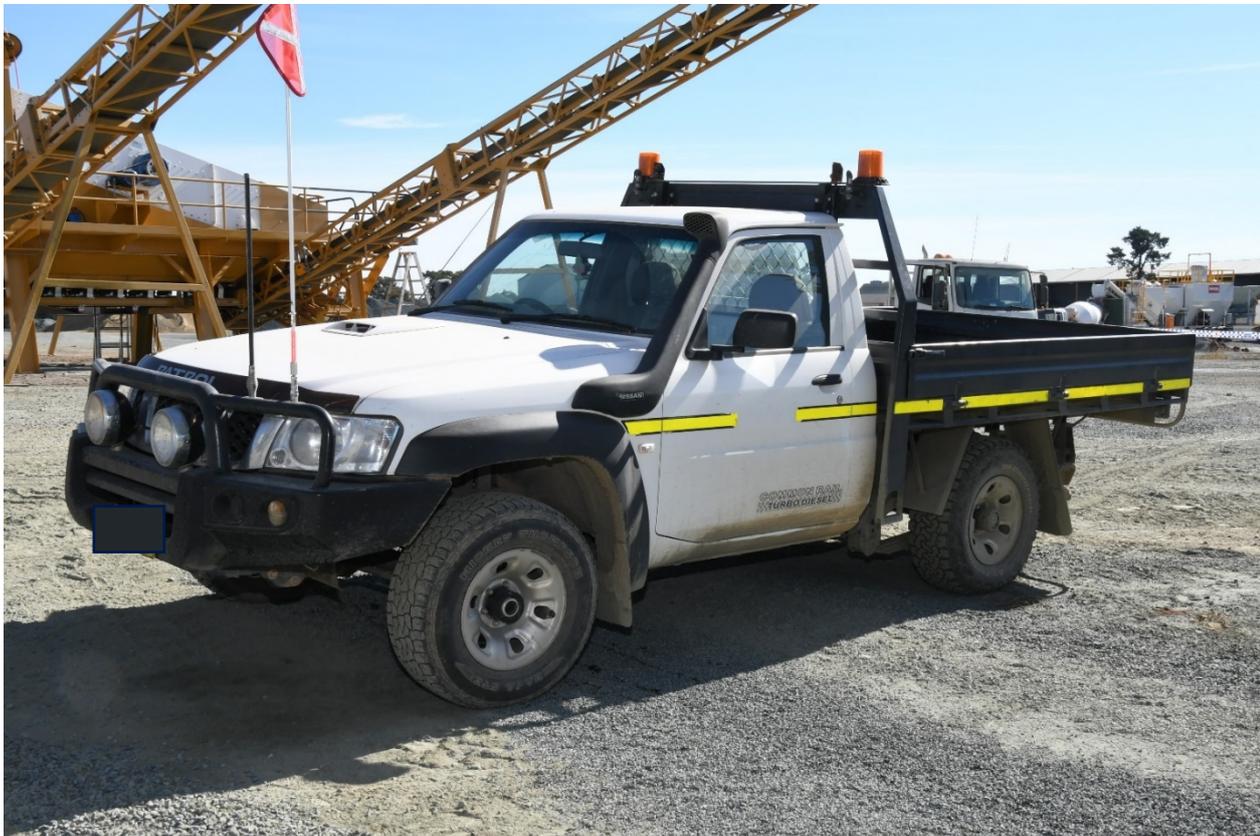
The front registration plate was slightly misshapen. No other damage was noted across the vehicle.

Figure 1 – The vehicle (Nissan Patrol) involved in the incident (Source: NSW Police)

A mechanical examination of the light vehicle was conducted by a NSW Police mechanical examiner. The examination found no mechanical defects or faults on the vehicle which may have been a contributing factor to the incident.

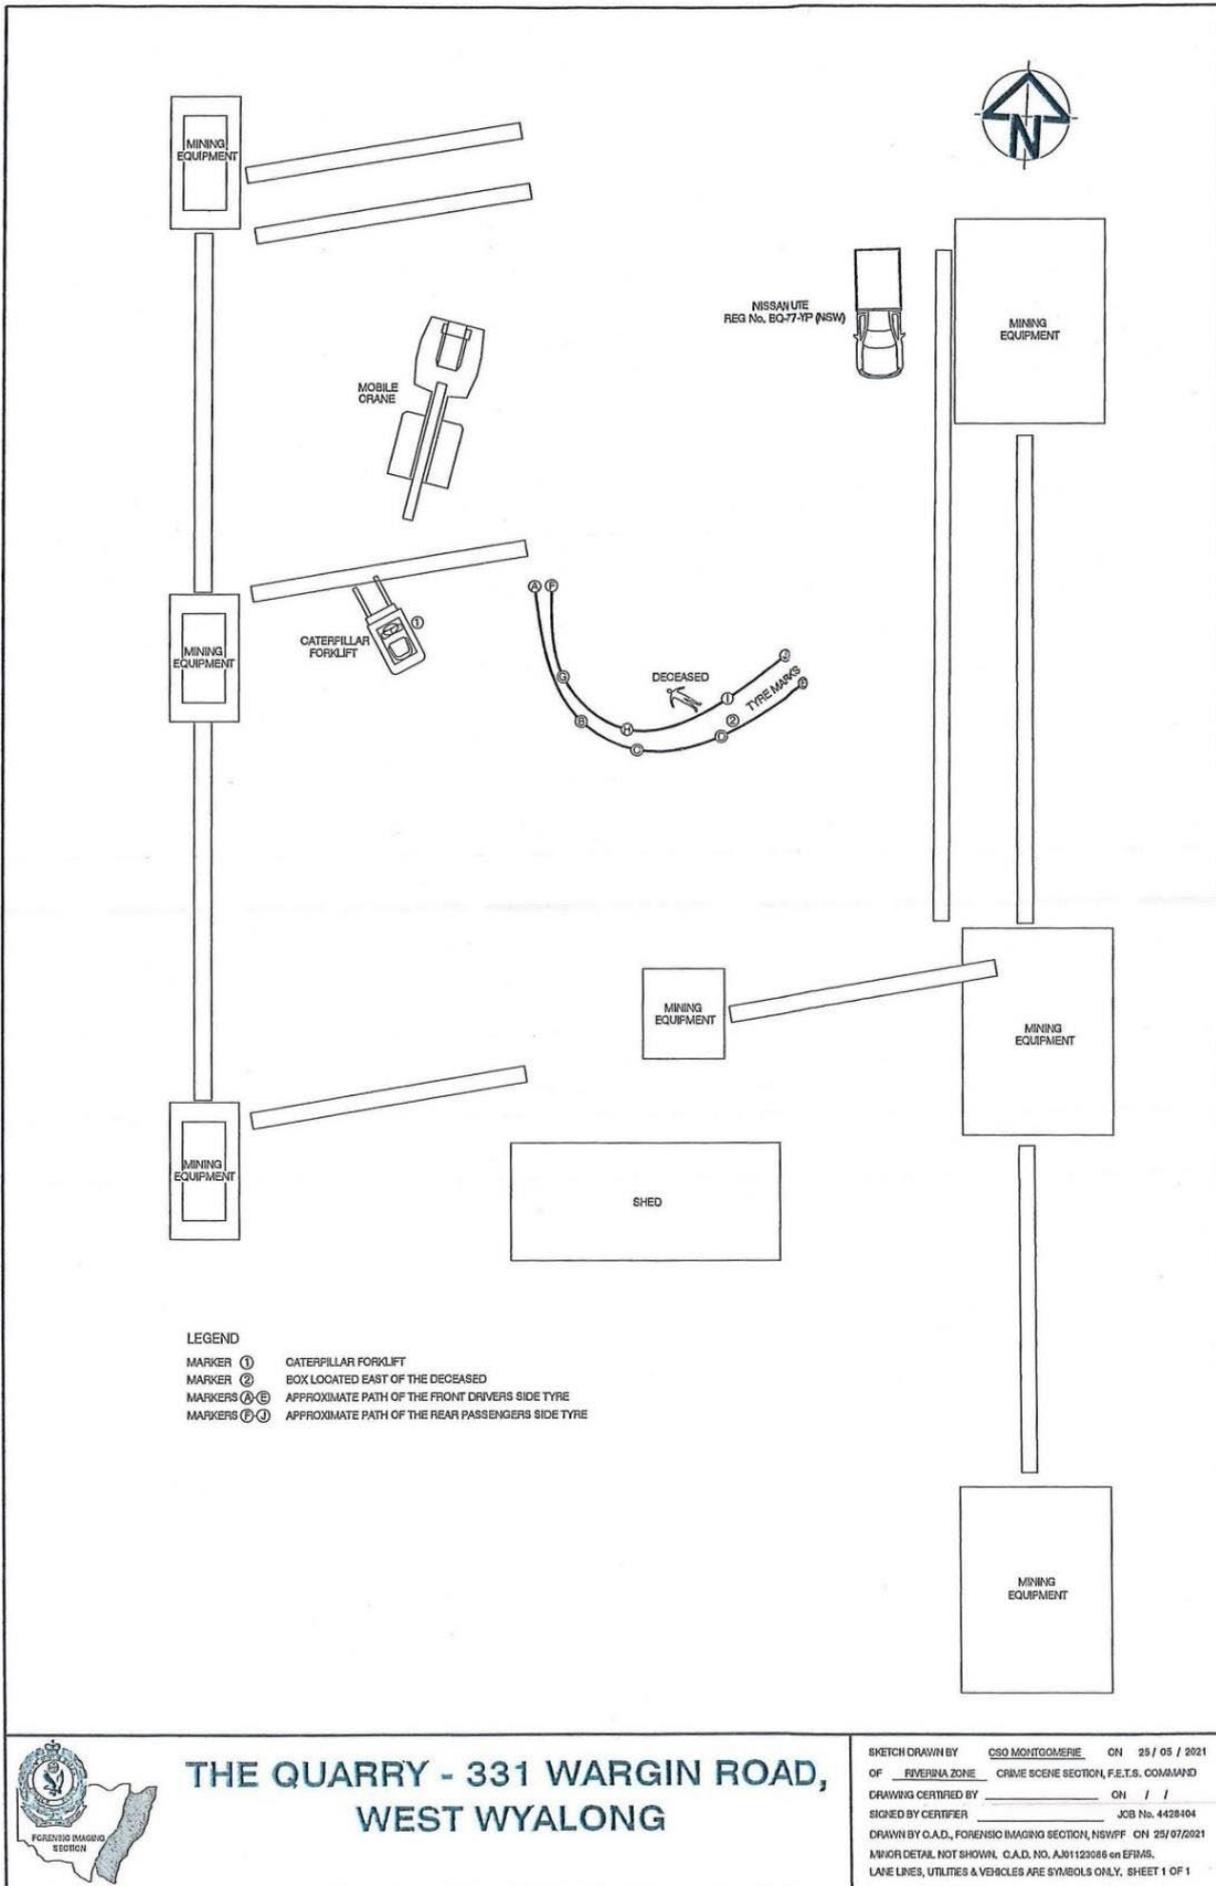
Figure 3 – Incident scene sketch (Source: NSW Police)

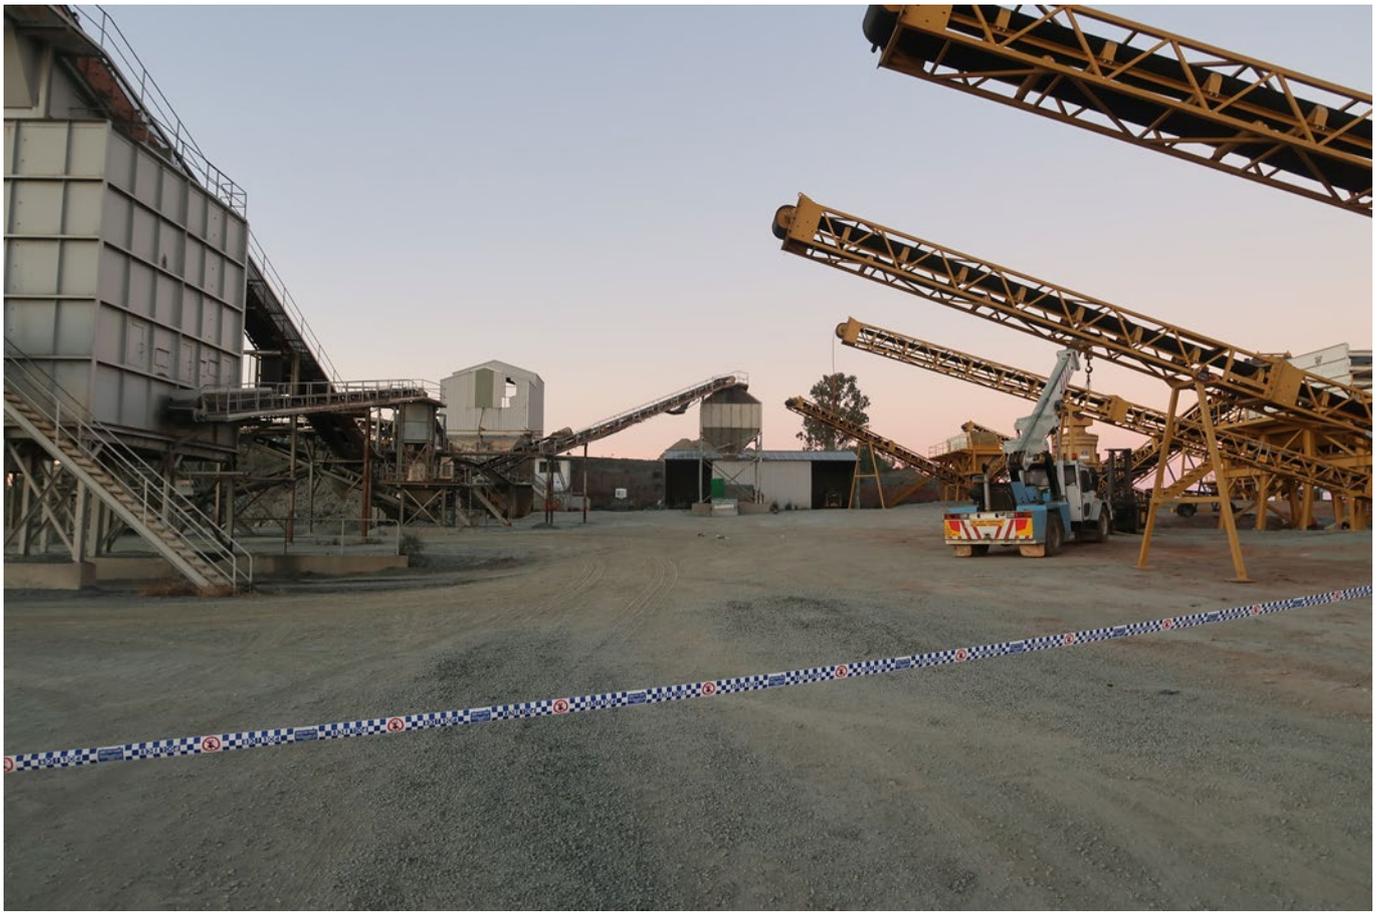
Figure 4 – View of incident scene in a southerly direction taken the day after the incident (Source: NSW Resources Regulator)

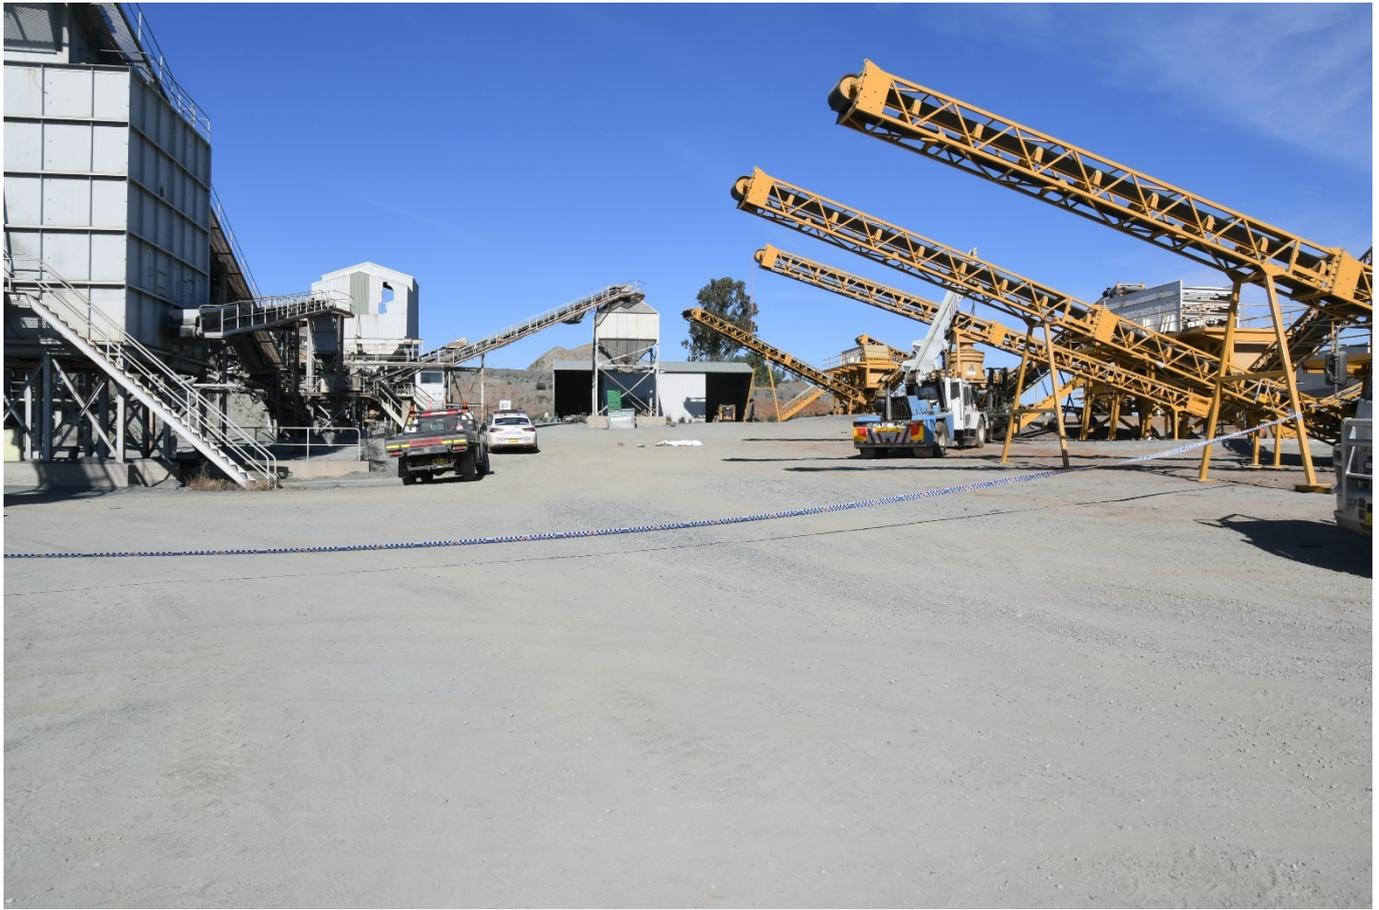
The examination found that the incident area was an unsealed, gravel surface. The surface was free of major defects and obstructions. There were no line markings, physical barriers or designated parking delineations for mobile plant operators or marked pedestrian walkways in the area. The light vehicle was parked nearby the incident scene, however, it had been moved after the incident to escort NSW Ambulance to the scene.

Mr Richens was in-situ at the time of examination. He was lying in the supine position with his arms and legs extended from his torso. Mr Richens was wearing an orange coloured hooded jumper, orange long sleeve work shirt, dark coloured pants and steel capped work boots.

Figure 5 – View of incident scene in a southerly direction taken the day of the incident (Source: NSW Police)
