# Weekly incident summary

# Week ending 3 March 2023

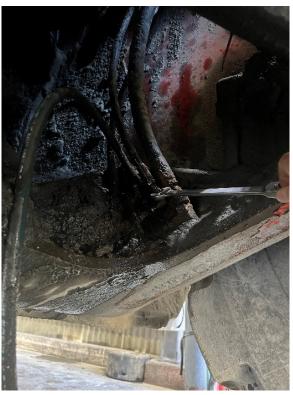
Dangerous incident IncNot0044173 Underground metal mine A fourth year mechanical apprentice was removing hoses on the retrieval circuit of a load haul dump (LHD). While undoing a hose, high pressure hydraulic oil sprayed the apprentice's left arm. The apprentice was cleared of injury.

Workers must ensure hydraulic systems are isolated and stored pressure is released before working on hydraulic systems.

Apprentices must be supervised and trained in workplace tasks.

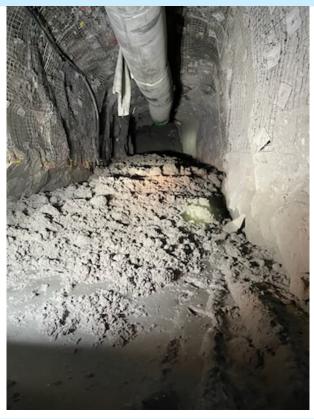
Dangerous incident IncNot0044167 Open cut coal mine Ground or strata failure

Mine designs should be guided by a robust geotechnical assessment, conducted by a qualified person. Geotechnical assessments and reviews should be conducted at appropriate intervals.

Where geotechnical hazards are known to exist, monitoring systems should be installed and monitored, with an early warning capability.

Clear withdrawal conditions (such as a TARP) should be part of any ground or strata failure principal hazard management plan.
