Investigation information release

LHD operator exposed to methane and carbon dioxide gas within unventilated section of underground roadway

Location: Narrabri Mine

Investigation information release IIR23-02

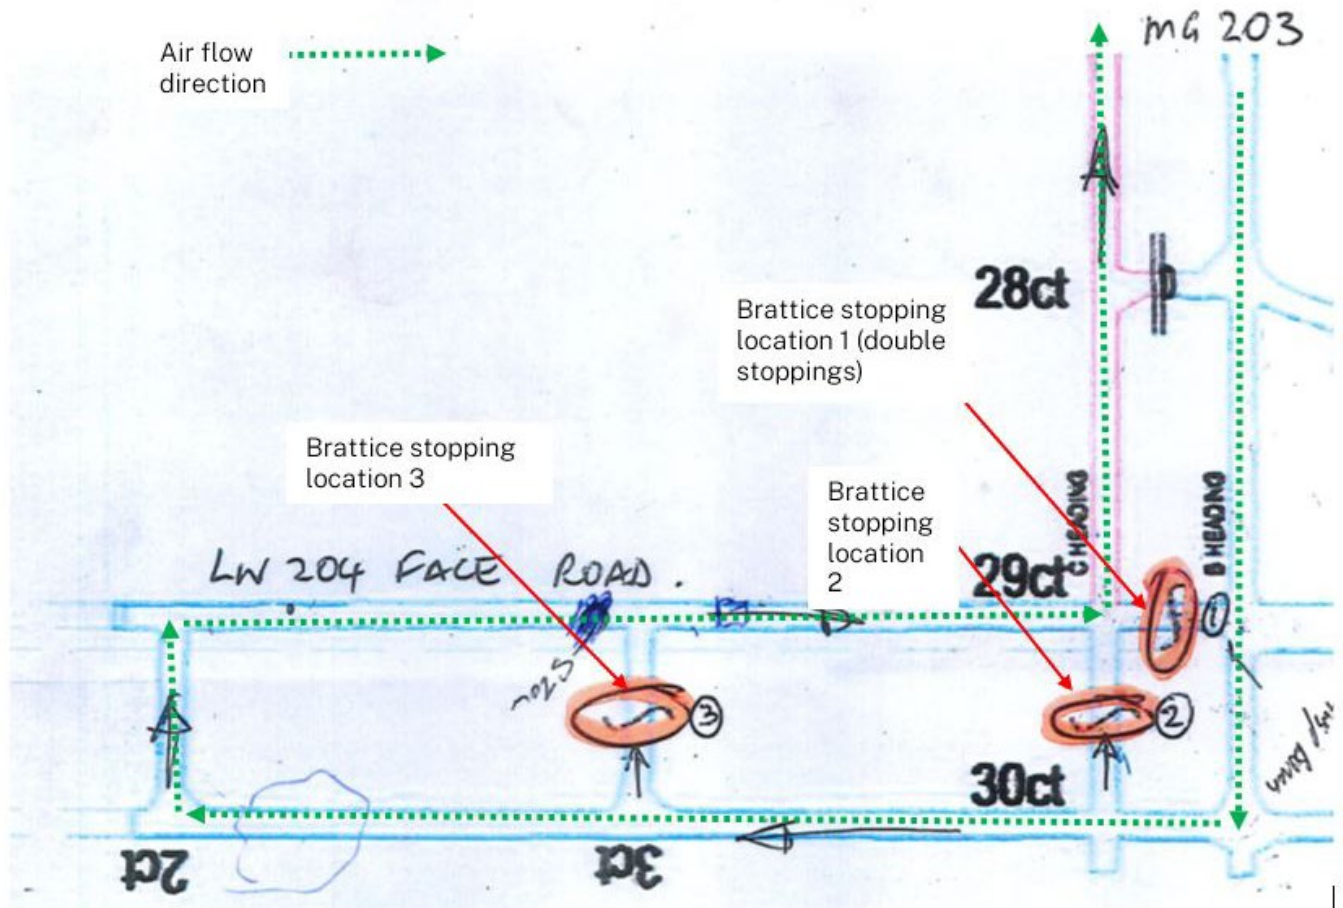
Figure 1 - Longwall 204 install face ventilation circuit.

To ensure the install face was adequately ventilated, the mine relied on a series of brattice stoppings used to direct and circulate airflow in a circuit as shown in figure 1 below.

About 8:30am, the dayshift deputy undertook a statutory inspection of the install face, observing that the double brattice stoppings between B and C headings at the 29 cut through (location 1 in figure 1) had been taken down. It was unclear how long the stoppings were not in place.

By around 12pm the contractor work crew had finished installing the strata support. The workers recalled that, after relocating the plant and equipment out of the area, they reinstated the stoppings at locations 1 and 2 depicted in figure 1.

About 9:15pm, the nightshift and afternoon shift deputies attended the install face and completed an inspection of the area. The deputies identified that the double stoppings at location 1 were not in place. The nightshift deputy reinstated one of the stoppings (closest to B heading) and obtained gas concentration readings at the area which did not identify high levels of methane or other noxious

Once notified, an undermanager and deputy demarcated the area, degassed the roadway and undertook a walkthrough of the area to investigate the gas exceedance. During the walkthrough it was identified that the brattice stopping at location 2 was not in place. It is unclear how long the stopping had been taken down.

- the removal and subsequent failure to reinstate the stoppings, redirected and restricted the circulation of airflow away from sections of the install face which, over time, likely resulted in the accumulation of methane and carbon dioxide gas
- statutory inspections undertaken at the install face failed to:
 - verify all stoppings were erected and remained in place in accordance with the mine's ventilation control device plan
 - monitor the volume of airflow in the roadway to verify it was sufficient.
- Leading up to the incident, there were previous ventilation issues at the install face that were not properly investigated by the mine, including:
 - a build-up of methane gas that had not previously been a commonly encountered issue
 - an incident involving the installation of a brattice stopping that restricted the ventilation of the install face and bleeder roadways.
