Investigation report

Serious injury of a worker at Thuddungra Mine

May 2023

Subtitle: Investigation Report into the serious injury of a worker at Thuddungra Mine on 10 August 2021

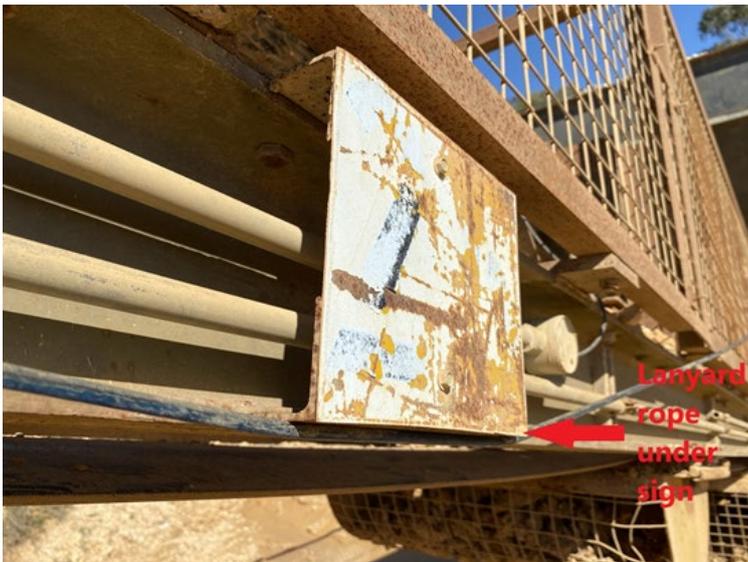
Figure 6 - Lanyard tucked behind metal sign

- tucked the lanyard beneath a metal sign on the side of the conveyor (Figure 6), and
- used cable ties to connect the lanyard to guarding on the side of the conveyor (Figure 7).

The investigation determined that the poor condition of the lanyard (stretched) resulted in the injured worker being unable to apply sufficient tension to activate the emergency stop when he tried to do so. As a result, the feeder and the conveyor motor continued to operate during the incident, albeit the belt did not move. In the event the issue affecting the belt was resolved while the

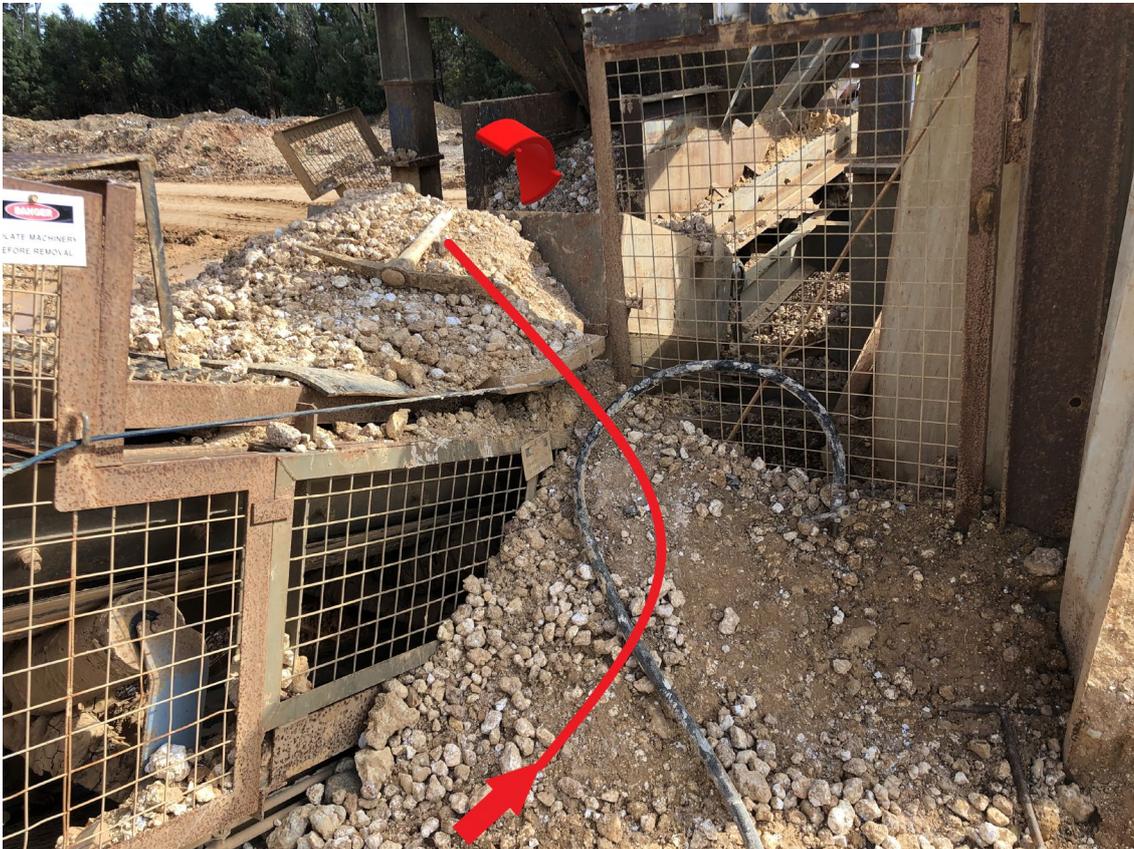
Figure 8 - Approximate path walked by the injured worker

The worker who became injured walked along the eastern side of the conveyor and up on some product that had built up at the side of the conveyor. He was not visible to the other involved workers at this point.

The worker who became injured walked up to inspect the chute on to some product that had built up on the top of the conveyor guard. The product was loose underfoot and as he bent forward, he lost his footing and fell head first into the chute. He put both hands out to brace his fall. As the feeder was still operating, product continued to go from the hopper into the chute.

As shown in Figure 8, there was a large build-up of material on the eastern side and across the top of the conveyor. This was largely because product spilled over the sides of the hopper during loading. However, some of the material was deposited by workers when they used hand tools to clear blockages around the conveyor. The built-up area provided the injured worker with a convenient means of accessing the top of the conveyor. It would have been more difficult for him to access that area if the built-up material was removed. The loose consistency of the material at the top and sides of the conveyor created a significant risk of slipping when the worker walked on it.

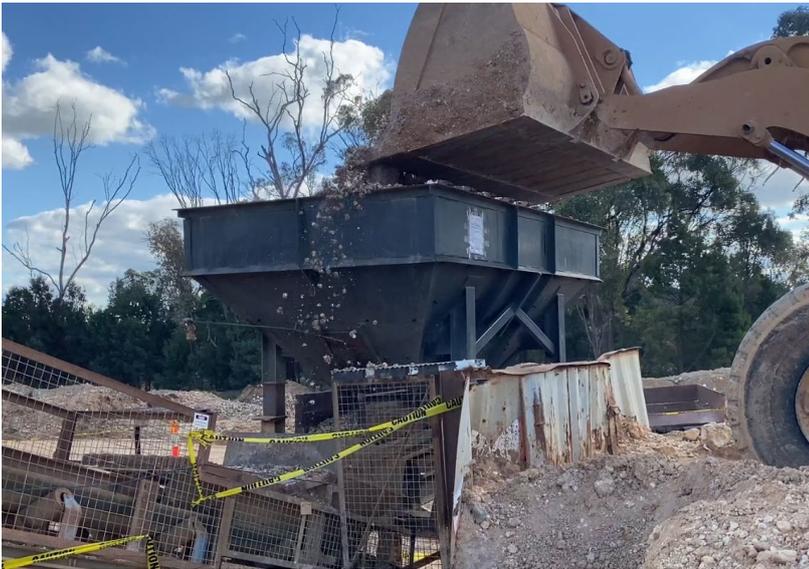
Figure 9 - Product spilling from the bucket of the loader

The investigation determined that the hopper was poorly suited for use with the loader. The width of the loader's bucket and the hopper were 3280 millimetres and 3510 millimetres respectively. When product was released from the bucket during loading, a portion would spill over the sides of the hopper and onto the conveyor and surrounds. The spillage contributed significantly to the material that built up around the conveyor. The spillage could have been considerably reduced if the hopper was wider or if suitably designed 'hungry board' panels were fitted across the sides of the hopper. If a comprehensive design risk assessment was undertaken, it would have identified the risks associated with spillage.

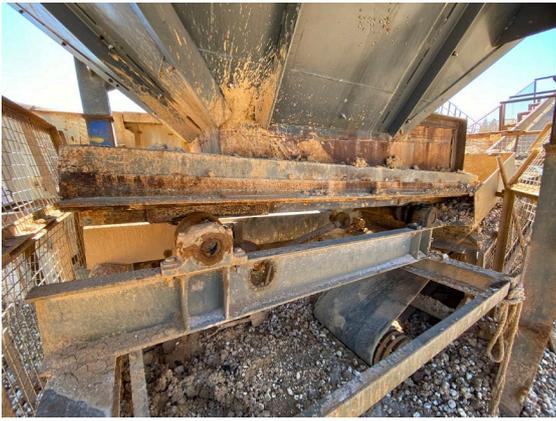
Figure 10 – Access issues under the conveyor

Although the mine's production levels decreased before the incident, the poor design and condition of the plant meant that disproportionate levels of housekeeping were required to maintain it in good working order. No provision was made for capturing spillage around the conveyor. As a result, spilt product tended to collect around the conveyor and its tail pulley.

A skid-steer loader, which was used to assist with housekeeping in the plant, was out of service for a considerable period. Even when it was operational, the poor design of the plant meant it could not access many of the areas where housekeeping was required. As a result, workers were required to climb under the hopper structure and use hand tools such as picks and shovels to manually clear material. Workers said this was arduous because it had to be done while bending over because of the limited access near the tail pulley. The access issues were recognised by the mine operator in its safe work method statement for the task. (see Section 6.7.2)

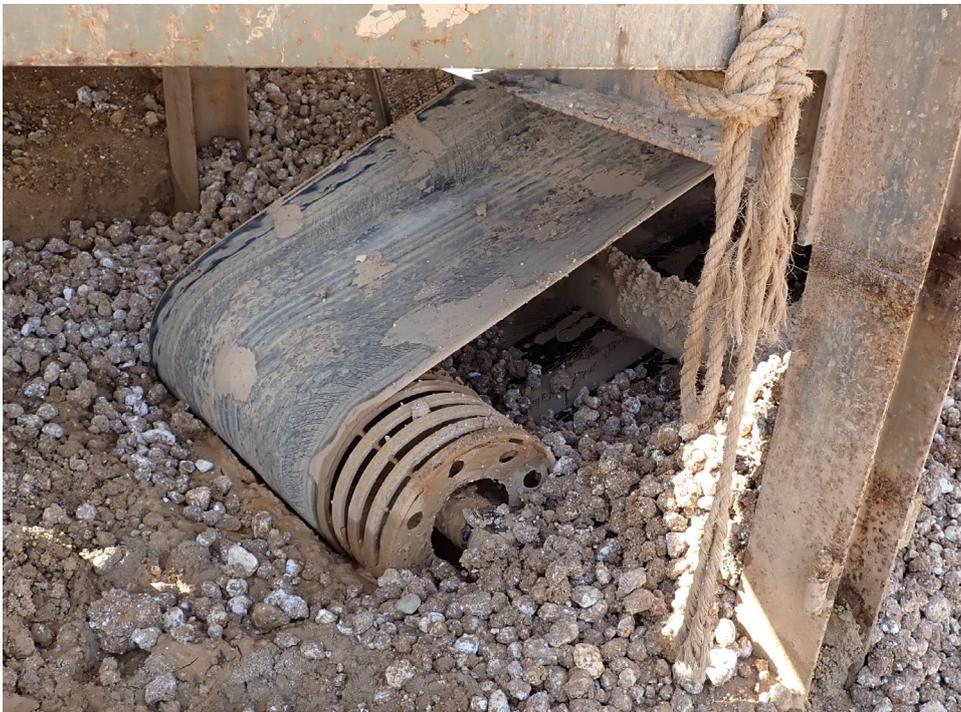
Figure 11 – Buried tail pulley – inside of belt covered in material

The belt was not tracking correctly around the tail pulley and there was no tracking protection fitted to it. The amount of material that was around the tail pulley is evident in Figures 11 and 12 that show the area before and after the material was cleared. The water that partially covered the tail pulley at the time of the incident had subsided before the photographs were taken. The investigation determined the conveyor was often operated with its tail pulley partially covered in material.

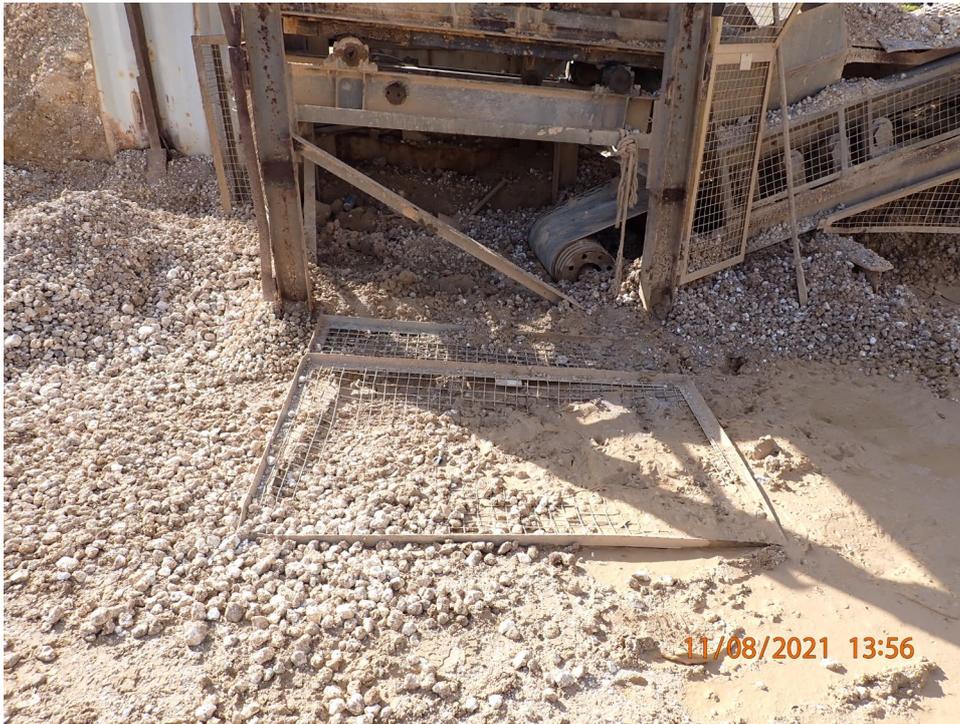
Figure 13 – Conveyor structure 11 Aug 2021

The worker's boots were packed with mud when he slipped and fell into the chute. Drainage in the plant was poor, and before the incident there were large areas of wet, clay material throughout the plant. The topography of the location resulted in water naturally being directed towards the hopper structure. Although muddy conditions were experienced for a considerable period, no effective drainage work was undertaken near the conveyor. At the time of the incident, the ground was wetter and muddier than the conditions depicted in Figures 13 and 14.

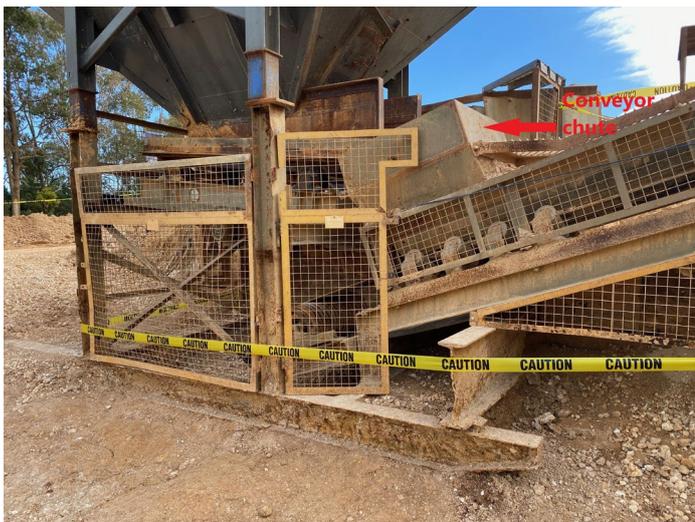
Figure 16 - Elevated position of conveyor chute

While step 3 provided that a pick and shovel should be used, the SWMS did not contain any information about where workers should stand while undertaking the task, the way they should use the pick and shovel and what they should do with the material they removed from the blocked chute. It also ignored the fact that the chute was unguarded and built at height. The most practical way to dig out the chute using a pick and shovel was to stand on top of the conveyor guard where the injured worker fell, thereby introducing the risk of falls from heights.

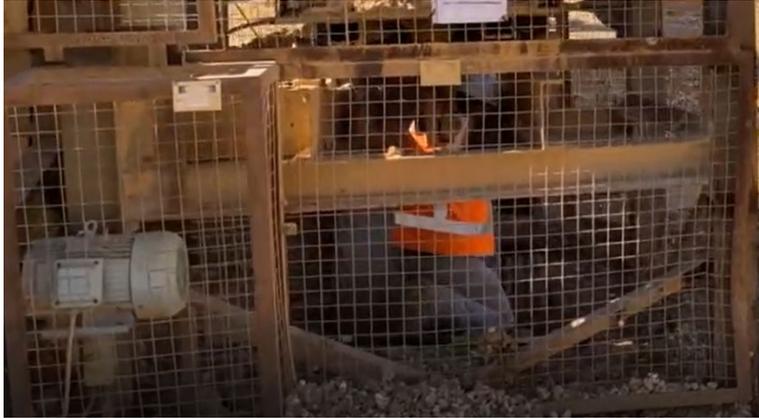
Figure 17 - Worker digging under structure

It should be noted that at the time the photograph in Figure 17 was taken, a significant amount of material had been previously dug out beneath the feeder and access would ordinarily be even more difficult than depicted.

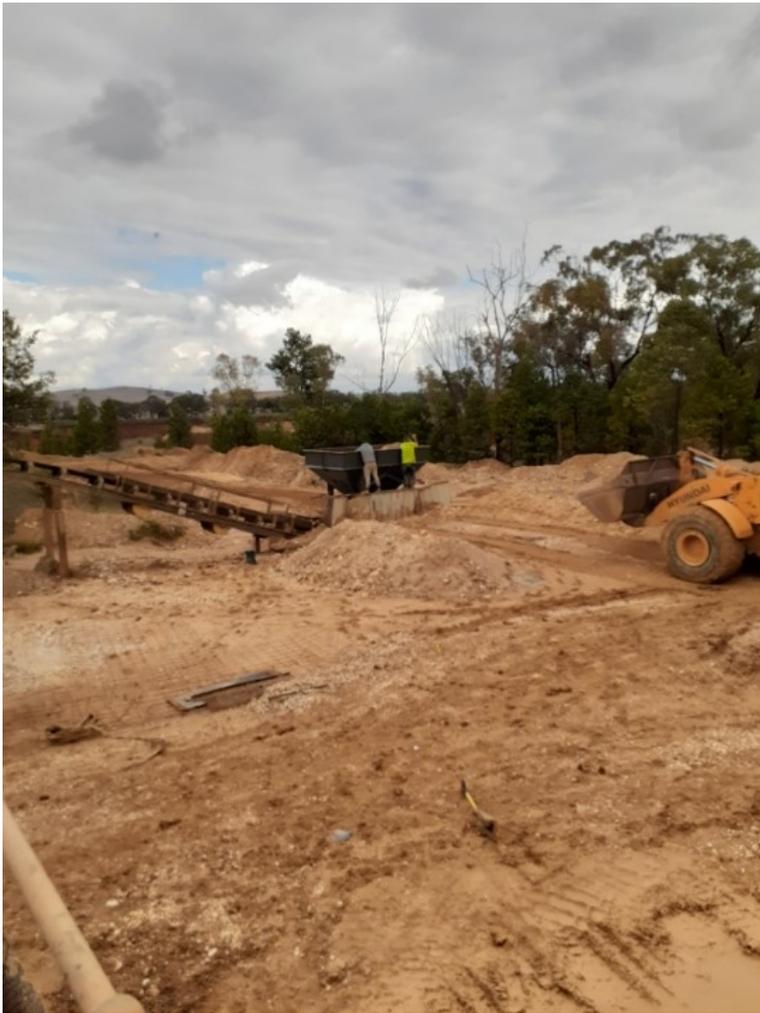
Figure 18 - Workers reaching into hopper

Up until several months before the incident, workers used metal bars to separate sticky product in the hopper. Workers would either get into the hopper or stand on a buckled fence next to the hopper and reach into it as shown in Figure 18. This introduced risks of falls from heights and entrapment.

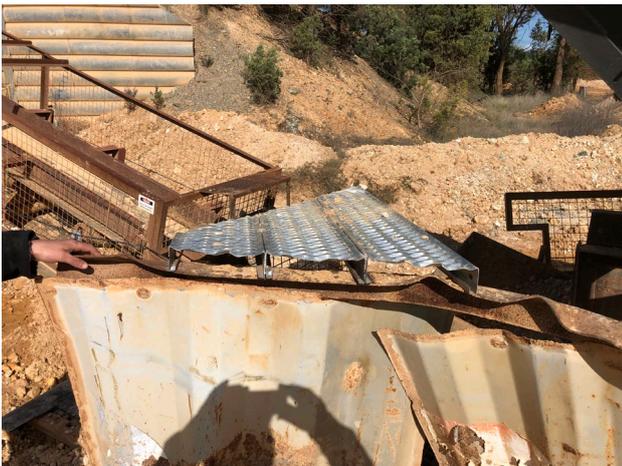
Figure 19 - Metal platform attached to buckled fence rail

The seat and the platform were installed on 30 July 2021. The other worker recorded the addition of the seat and platform in the mine's 'Record of maintenance work'. No risk assessment or change management processes were undertaken or followed in respect to the seat or platform. The use of the seat and platform in the manner described above carried a significant risk of falls from heights. No controls were implemented to manage that risk.

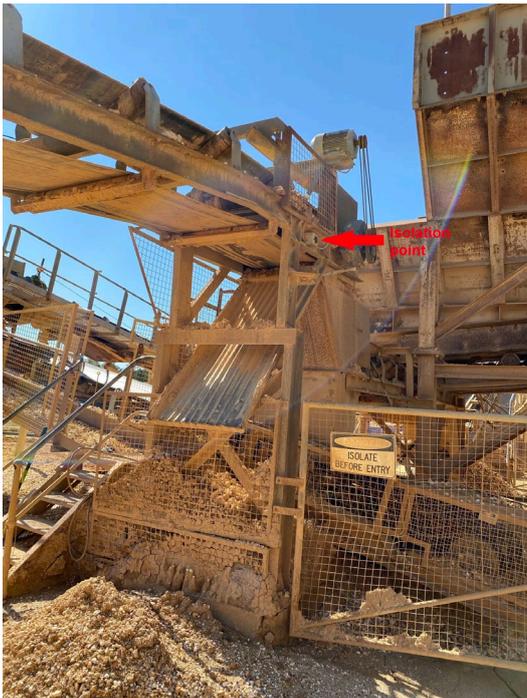
Figure 23 – Conveyor's isolation point

The isolation points for the conveyor and the feeder were in unsafe and impractical locations. The conveyor's isolation point was about 2.1 metres above ground level. There were no safe means for workers to access that point. At the time of the incident, the injured worker was unaware of the location of the conveyor's isolation point.

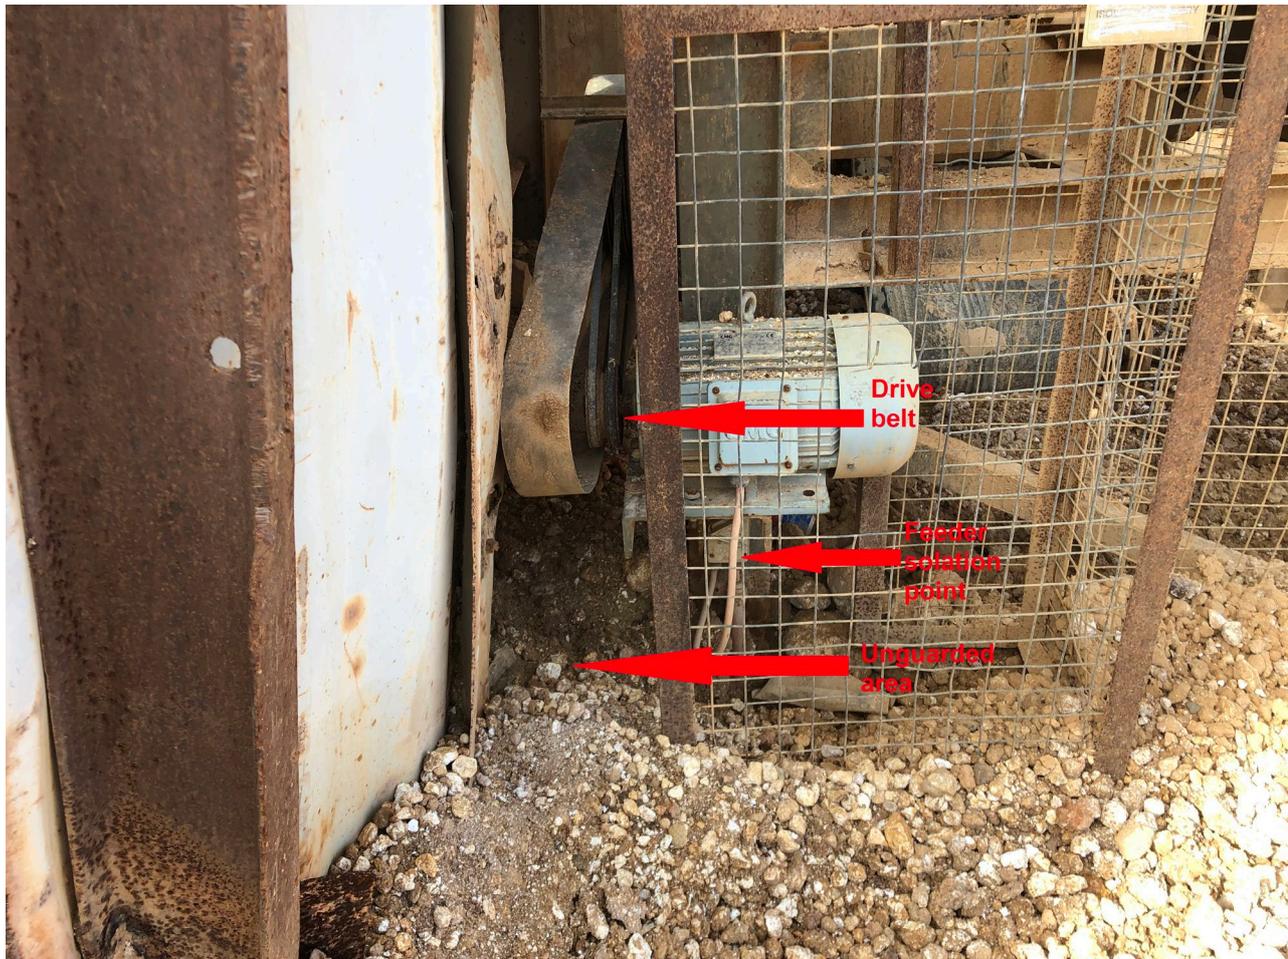
Figure 24 - Feeder isolation point

The isolation point for the feeder was in an obscure location beneath the feeder at the rear of the hopper structure. It was adjacent to rotating drive belts that were unguarded. To reach the isolation point, workers had to reach through a gap made in a section of guarding. Workers accessing the feeder's isolation point risked being entangled by the drive belts.

The location of the feeder's isolation point was not easily identifiable or sign posted and information about its location was not provided as part of the mine operator's training. There was a significant risk that workers at the mine would not know how to access it in the event of an emergency. It was fortunate in this instance that the injured worker had previously told the other worker where the isolation switch was located.

The belts that drove the plate feeder (Figure 24) and conveyor (see Figure 25) rotated at high speed when operating. Neither was effectively guarded.

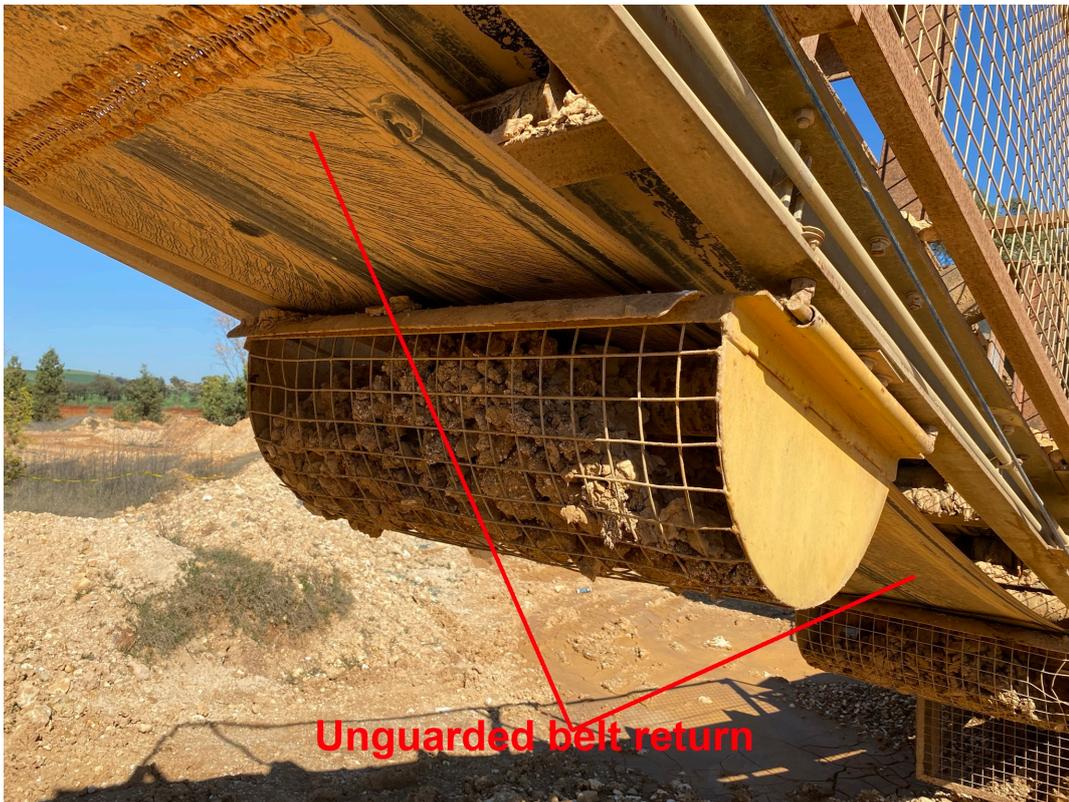
Figure 26 -Underside of conveyor

The underside of the conveyor was not guarded. Workers walked under the conveyor while it was operating, exposing themselves to the risk of being entangled by rotating parts and the moving belt.
