## Investigation report

# Near collision between haul truck and light vehicle at Maules Creek Mine

*June 2023*

**Published by the Department of Regional NSW**

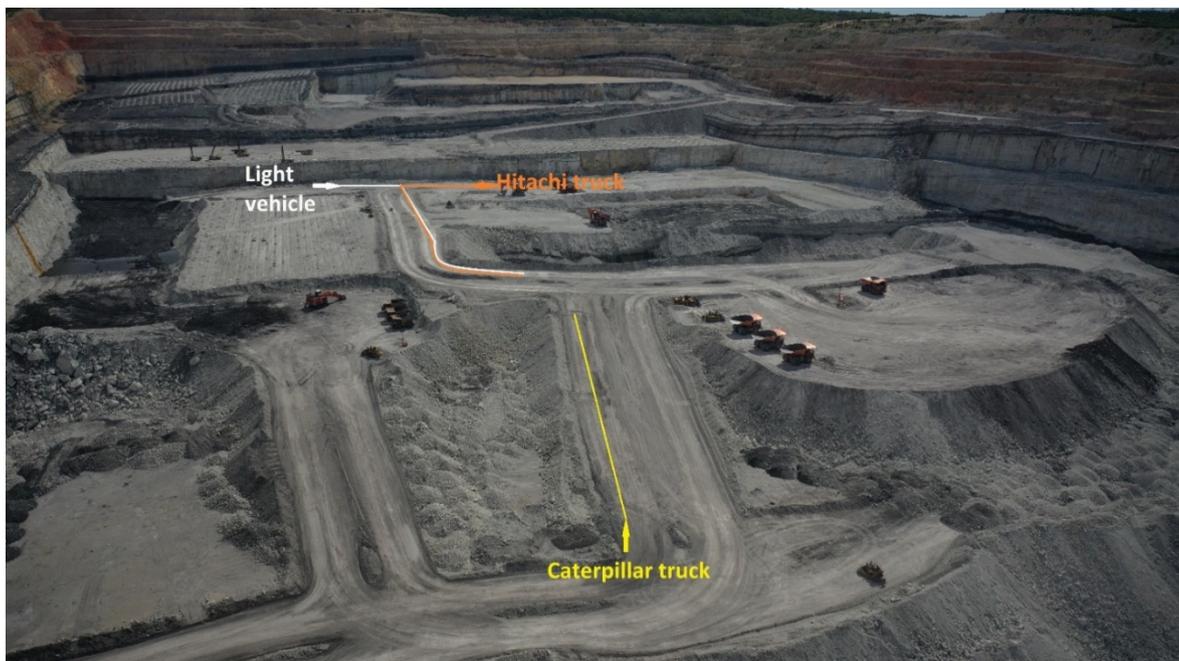
Figure 3 - Paths of travel prior to incident

The haul truck was travelling about 35 kph as it travelled around the bend. As it reached the apex of the bend, the haul truck operator saw the light vehicle stopped near the intersection. He was about 65 metres from the light vehicle at this time. The haul truck operator applied the truck's retarder but did not activate the service brake. The light vehicle operator looked in his rear vision mirror and saw the haul truck travelling towards him at speed. He put the light vehicle into gear and tried to move forward and to the right to increase the distance between it and the Hitachi truck. However, the light vehicle's engine stalled and it only moved forward by several metres.

The haul truck operator realised additional evasive action would be needed to avoid a collision with the rear of the light vehicle. He steered the truck to the left, narrowly avoiding a collision with the

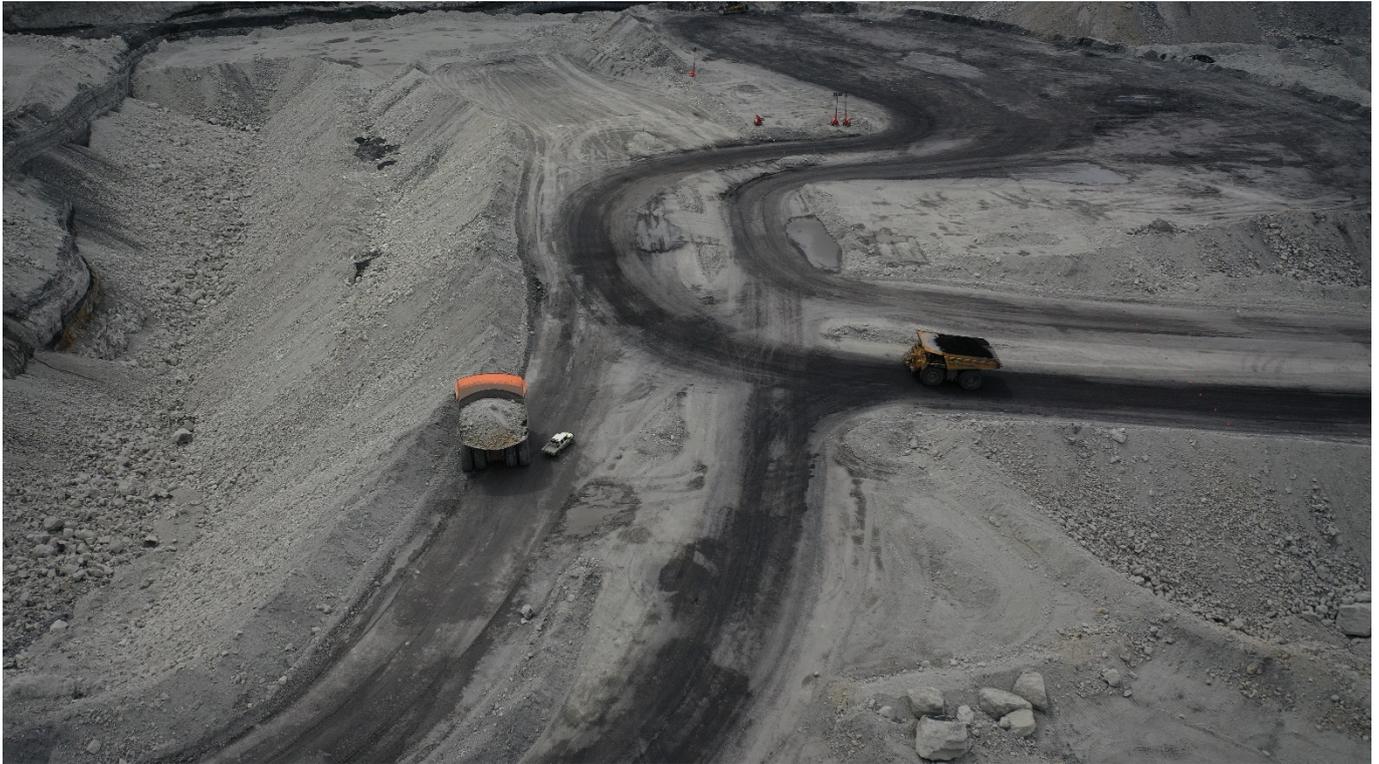
Figure 4 - Position of vehicles following incident

light vehicle and causing the front of the truck to hit the left roadside windrow. The rear right side of the haul truck stopped 1.65 metres from the rear left side of the light vehicle.

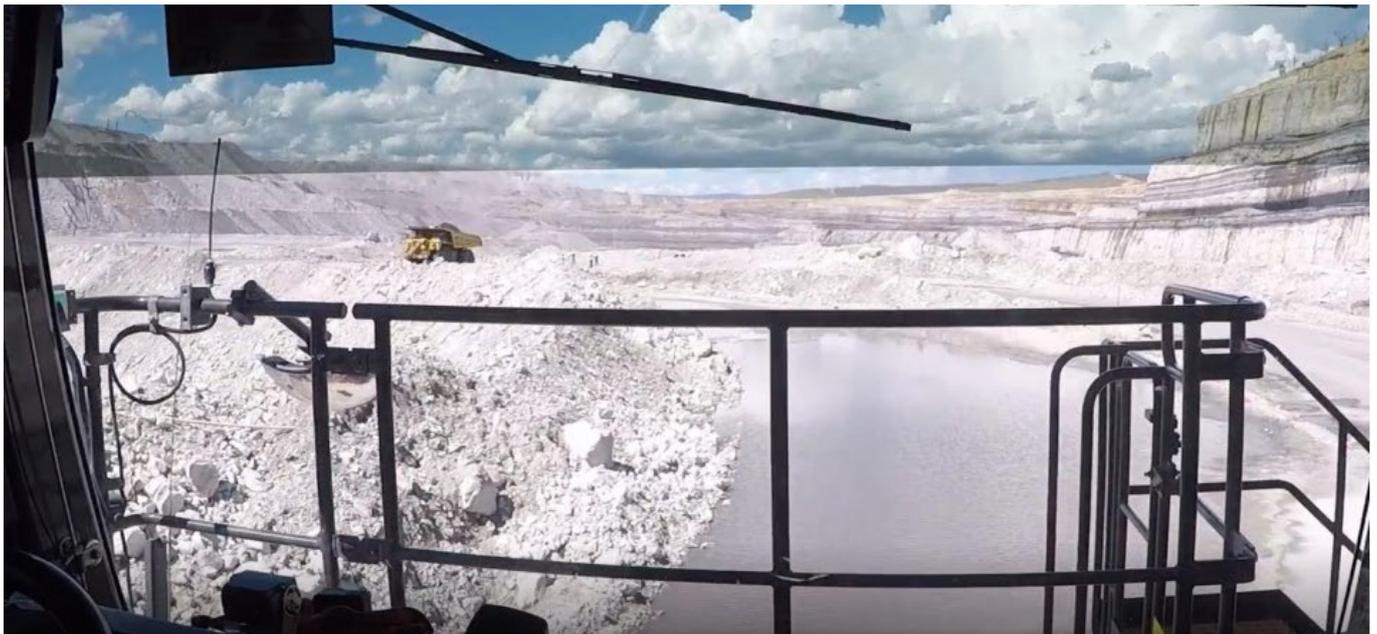
Figure 6 – View from cabin of haul truck when about 100 metres from the light vehicle – light vehicle not visible

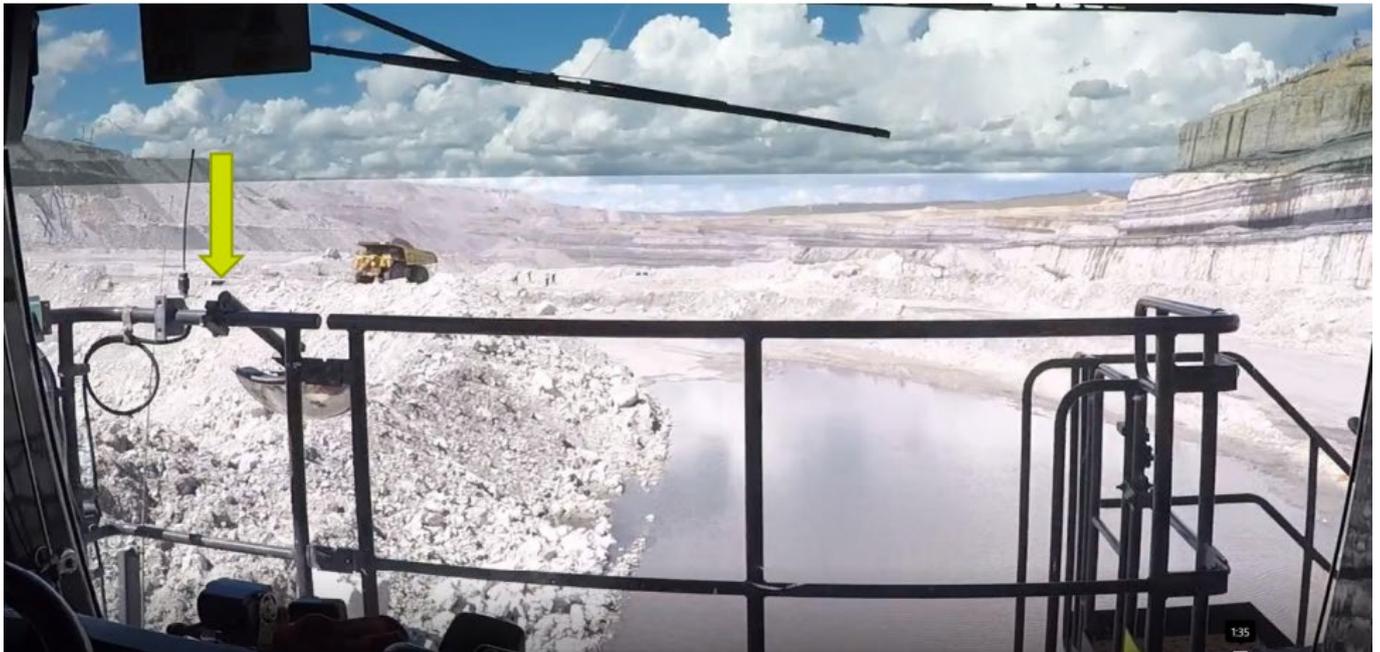
Testing conducted as part of the investigation identified the light vehicle became partially visible to the haul truck operator when he was about 88 metres away from it. However, as can be seen by Figure 7, it is difficult to identify the light vehicle even with the benefit of hindsight. Additionally, the presence of the Caterpillar truck at the intersection (and other distractions referred to in Section 4.1.5) drew the haul truck operator's attention away from the light vehicle.

Figure 7 - View from cabin of haul truck when it was about 88 metres from light vehicle - light vehicle partially visible

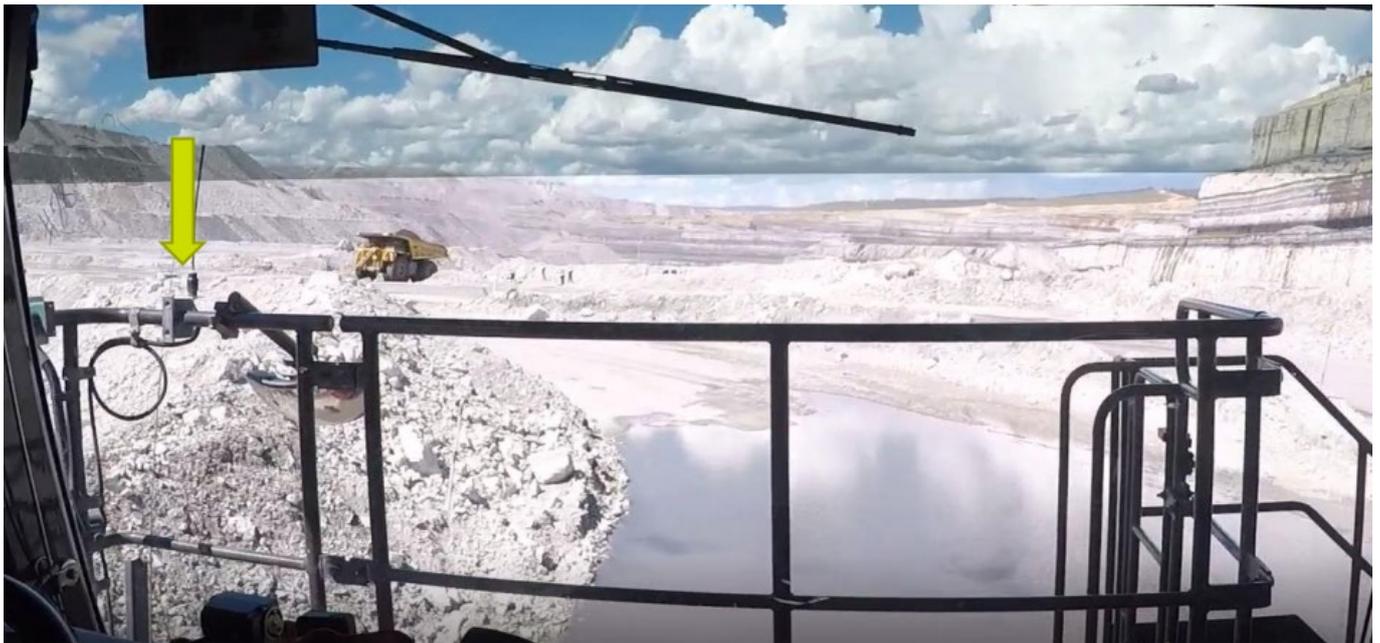
As the haul truck continued to travel along the road approaching the intersection, the light vehicle continued to be fully or partially obscured by the windrow as shown by Figure 8 and Figure 9.

Figure 8 - View from cabin of Hitachi truck when it was about 80 metres from the light vehicle - light vehicle not visible

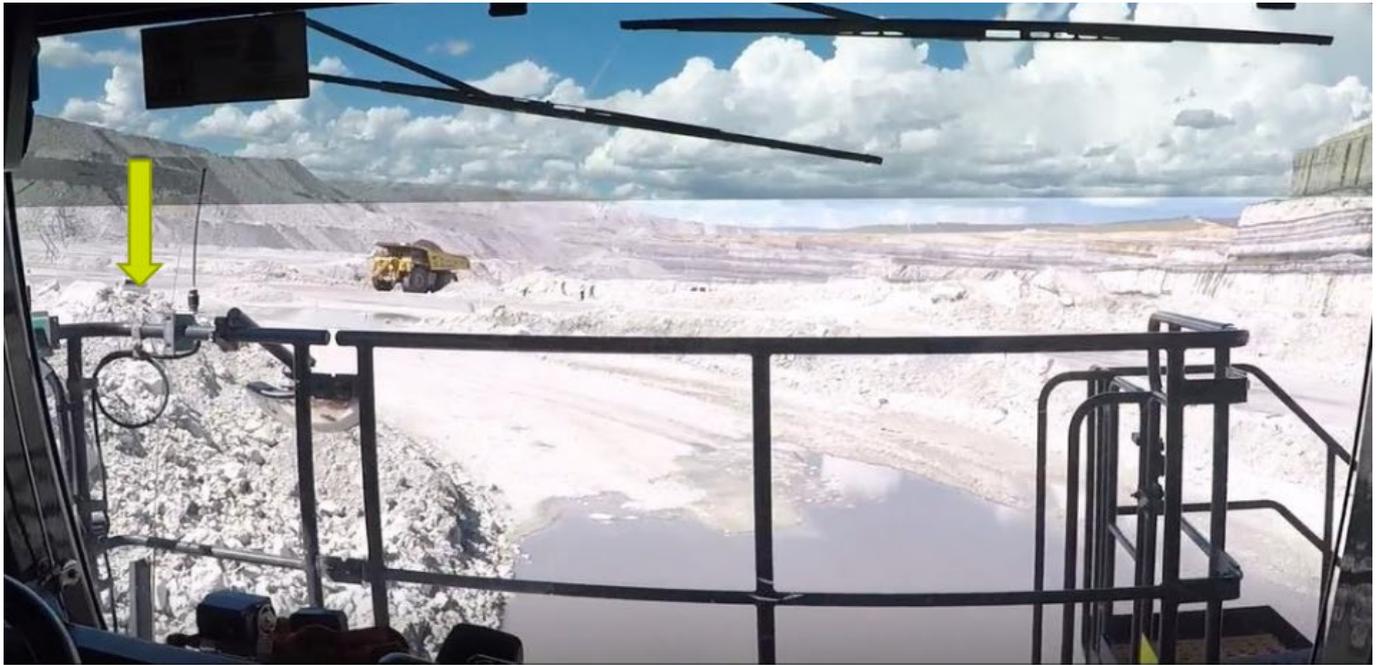
Figure 9 - View from cabin of haul truck when it was about 65 metres from the light vehicle - light vehicle now visible

The light vehicle became more fully visible when the haul truck was about 65 metres away from it. It remained visible from that point onwards.

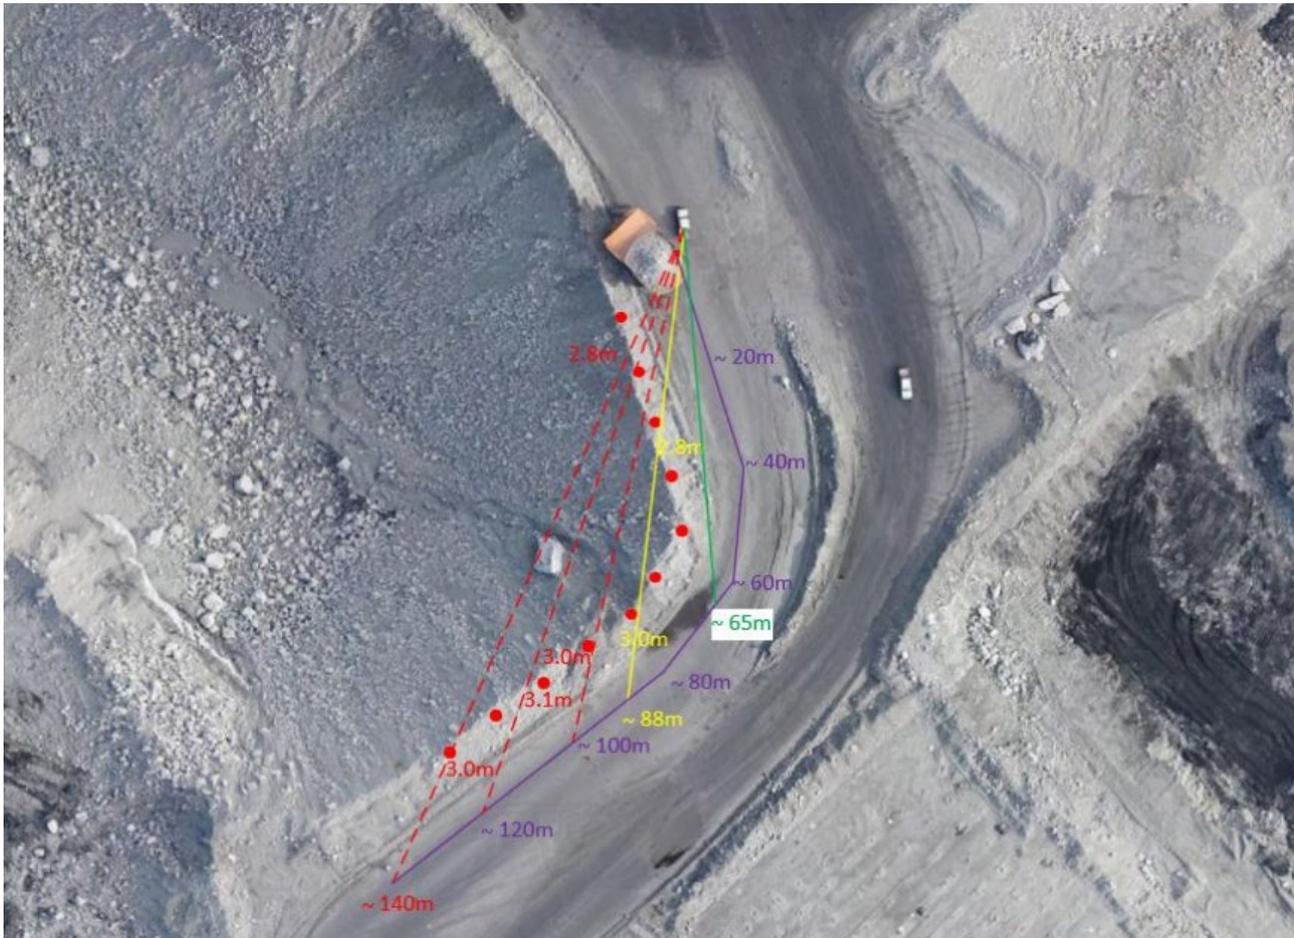
Figure 10 - Plot of lines of sight from cabin of Hitachi truck

The effect of the roadside windrow on line-of-sight distances of the light vehicle from the cabin of the haul truck are plotted in Figure 10.

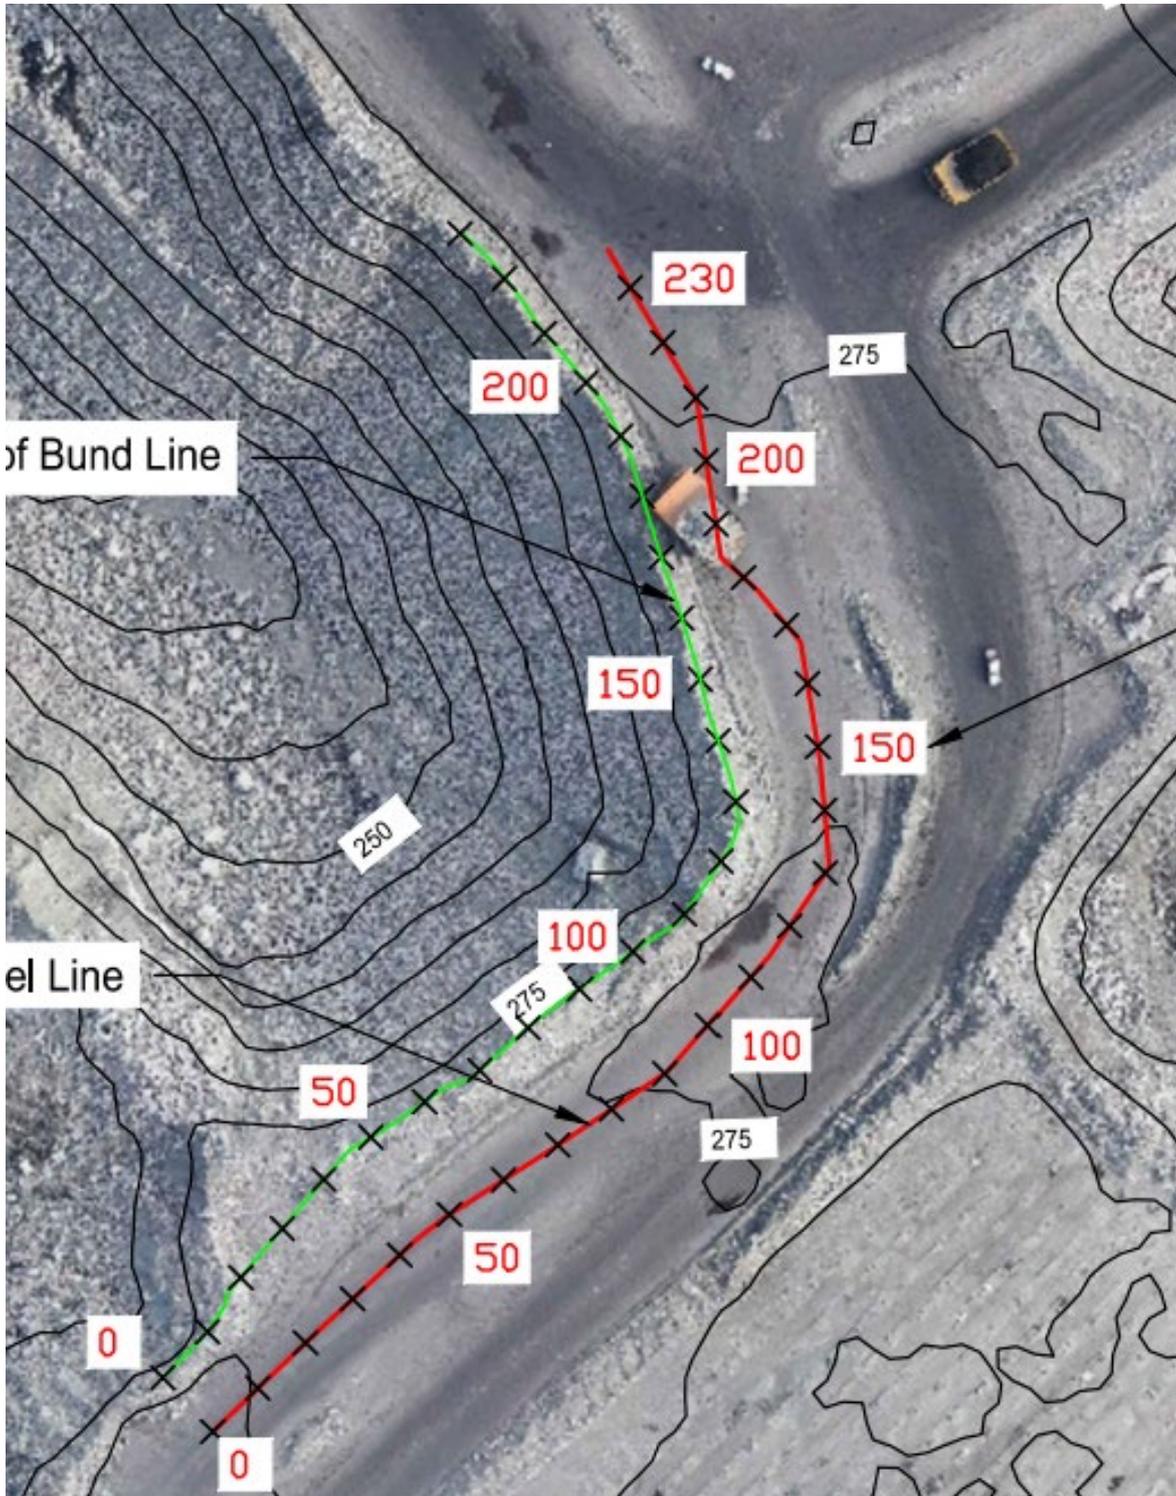
Figure 11 - Long section distances at the incident location

The effect of the roadside windrow heights on the haul truck operator's sight distance was exacerbated by the relatively short distance between the intersection and the preceding bend. As shown in Figure 11, the distance between the intersection and entry to the bend was about 85 to 90 metres (each cross represents 10 metres).

Increasing the radius of the inside curve of the bend, or opening up the angle of approach to the intersection, would have created a more open curved approach and improved the line of sight to the intersection, thereby increasing the sight distance of vehicle operators.

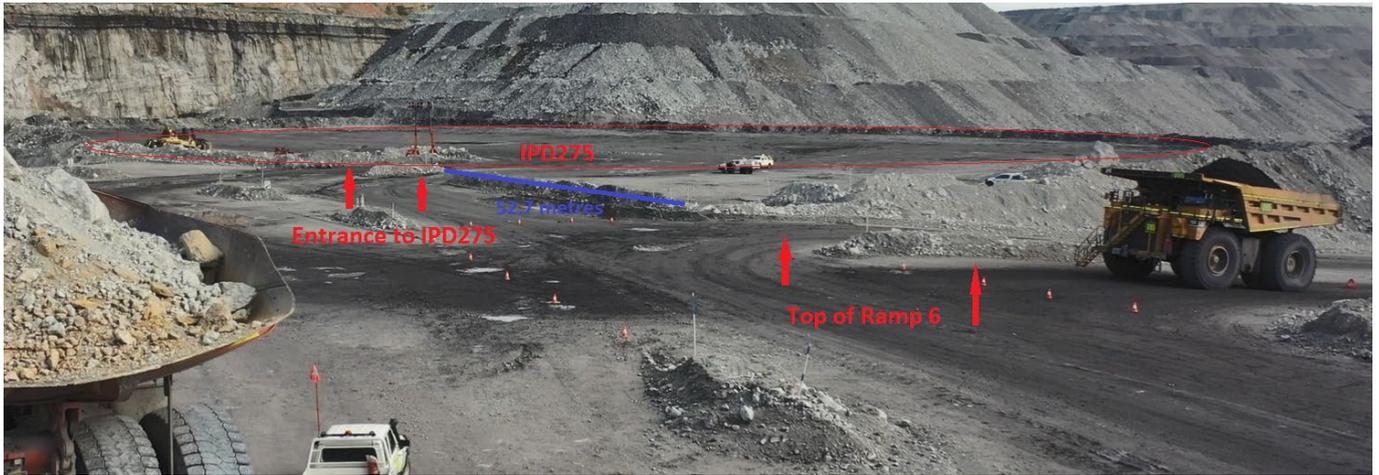
Trucks accessing IPD275 were a potential point of distraction for operators approaching the intersection. The haul truck operator told investigators he was looking into IPD275 as he approached the intersection. This distracted his attention away from the light vehicle.

Figure 13 - Proximity of IPD275 intersection to incident intersection – a truck operator’s perspective

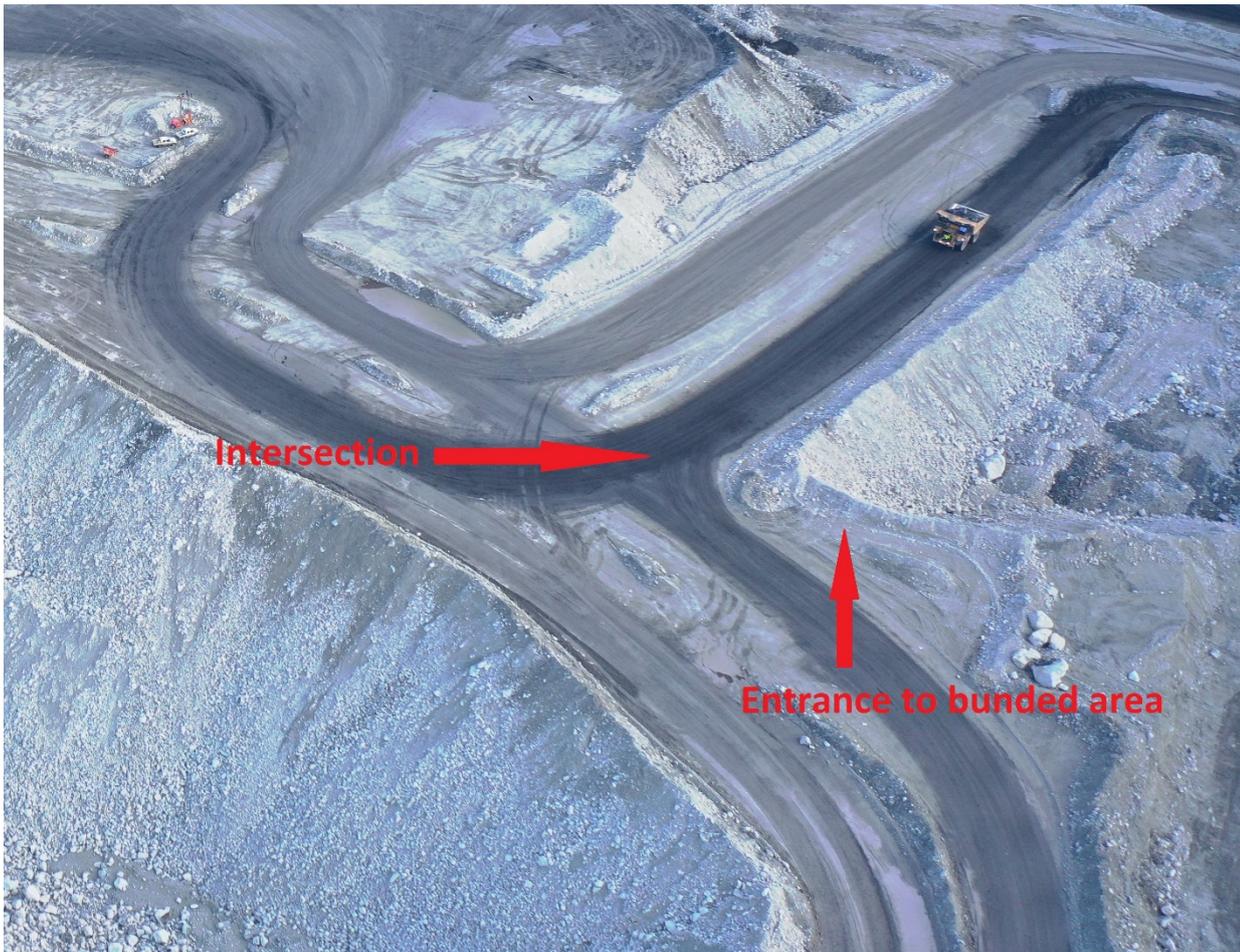
Figure 14 - Bunded area off the access road to IPD275

A bunded area was constructed to the side of the westbound lane of Ramp 6. There was nothing preventing vehicles entering and exiting the bunded area from the IPD275 access road. It was not demarcated as a no-go zone as it should have been if the area was not in use.

The bunded area had the appearance of a road, although the mine operator told investigators it was not a road. It said the bunded area was established between 10 and 15 November 2021 to house a lighting tower. Regardless of its actual or intended use, the area was an additional distraction for vehicle operators approaching the area.

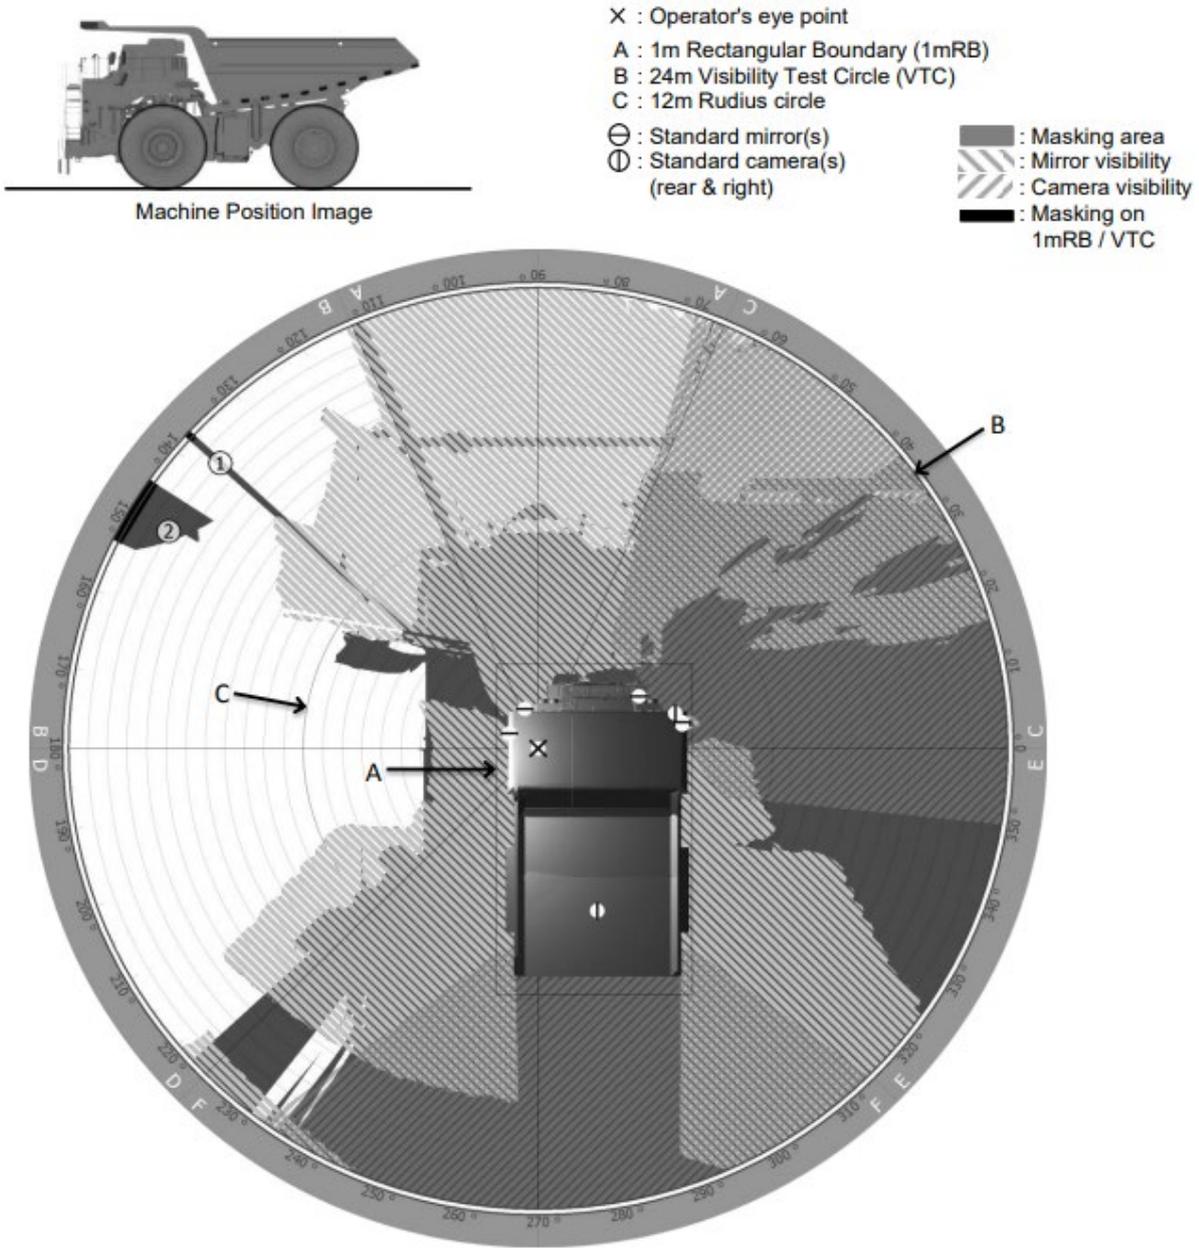
Figure 15 - Visibility map for Hitachi Machine Model EH5000AC-3

Numerous blind spots exist from the cabin of Hitachi EH5000AC-3 trucks as shown by the following visibility map:

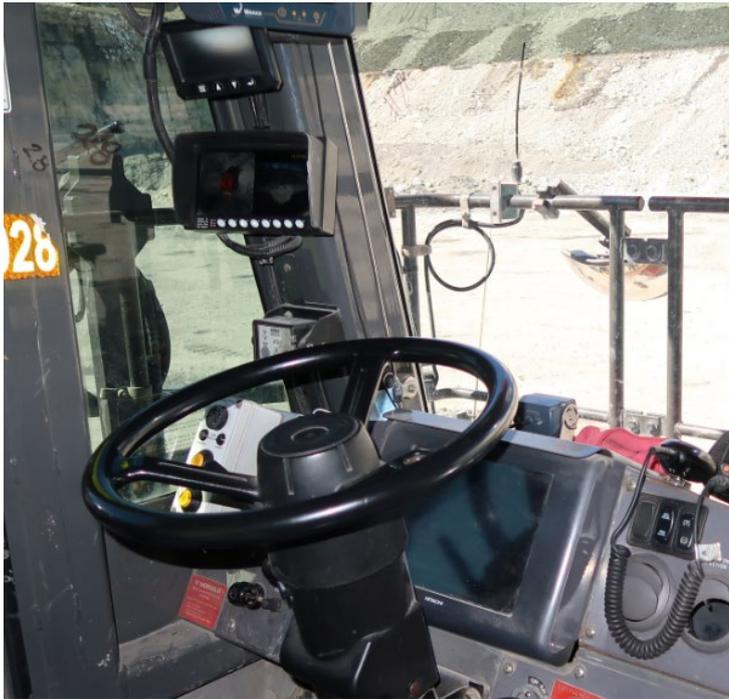
Figure 16 - View from cabin of Hitachi truck

Aftermarket instrumentation retrofitted by the mine operator on the front left pillar of the haul truck's cabin may have further reduced the operators' view.

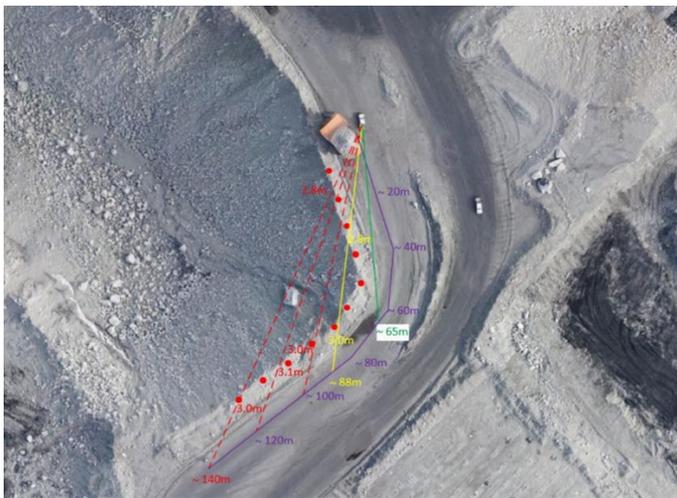
Figure 17 - Sight distance analysis based on incident

The light vehicle stopped about 19 metres before the intersection and slightly to the left of the centre of the lane it was travelling in. This reduced the limited sight distance that the haul truck operator had as he approached the light vehicle. This is evident from Figures 17 and 18 that show the haul truck operator's sight distance would have increased from 65 to 70 metres if the light vehicle was positioned further forward and to the right of the centre of the lane.

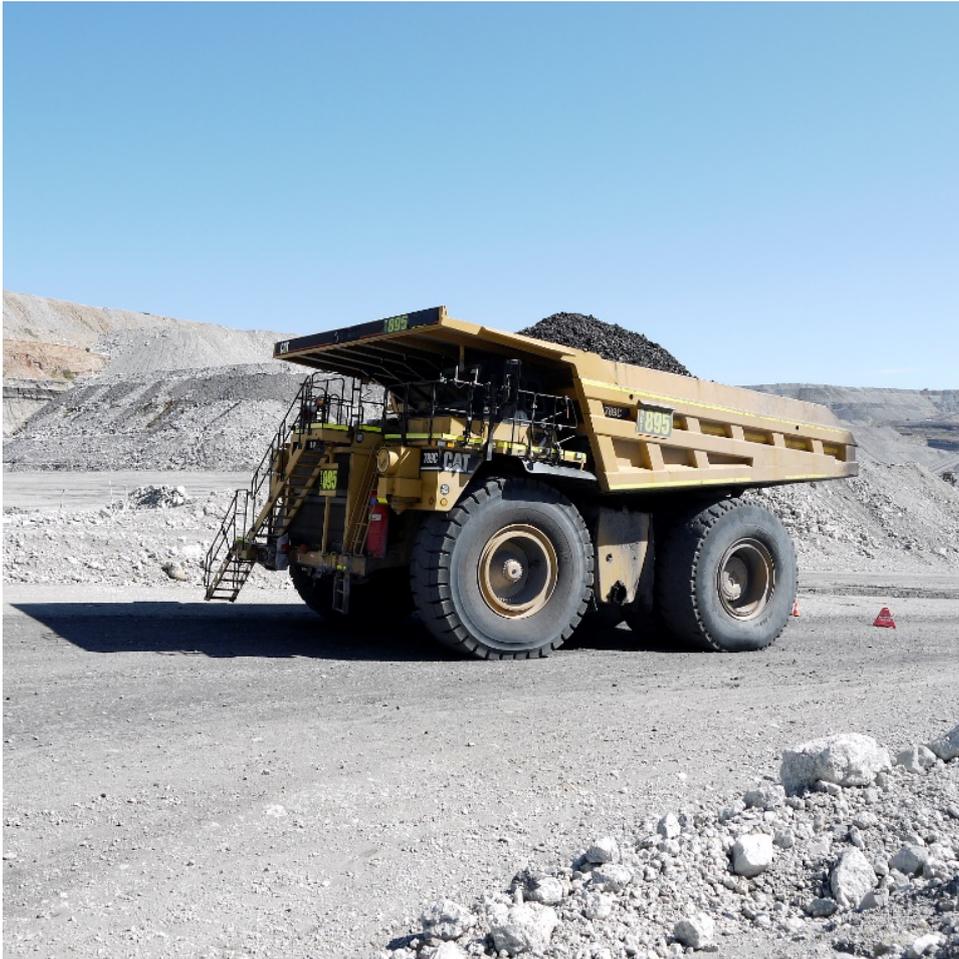
Where the Caterpillar truck stopped at the top of Ramp 6 had a grade of 9 percent.

Figure 19 - Stopped position of Caterpillar truck showing grade

This may have impaired the operator's ability to see the light vehicle by changing the angle of his field of view, effectively increasing the size of the truck's height related blind spot.

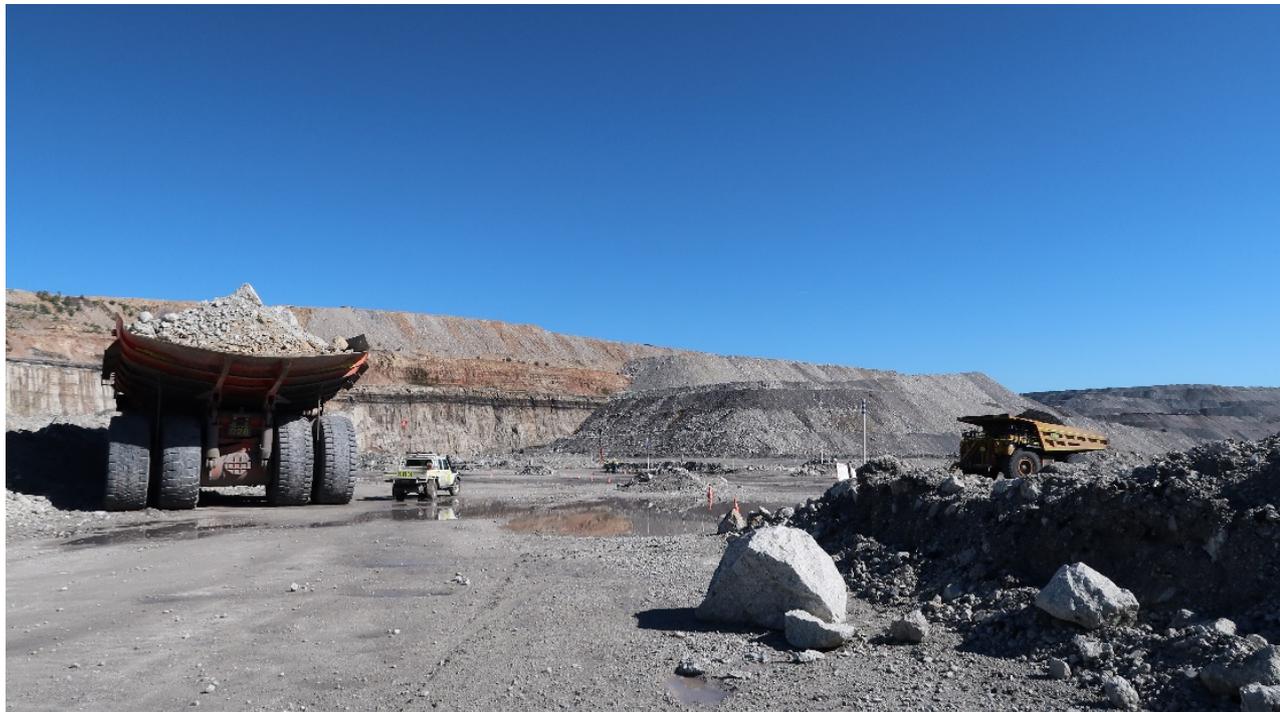
Figure 22 - Large rock on road

There was a large rock on the right edge of the northbound lane on the exit to the bend before the intersection. It provided an additional point of distraction. The haul truck operator stated he saw the rock on previous runs through the area and was looking out for it as he travelled around the bend.

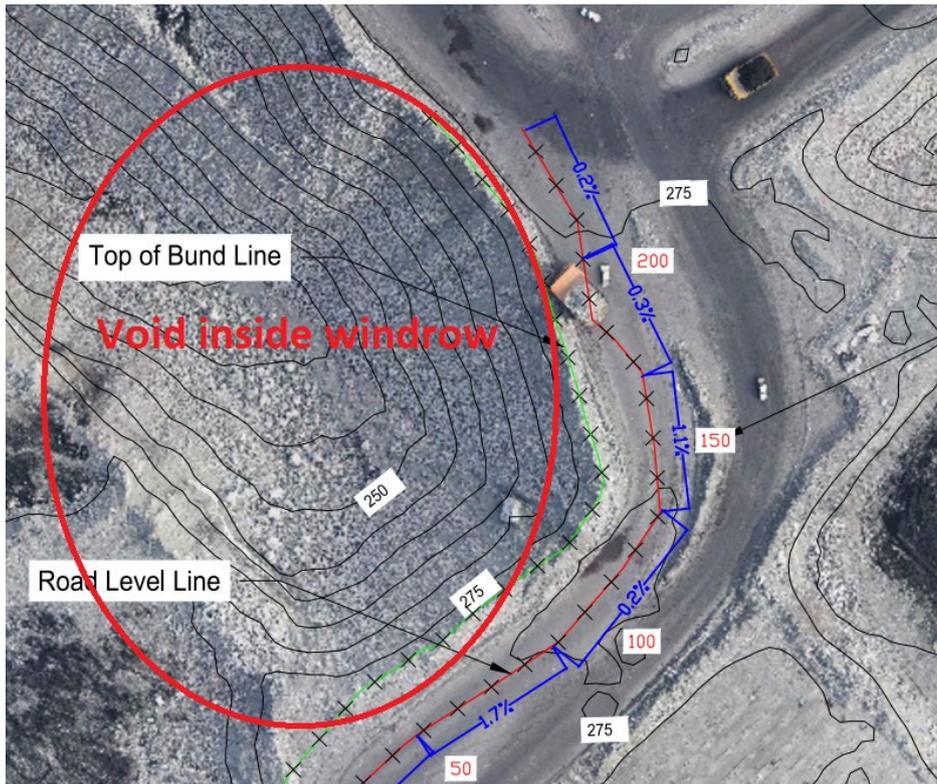
Figure 24 - Contour survey showing void

other side of the road and higher windrows were required to avoid the risk of vehicles entering the void.

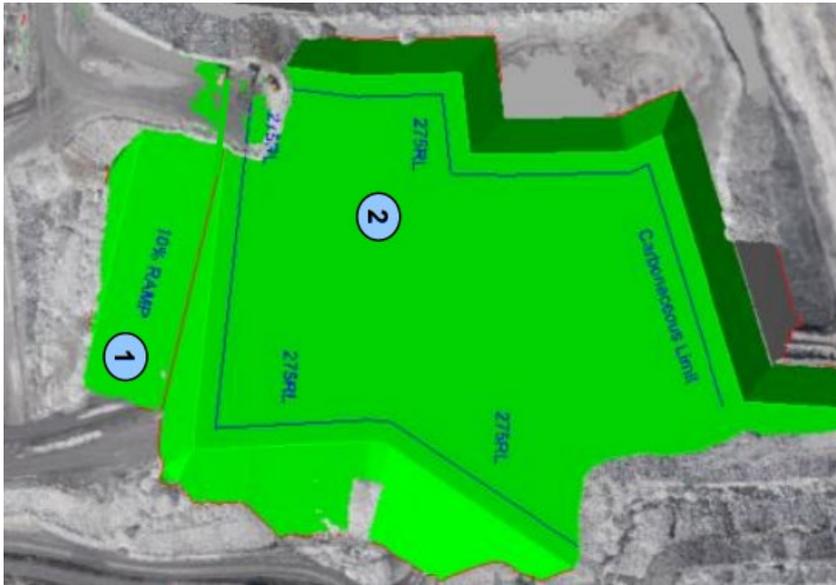
Figure 25 - Insert from IPD275 plan

Although mining supervisors discussed making some changes to the plan that would have permitted a flat spot to be established, the ramp was ultimately commissioned without the flat spot required by the standard.
