Weekly incident summary

Week ending 22 March 2024

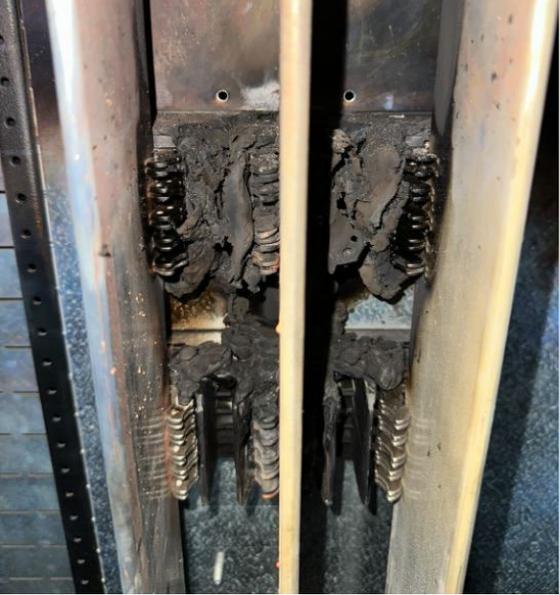
Incident type	Summary	Comments to industry
Dangerous incident IncNot0046589 Underground metals mine	A switchroom starter for an underground conveyor tripped and couldn't be reset. An electrician could smell something burning and opened the cubicle doors. The cubicle emitted smoke, but no flames were seen. A further investigation revealed that the busbar plug had melted.	Mine operators must review the service life of all circuit breakers considering the operating conditions and clearance of fault conditions. Mine operators should also ensure workers are aware of procedures and competency requirements for the restoration of electrical protection. Mine operators should ensure that the electrical protection devices are rated for the application.

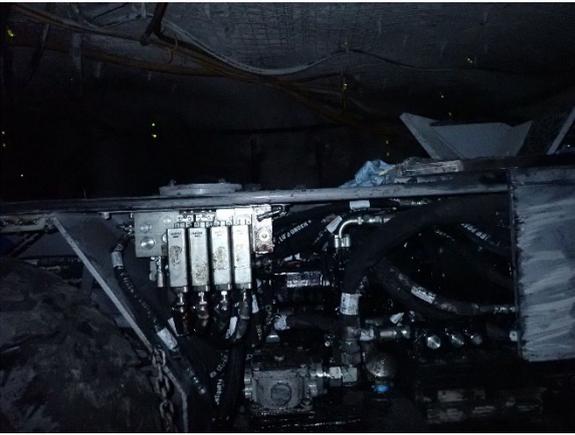
<p>Dangerous incident IncNot0046591 Underground coal mine</p>	<p>A shuttle car had a leaking valve bank during night shift that was repaired. On the day shift, it was found to be leaking again during the prestart. A fitter isolated the shuttle car and was sprayed with hydraulic oil in the face and chest while removing the brake pressure solenoid. The fitter had oil in his left eye despite wearing safety glasses.</p> <p>The accumulator circuit pressure was not dissipated.</p>

<p>Effective isolation and energy dissipation practices are critical risk controls when working with high pressure fluid systems. Mine risk assessments on hydraulic systems must identify and provide effective controls for areas where trapped fluid poses a hazard.</p> <p>Workers must be trained regularly in the isolation procedures for equipment they are tasked to operate, maintain, and repair on site.</p>
