Weekly incident summary

Week ending 8 March 2024

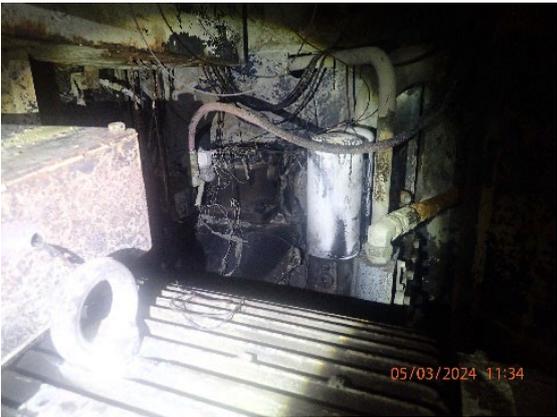
Incident type	Summary	Comments to industry
Dangerous incident IncNot0046464 Underground metals mine Fire or explosion

Underground workers had to retreat to refuge chambers following a fire on a compressor. An emergency response team was sent to one person who was in a refuge chamber close to the fire location. Nobody was injured.

Maintenance systems must be comprehensive and should consider all reasonably, foreseeable risks of fire or explosion. Plant and equipment must be maintained in accordance with Work Health and Safety Regulation 2017 clause 213 Maintenance and inspection of plant. Non-destructive testing (NDT) inspections should be scheduled at pre-determined intervals to minimise the risk of equipment failure.

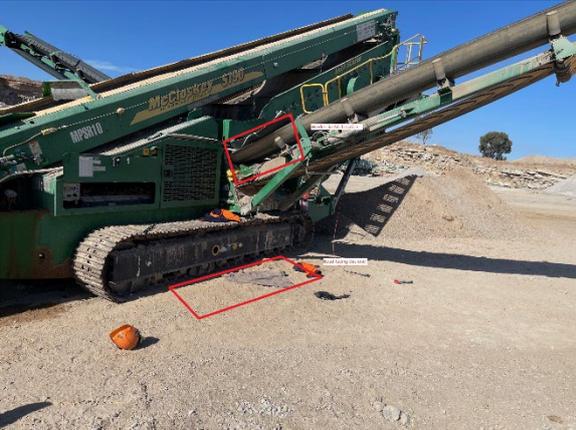
Incident type	Summary	Comments to industry
<p>Serious injury IncNot0046472 Construction materials</p>	<p>A worker fell about 2.4 metres and suffered 2 breaks and 3 fractures to his lower back. He was helping a contract welder with maintenance on a side conveyor on a tracked mobile screen when he fell backwards, striking the machine tracks before hitting the ground.</p>

<p>Mine operators are reminded that they have specific obligations under the WHS Regulations to manage the risk of a fall by a person. This includes having suitably rated attachment points for lanyards.</p> <p>Work positioning systems require a high level of competency on the part of the user and supervisor to ensure safe use. Users should undertake competency-based training on work positioning systems. This training should include the selection of the correct harness and lanyard type. For more information about working at heights please refer to the SafeWork Code of practice: Managing the risk of falls at workplaces.</p>

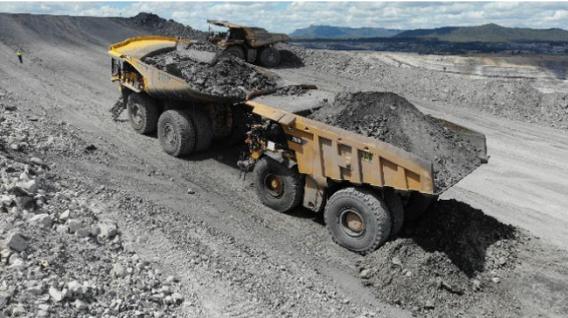
<p>Dangerous incident IncNot0046493 Open cut coal mine Roads or other vehicle operating areas</p>

<p>Two loaded trucks collided while driving up a ramp. The truck in front stopped and the truck behind ran into the back of it. The tray of the front truck went over the cab of the rear truck as per design and there were no injuries.</p>

<p>Drivers should remain focused on the task at hand and not be distracted while driving. Drivers should find a safe place to stop and address any issues, rather than continuing to drive.</p> <p>Schedule 2 of the Work Health and Safety (Mines and Petroleum Sites) Regulation 2014 includes the requirement that a health control plan must address control measures for minimising the risk that a worker will be impaired by fatigue.</p> <p>Mine operators should include worker fatigue monitoring and response technology as a part of their fatigue risk analysis.</p>
