# Investigation information release

## Driller's assistant seriously injured at CSA mine

Incident date: 11 April 2024

**Location:** CSA mine, Louth Road, Cobar NSW

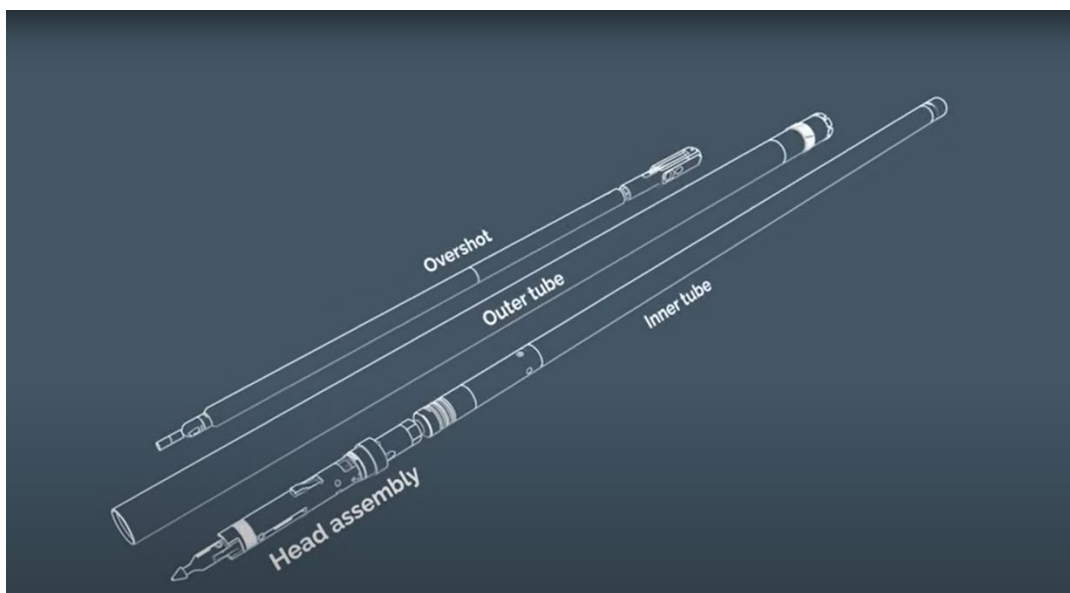
Two workers, operating a Boart Longyear drill rig, were conducting diamond drilling at the 8470 EXP level of the mine about 1.35 am on 11 April 2024. Drilling operations were conducted by a driller and a driller's assistant, with each worker having specific tasks. Drilling operations were conducted to obtain core samples from the ground using an outer tube, an inner tube and an overshot (**figure 1**).

Figure 1: Parts used to obtain core samples

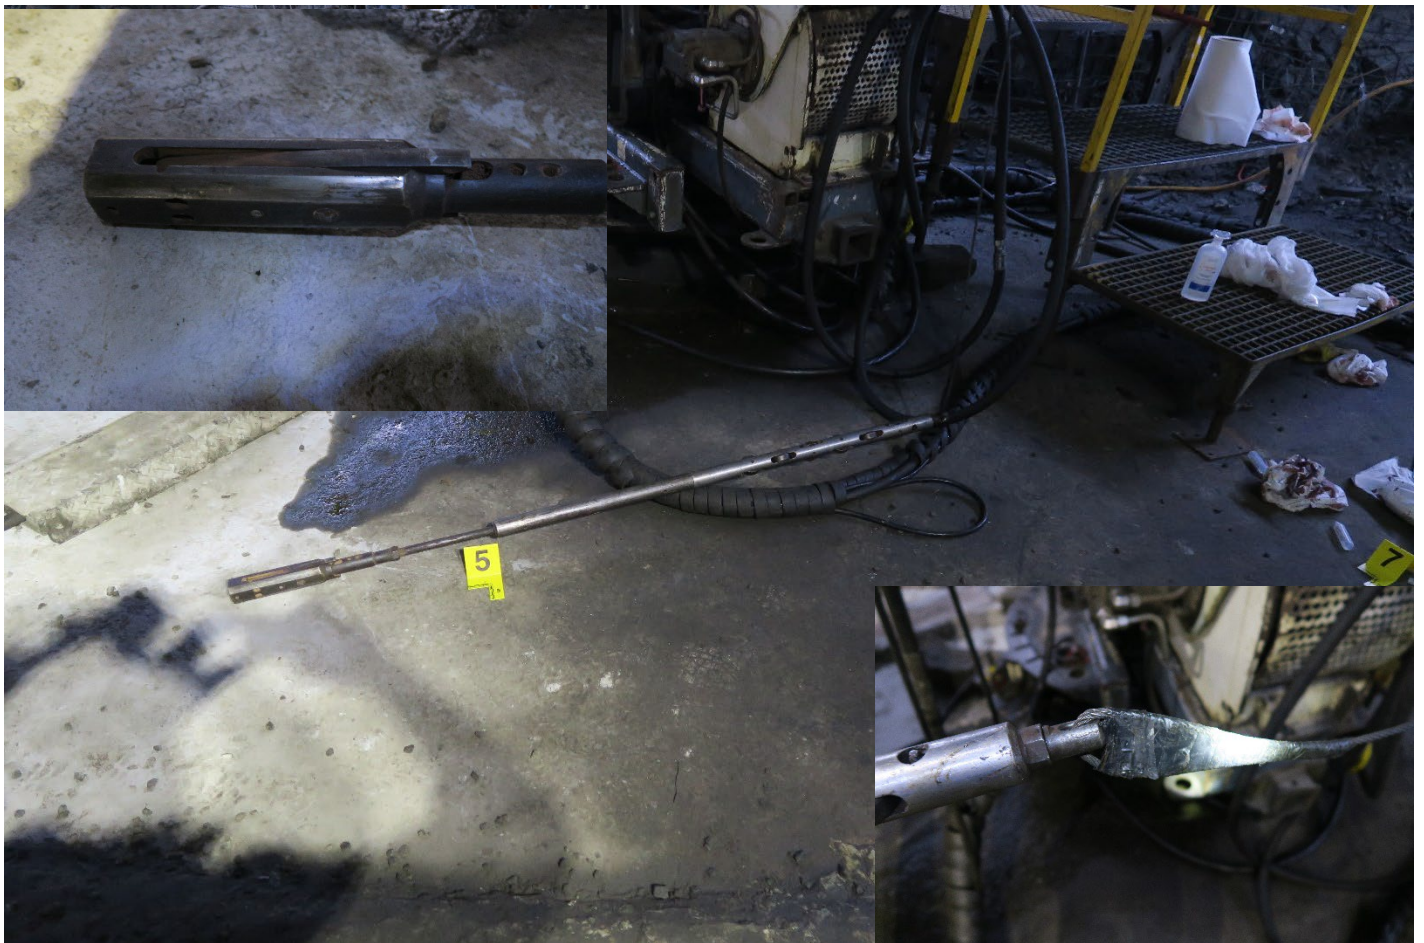
One of the tasks conducted by a driller's assistant included the operation of an overshoot (**figure 2**). An overshoot was connected to a drill rig's winder via a steel cable. It is manually lowered into an outer tube after which a locking pin (ezy-lock) connects it to the inner tube that contains a core sample. The overshoot is then retracted by operation of the drill rig's winder, extracting the inner tube with the core sample. When not in use the overshoot was normally positioned on the jump up stand.

Figure 2: Photo of the overshoot with inner pictures of the locking pins and cable connection

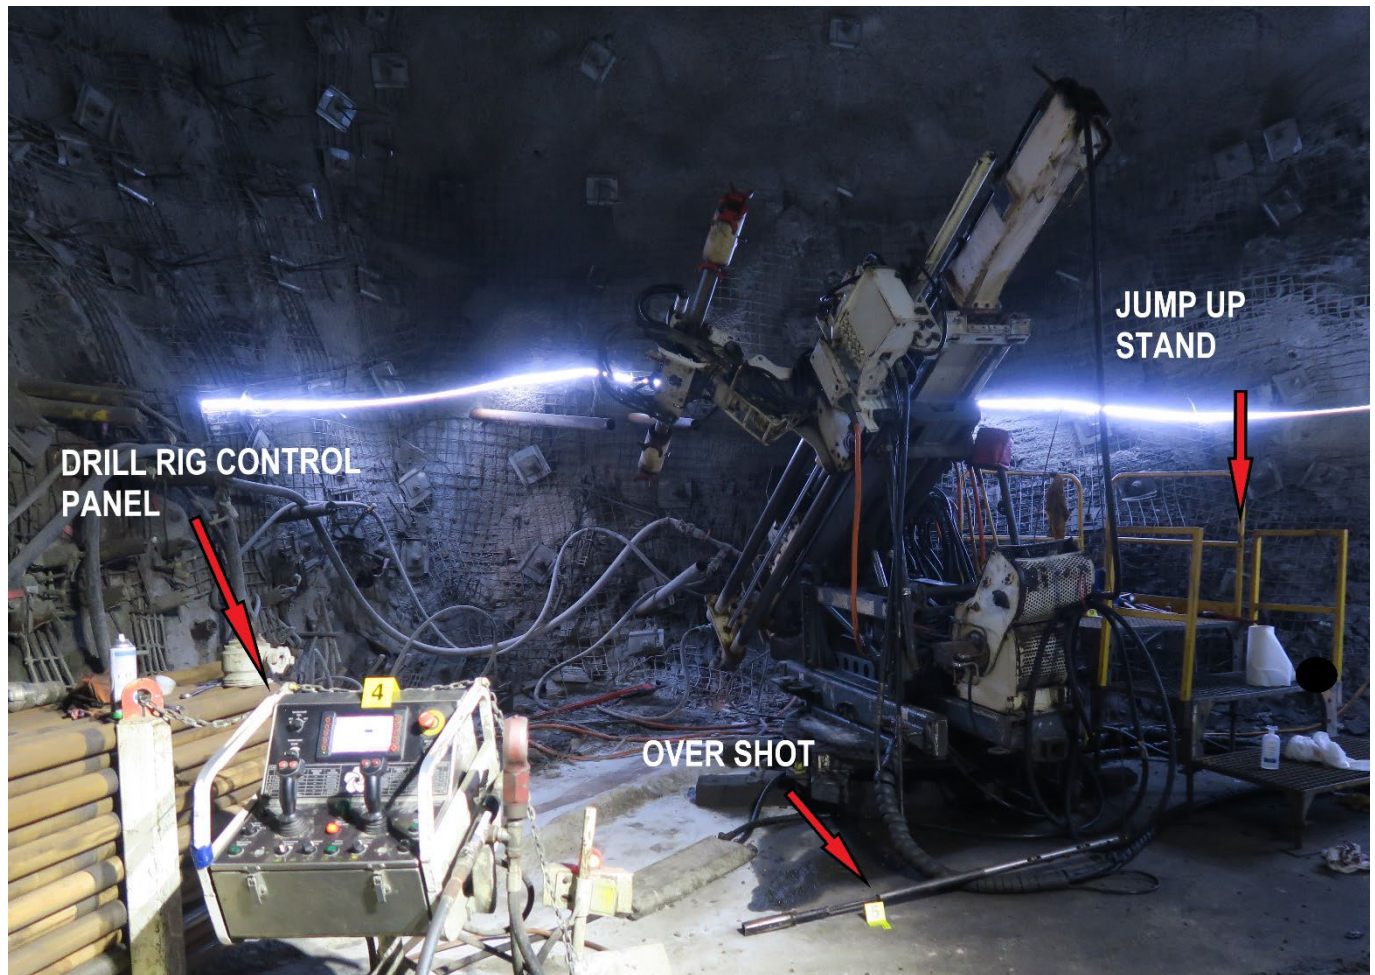
While operating the control panel, the driller saw the driller's assistant in the vicinity of the jump up stand. A short time later, the driller saw the assistant fall backwards off the stand onto the ground, a height of about half a metre. The driller ran to help and found the worker unconscious with serious head injuries.

At the time of writing it was unknown what caused the assistant to fall backwards. The overshoot had not been inserted into the drill rod, and immediately after the incident, the driller saw the overshoot suspended by a cable about 1 metre from the top of the mast. The overshoot was swinging back and forth. It was not known where the overshoot was situated or stored immediately before the incident.

Figure 3: Photo of the drill rig, control panel, overshoot and jump up stand at incident site – 8470 EXP level

Mine operators and plant contactors are reminded of their duty to manage the risk to health and safety associated with an object falling (the risk) on a worker in accordance with *clauses 54 and 55* of the *Work Health and Safety Regulation 2017* by, so far as reasonably practicable, taking the following steps in the following order and in combination:

1. Eliminating the risk, or
2. minimising the risk by providing:
  - a. adequate protection against the risk through a safe system of work that:
    - i. prevents an object from falling freely, or
    - ii. arrests the fall of a falling object if prevention is not reasonably practicable.
  - b. A secure barrier or an exclusion zone that prohibits entry by workers into the fall zone.
