Investigation report

Serious hand injury to a worker operating a mobile screen

July 2024

Published by the Department of Primary Industries and Regional Development

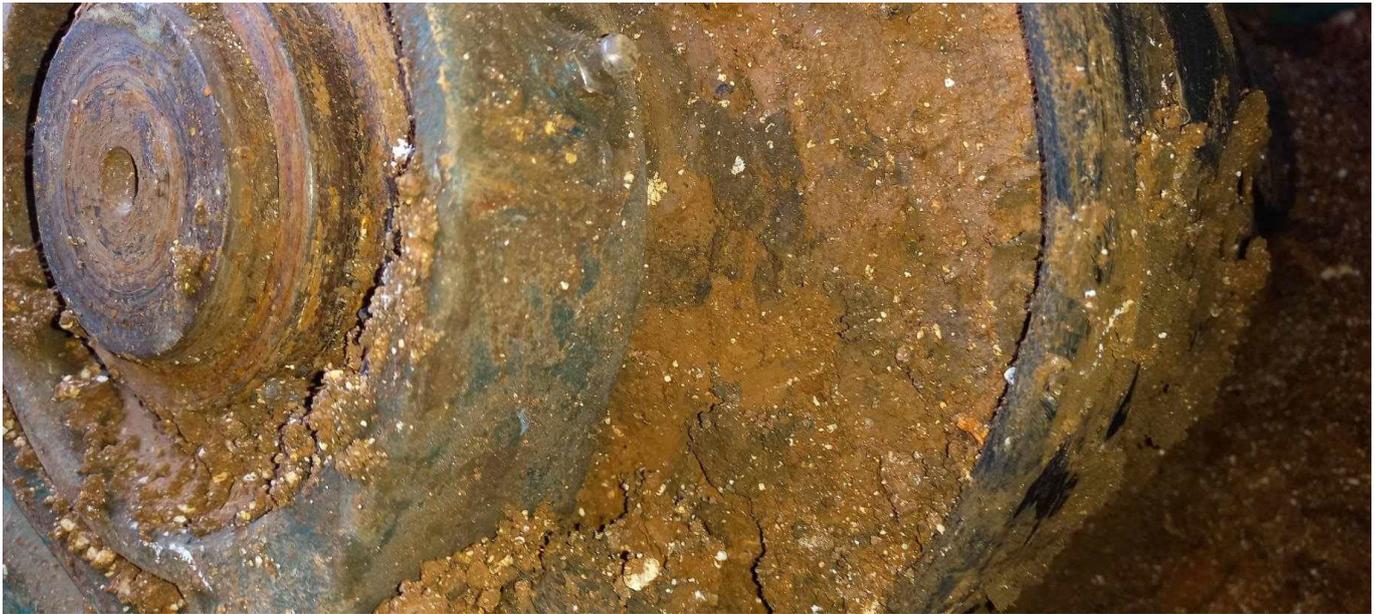
The incident occurred at the stockpile area of the mine where two workers were cleaning the tail drum of the main conveyor on the mobile screen. The conveyor belt had tracked to one side due to a build-up of clay mud on the tail drum caused by wet conditions at the mine and lack of regular cleaning of the mobile screen. The workers had two weeks (the injured worker) and four months (the other worker) experience respectively operating the mobile screen and were conducting the task with no instructions having been provided to them regarding a safe work practice or procedure.

Figure 2 Photograph taken by a worker of clay mud build-up on the tail drum and main conveyor belt prior to the incident

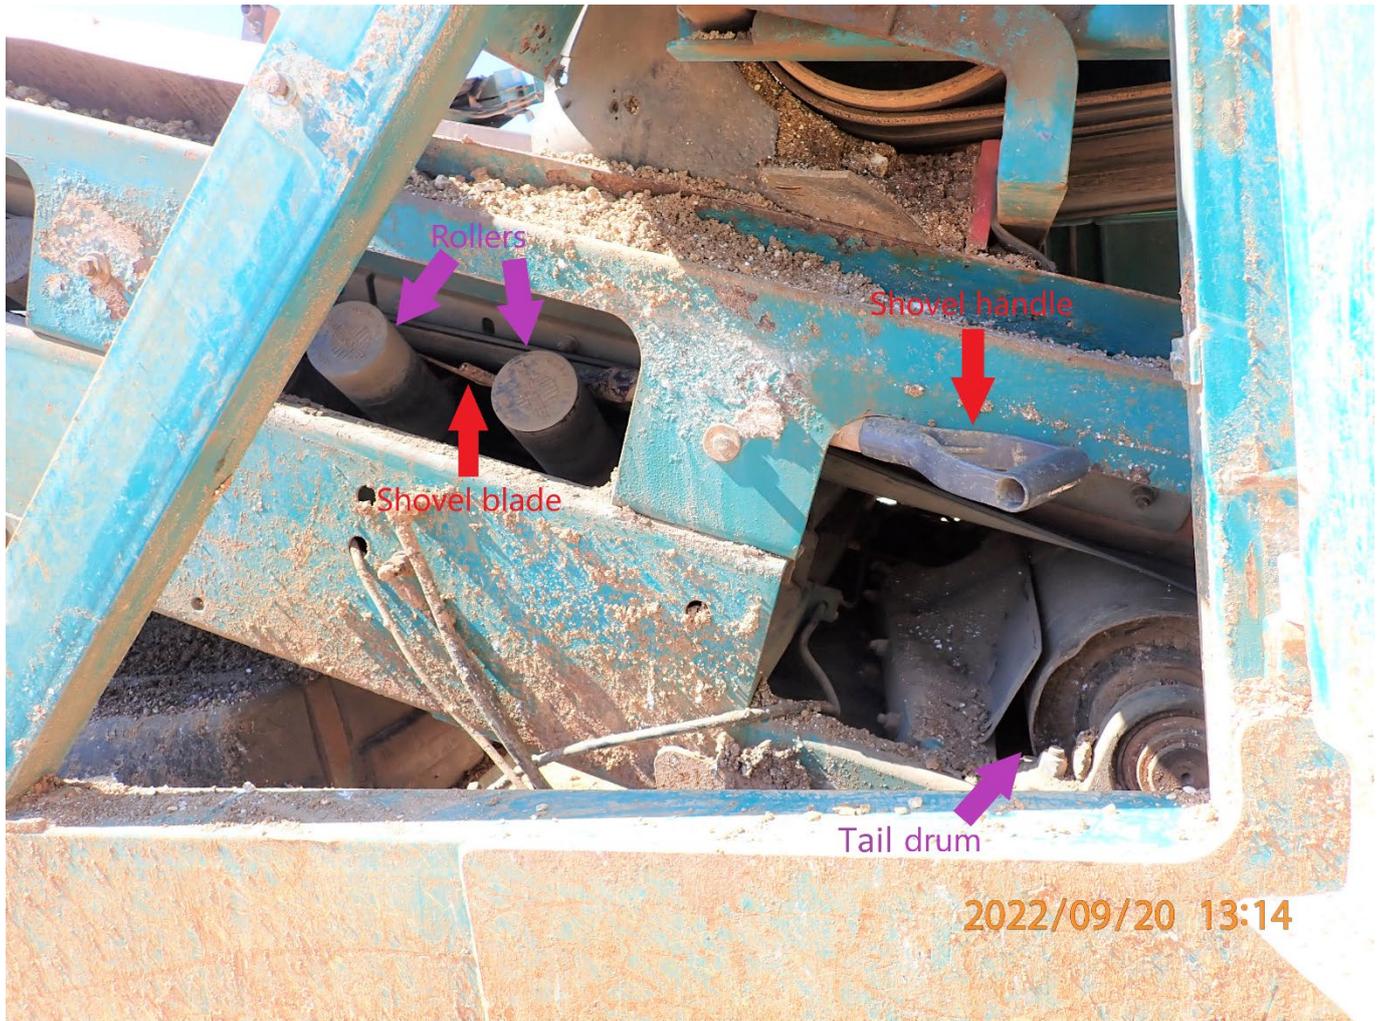
While the belt was moving at speed one worker walked around to the opposite side of the mobile screen. At this time the injured worker again placed the spade against the rotating tail drum, which caught the spade causing it to be pulled into the conveyor rollers. The worker had one hand on the handle and the other hand on the shaft of the spade as it was drawn into the moving conveyor rollers. The motion of the conveyor rollers caused the spade to be pulled across his shoulder. He forcefully 'yanked' his hands off the spade to prevent his hands and arms from being pulled into the conveyor belt along with the spade. In doing so, he sustained serious injuries to his left hand consisting of degloving of the thumb and a tip amputation to his ring finger.

Figure 3 Final resting position of the spade following the incident
