Weekly incident summary

Week ending 21 July 2024

Weekly incident summary week ending 21 July 2024

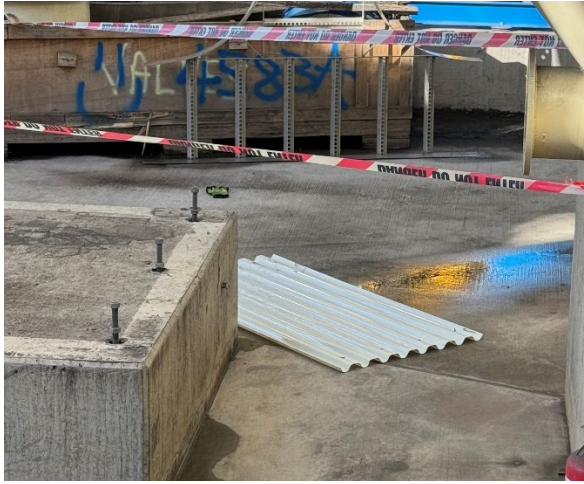
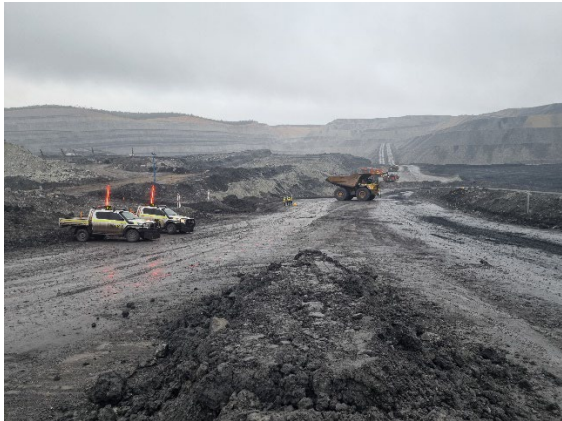
Incident type	Summary	Comments to industry
<p>High potential incident IncNot 0047289 Open cut coal mine Roads or other vehicle operating areas</p>

<p>An empty CAT789 truck was descending a ramp. Rain had started to fall about 30 minutes earlier.</p> <p>As the operator rounded a left-hand bend towards the bottom of the ramp the truck lost traction at slow speed, resulting in the truck sliding about 50 m down the ramp, crossing the centre line, and ending up rotating 90 degrees.</p>

<p>Situational awareness is a key control when operating mobile equipment. Adequate supervision, training, job planning and risk assessments should be considered and completed before undertaking tasks. Procedures to assess the adverse effects caused by changes in weather and road conditions should be communicated to workers and implemented to prevent incidents.</p> <p>Following a recent awareness campaign on vehicle interactions the Regulator published a video that can be used for training purposes and toolbox talks. Mine operators are encouraged to use this resource. You can watch the video on YouTube.</p>

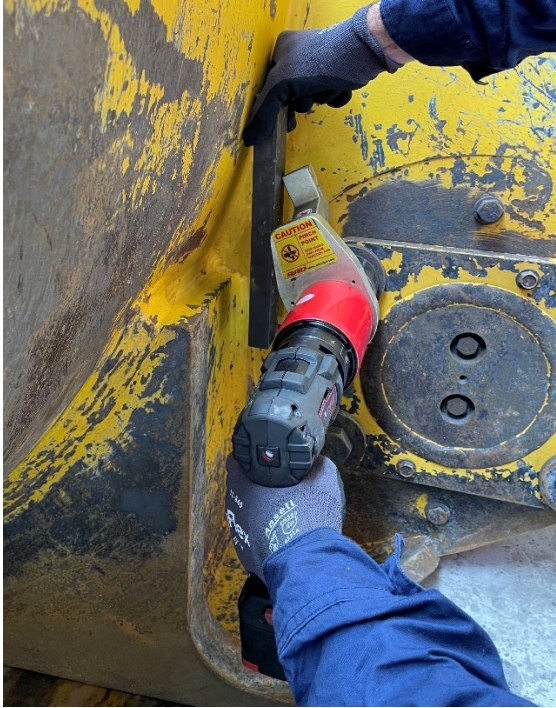
<p>High potential incident IncNot 0047281 Open cut coal mine</p>	<p>A mechanical tradesperson was removing the bucket pins from a front-end loader during a bucket change out. He attempted to remove one of the pin cap retaining bolts with an impact wrench but could not loosen the bolt. He obtained a battery powered torque wrench to complete the task. When setting up the torque wrench on the bolt he was attempting to remove he determined that the torque reaction arm required packing for it to engage against the back of the bucket. He obtained a piece of steel for this purpose.</p>	<p>There were 2 incidents this week involving inadvertent operation of battery powered torque wrenches. Both incidents were very similar in cause and circumstance.</p> <p>Workers are reminded that they should only use mechanical equipment if they are trained and competent. Equipment should only be used in the manner intended by the original equipment</p>

Incident type	Summary	Comments to industry
	<p>While positioning the steel packer with his right hand between the torque arm and the bucket he inadvertently operated the torque wrench trigger with his left hand causing the reaction arm to rotate against the steel packing. His thumb was between the steel packing and the bucket, resulting in a crush injury.</p>

<p>manufacturer (OEM) and described in the mine operator's procedure.</p> <p>Mine operators must ensure that their mechanical trades are trained and competent to operate the equipment available to them. Mine operators must also ensure that appropriately risk assessed procedures are available to tradespeople during planned maintenance activities.</p>
