Investigation information release

Haul truck collides with excavator

Incident date: 20 February 2025

Location: Mt Arthur North (coal mine), Muswellbrook, NSW

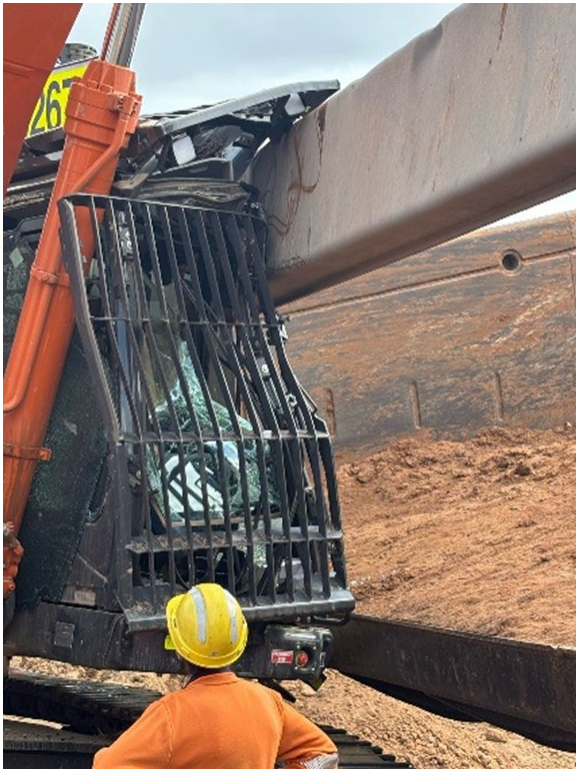
The rear of the truck and its tailgate collided with the side of the excavator's cabin. This caused the front left side pillar of the excavator to be pushed inward towards the operator and the cabin roof forced upward. Extensive damage was occasioned to the excavator's cabin and the operator was unable to exit the cabin using the normal means of egress.

Figure 1 - Collision between truck and excavator

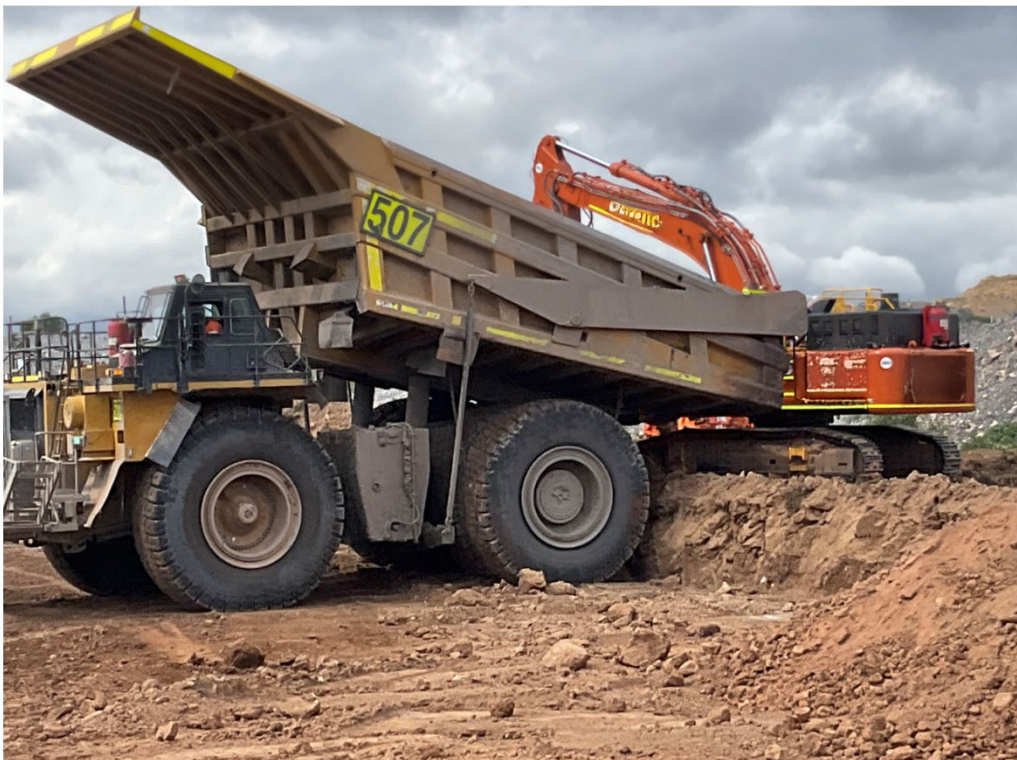
The excavator was on an angle across a relatively narrow bench, which was 1.9 metres high. The haul truck reversed towards the excavator without positive communications established between the operators.

The excavator operator tried to move the excavator out of the truck's path but was unable to do so because of the large size of the truck and the position of the excavator on the bench.

Figure 2 - Position of truck and excavator

- ensure when excavators are working in close proximity to haul trucks hard barriers are in-place, such as a sufficient bench height above the running surface, or an adequate separation windrow is maintained if operating at a level where interaction can physically occur

- ensure that backscratching only occurs in locations that are specifically designed for that purpose
- consider, and where reasonably practicable, incorporate the use of available technology to control mobile plant interactions such as proximity detection and collision avoidance systems
