Weekly incident summary

Week ending 28 February 2025

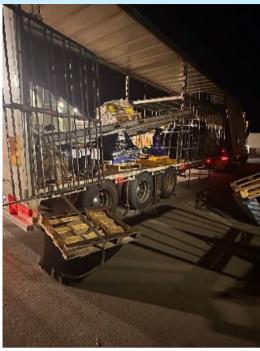
Incident type	Summary	Comments to industry
High potential incident IncNot0048660 Open cut coal mine	While unloading a freight delivery truck with a forklift, the forklift loading board made contact with the mezzanine deck on the truck, and dislodged it from its locating pins. The deck fell to the lower level. Nobody was injured.	Incidents such as this serve as a reminder of the need to have no-go zones and/or safe standing zones in place where there is a possibility for energy release when there is a risk of objects falling from a height.

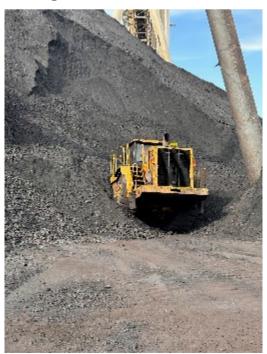
High potential incident IncNot0048656 Coal processing plant

A loader was taking a bucket of run-of-mine (ROM) coal from a stockpile when a portion of the stockpile collapsed onto the bucket and the left-hand side front wheel. The loader could not reverse out because of the additional weight of the material in and around the front of the machine.

The loader operator was uninjured and was able to get out of the machine.

Mine operators are reminded of the potential hazards associated with stockpiles.

Before starting work, supervisors and equipment operators should inspect and assess the work area to determine if hazards are present - such as the potential for material bridging and subsequently collapsing.

Planning for the work must include identifying hazards, risk assessment and control.

Additionally, workers must be familiar with different stockpile material properties and how this influences material behaviour on stockpiles.
