# Weekly incident summary

## Week ending 7 March 2025

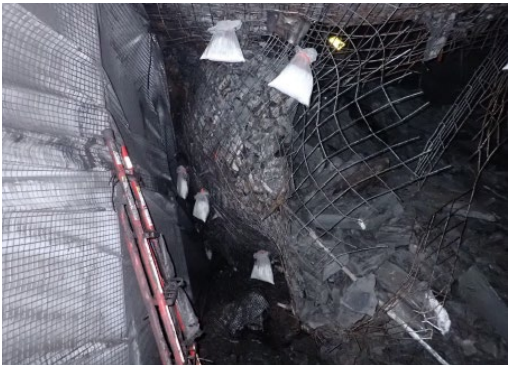
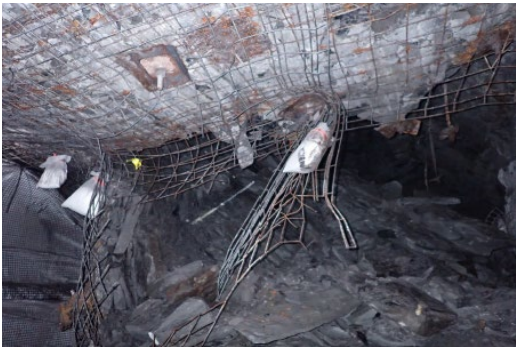
<p>See the link below to view a video developed by the Resources Regulator to help workers on mine sites ensure isolation is carried out correctly to prevent incidents in mines and to ensure workers understand how it is done properly.</p> <p><a href="http://www.resources.nsw.gov.au/news-articles/effective-isolation-procedure">www.resources.nsw.gov.au/news-articles/effective-isolation-procedure</a></p>
<p>Dangerous incident IncNot0048700 Underground coal mine Ground or strata failure</p>  	<p>A shearer was cutting back into the tailgate for a second shear of shift when the continuous miner worker noticed what appeared to be a roof fall adjacent to the tailgate drive. The longwall mining supervisor was contacted, who inspected and identified a roof fall that was impeding access from the tailgate. The area was barricaded to prevent access.</p>

<p>This incident highlights that loading applied to an active tailgate roadway ground support increases immediately outbye the faceline as the face retreats and abutment loads are redistributed outbye. This increase in loading on the installed ground support, particularly if accompanied by the presence of a localised geological anomaly can result in a fall of ground.</p> <p>The improvement of geotechnical inputs into ground support design has significantly reduced such failures over the past decade, however strata failure remains a fundamental risk with localised geological anomalies potentially affecting the adequacy of the ground support as it was designed and installed. Ground support designs will ideally be able to tolerate localised changes that demand more load-carrying ability from the installed ground support.</p>
