Investigation report

Forklift attachment injures worker

April 2025

Published by the Department of Primary Industries and Regional Development

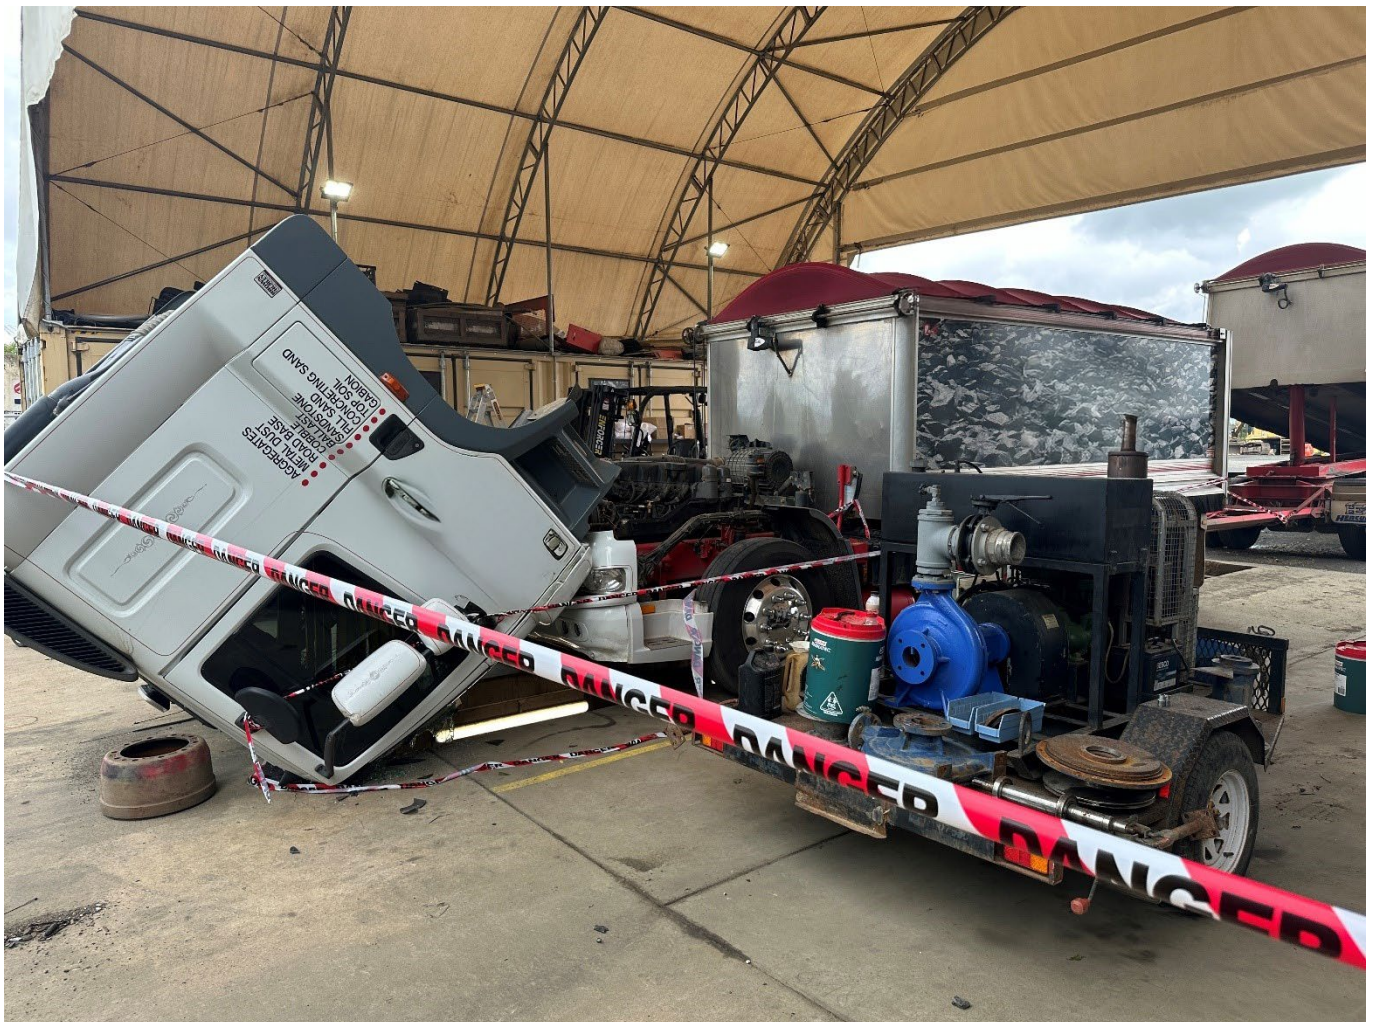
An apprentice mechanic was conducting an inspection of a tipper truck and dog trailer in the quarry's workshop on 1 March 2024. The hydraulic tilt lift cylinder detached from its mount as the worker tilted the cabin forward. This caused the front and top of the cabin to impact the ground.

Figure 1: Truck cabin in contact with the workshop ground

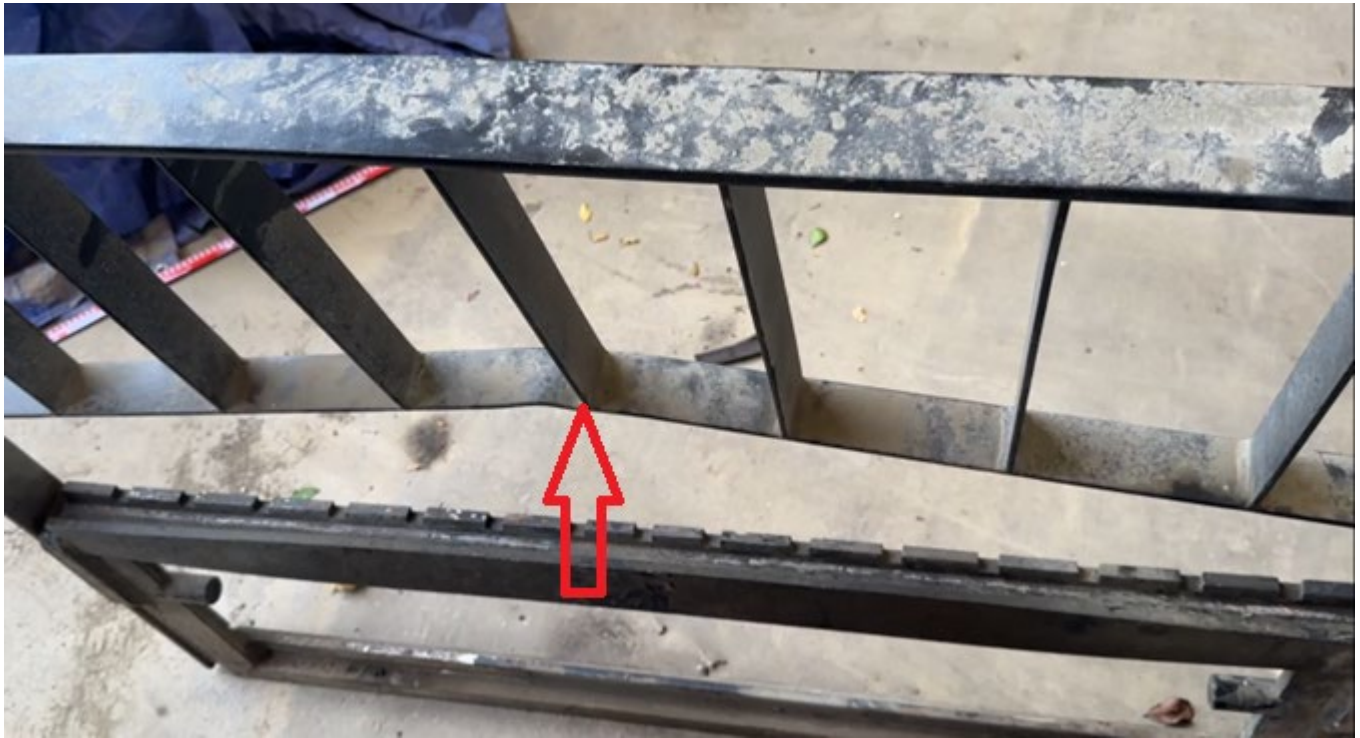
Figure 2: Previous damage to forklift's load guard

14. The pre-existing damage to the fork headboard/load guard may have contributed to the failure of the load guard/tynes assembly.

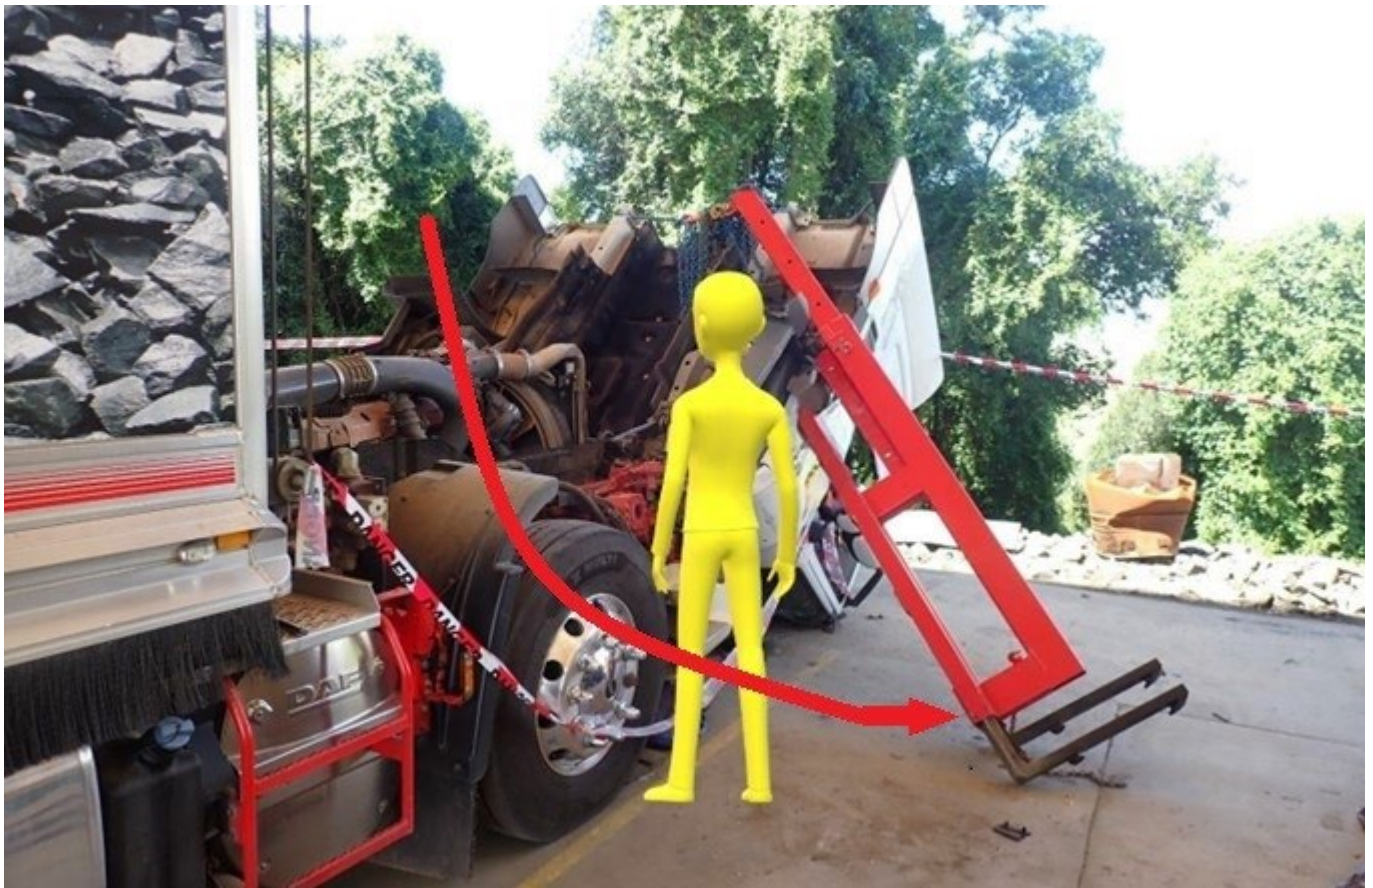
The fork headboard/load guard detached from the body of the forklift. The forklift's tynes also detached from the fork headboard/load guard, causing the tynes and the forklift end of the jib to swing in a forward and downward motion. The far end of the jib was suspended by the chains that remained attached to the underside of the truck's cabin.

The unrestrained end of the jib hit the mechanic's leg causing him to fall to the ground. The tynes remained within the jib pockets and hit the ground in close proximity to the mechanic. The fork headboard/load guard and the jib remained suspended above the mechanic as he lay on the ground.

Figure 3: General location of worker and the movement of the jib/tynes

12. The wheels of the forklift remained stationary during the lift. This, coupled with the orientation of the forklift and jib relative to the truck cabin's pivot point, introduced side loading forces

13. Forklifts are not designed to sustain side loads. The separation of the load guard/tynes assembly was likely to have been caused by the introduction of side loads

- e. workers are not positioned in the path of suspended/moving loads or equipment and performing work in the line of fire when undertaking lifting activities

- develop and implement a safe system of work in relation to the operation of forklifts to ensure that risks to operators and other workers are eliminated or minimised so far as reasonably practicable
- establish and maintain suitable exclusion zones that appropriately account for the potential for suspended loads to drop, swing and topple.
