Lessons learned – Requires comprehensive investigations

Small Mines Roadshow 2025

Review of 3 dangerous incidents (Section 190) investigated by the Resources Regulator

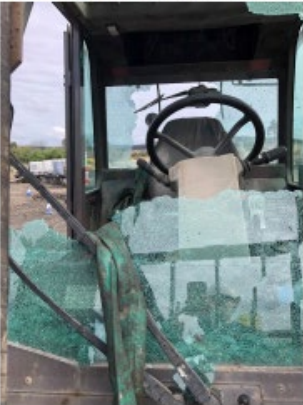
In the past month, there have been 2 significant incidents involving the use of mobile plant in a pulling activity. Both incidents involved workers who were in the line of fire of metal objects traveling at high speed when the rope or sling they were attached to suddenly recoiled.

Figure 1 - Forklift with shattered rear and front windcreens after the M36 nut projectile narrowly missed the operator

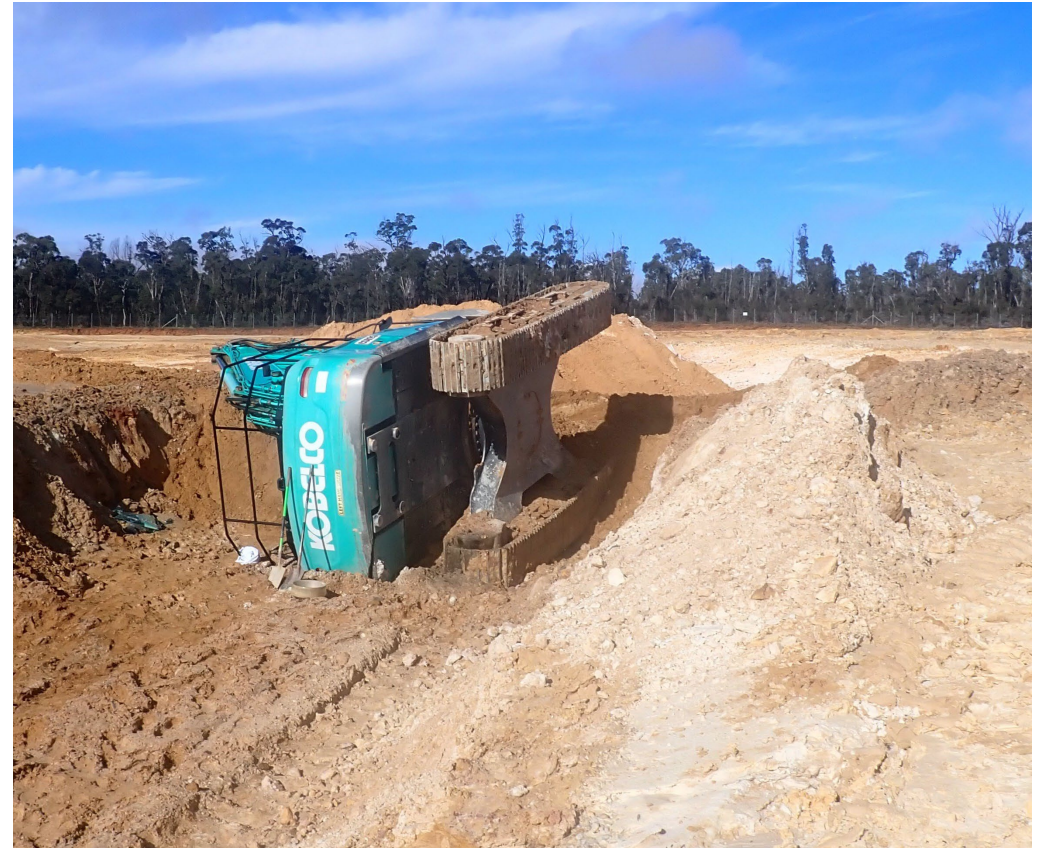
S 190 (2) (d) the unintended overturning of a vehicle or of plant weighing more than 1,000kg.

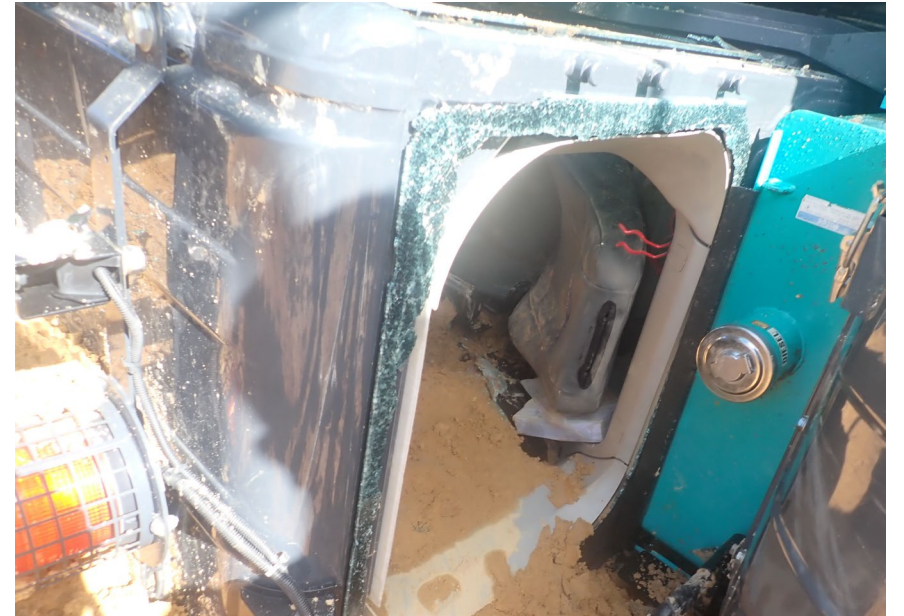
Apparent causes (Controls failed or missing – Lessons learned)

- Operator did not follow the SWMS when conducting a risk assessment of the work area. (SWMS requirement)
- SWMS did not address the risk of roll-over and poor lighting when moving to and travelling around a work area.
- Bund on the trench was not at the correct height and missing.

- Poor lighting on the excavator and reversing lights were poorly maintained.

- Poor situational awareness of the operator when reversing.

- Dark and foggy in the early morning.
- No artificial lighting in the area.

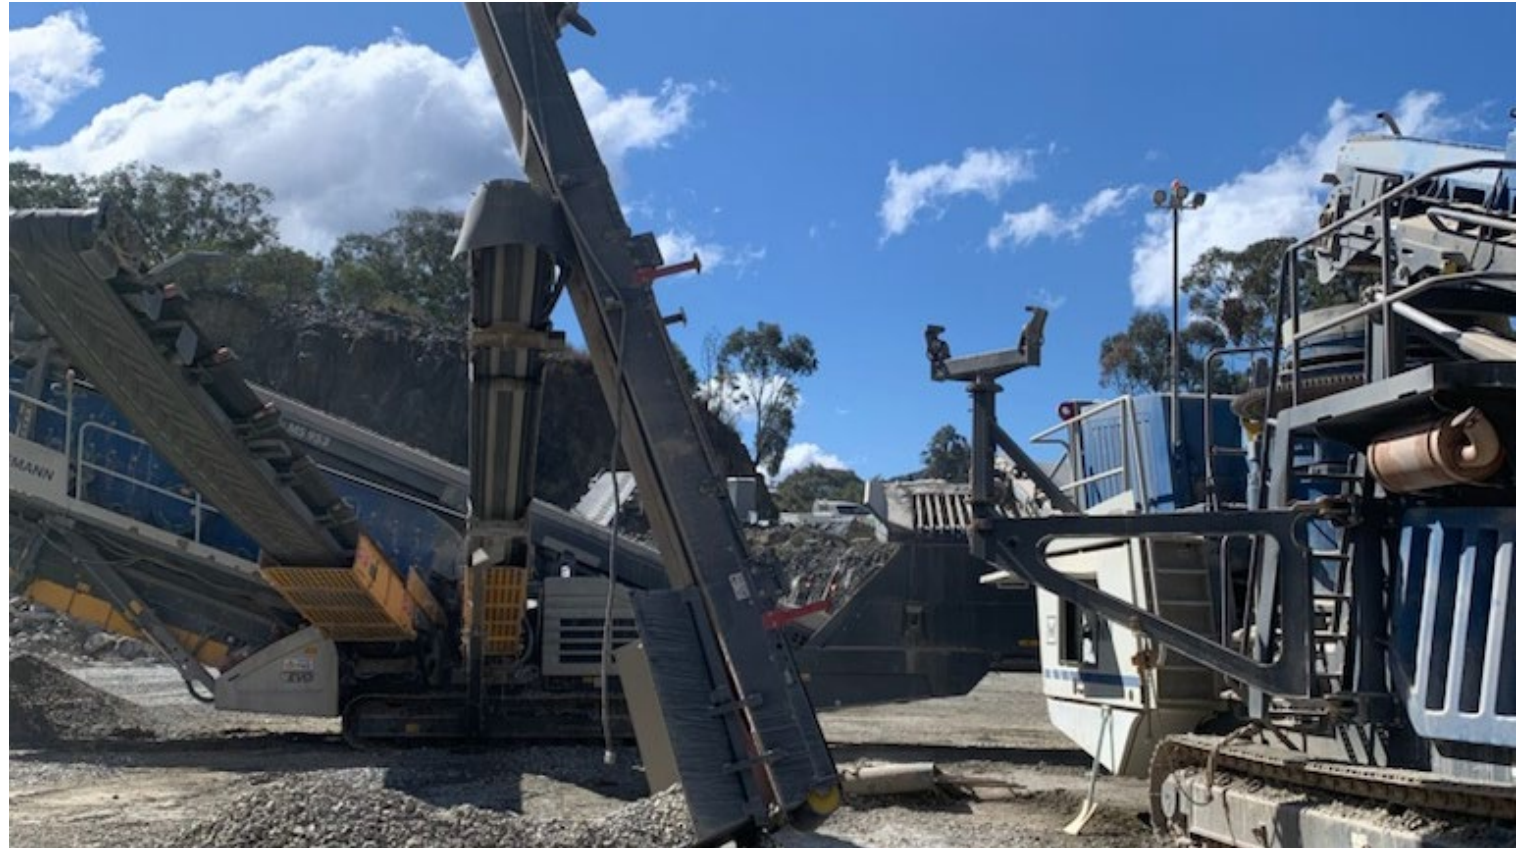
S 190 (1) (e) the fall or release from a height of plant, a substance or a thing, or

(1) (g) the collapse or partial collapse of a structure.

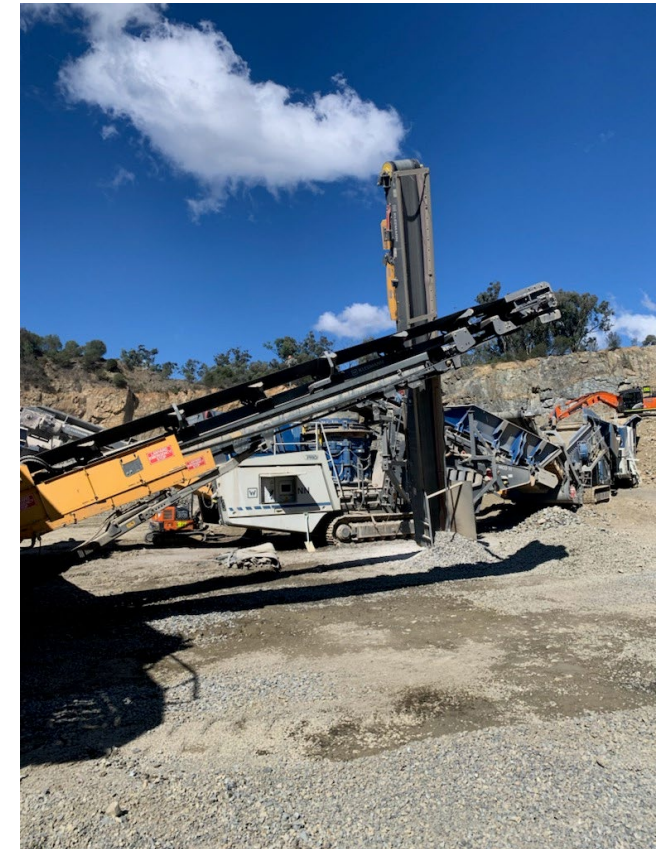
- SWMS did not document the procedure to verify the equipment was set-up as required by the OEM.
- No change management or risk assessment process on the impact of the design changes (new hopper) to the operation of the mobile plant.

- Missing bolts not identified when commissioning plant.

- No structural design considerations for the hopper.
- Abnormal setup required the conveyor to be extended, leading to over-balancing the conveyor when the new feed hopper was full.
- A bigger feed hopper caused increased material weight on cantilevered section of the conveyor.

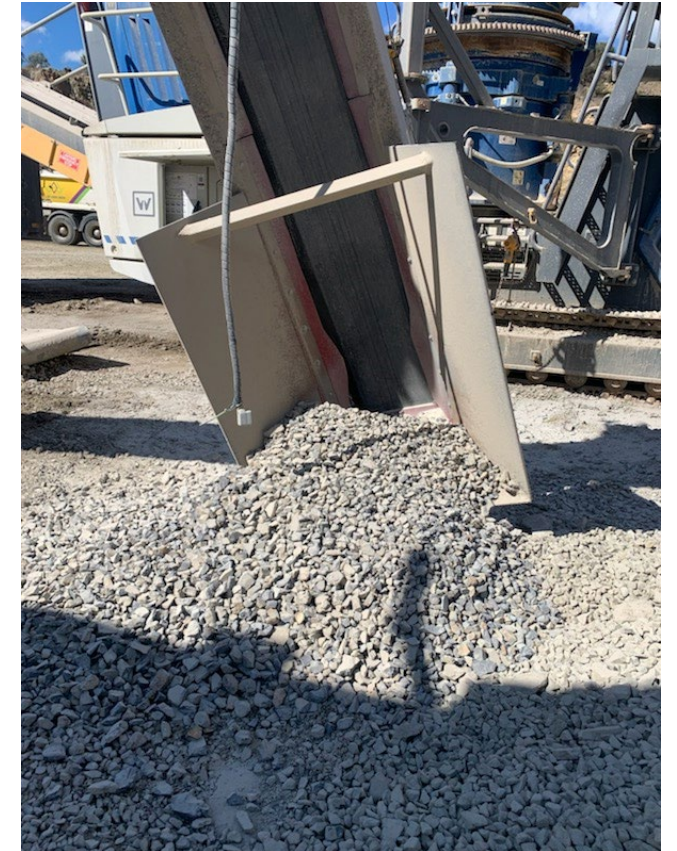
- Training did not specifically address the correct process for installation and setup of equipment prior to operation as described by the OEM.
- Workers did not identify missing bolts were required for the mounting flange during assembly, to prevent the conveyor belt lifting out, as specified in the OEM manual.
- Reliance on worker experience rather than set procedures for commissioning the plant once set-up.

- A different setup compared to the previous location meant the conveyor was extended further out leading to the over-balancing of the hopper end of the conveyor.

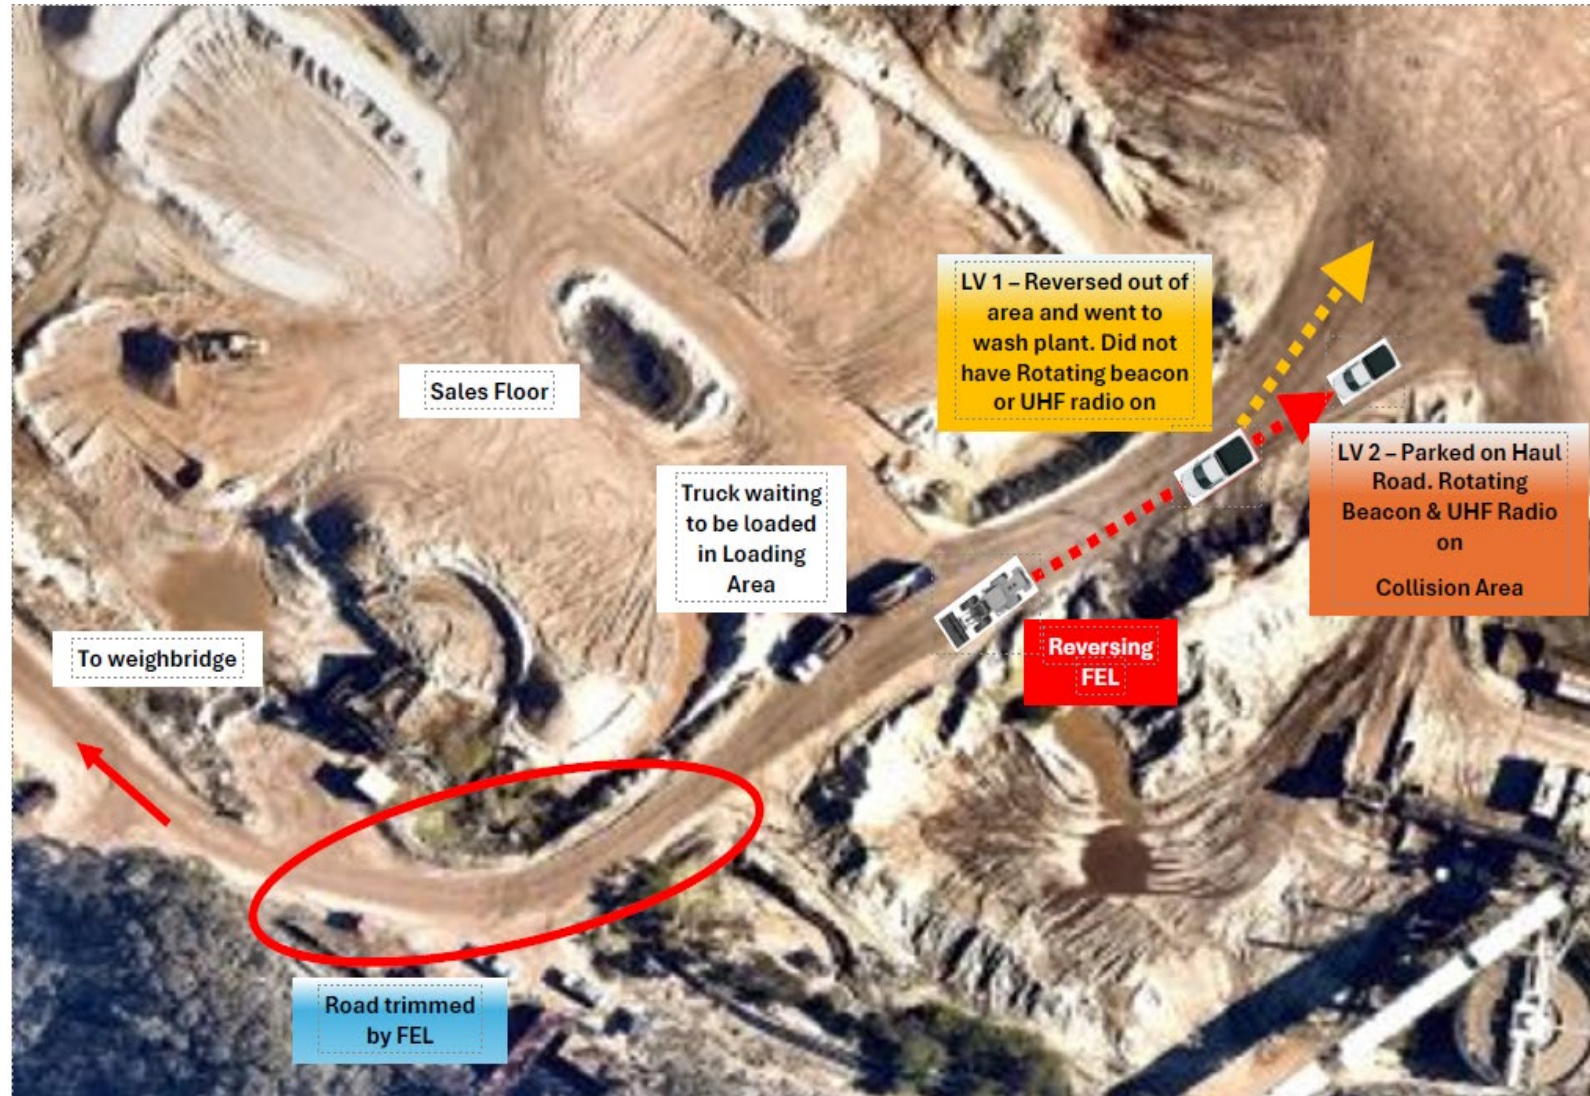
Dangerous Incident S 190 (1) (m) a collision involving a vehicle or mobile plant
