Small mines high visibility campaign 2024

Small Mine Roadshow

February / March / April 2025

Small mines roadshow

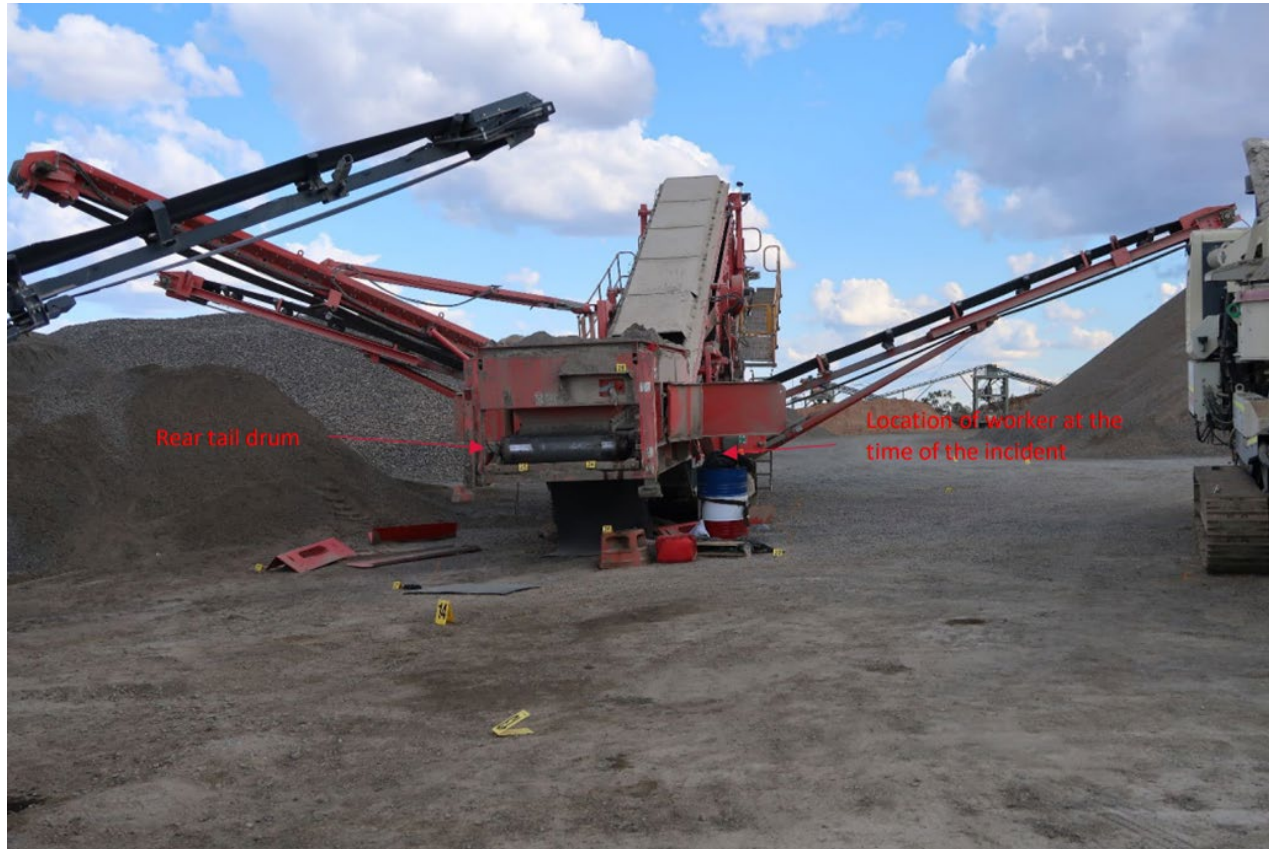
Entanglement – amputated arm (Aug 2023)

A worker assisting with tracking the belt on a mobile screen was seriously injured when his arm became entangled in the screen's rotating tail drum.

While undertaking the task, one of workers was in proximity of the right-hand side of the screen toward the rear of the item of plant. The screen was engaged with its conveyor operating. The worker's arm became entangled in the rotating tail drum of the screen, pulling the worker into the drum up to his shoulder.

An emergency response was activated. The injured worker was trapped for several hours until emergency services and a medical team released him. The worker's arm was amputated as a result of the incident. The worker was transported to the entrance of the quarry and then airlifted to hospital.

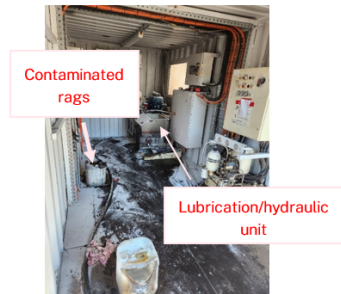
Figure 1 Inside the Crusher Lubrication Container

Two workers sustained burn injuries when cleaning fluid they were using ignited after a cordless battery-powered handheld blower was operated.

Two workers were changing the lubricating oil on a Nordberg HP300 cone crusher at approximately 11:50 am on 13 May 2024. The hydraulic/lubrication unit was located at the rear of the purpose-built shipping container, known at the site as the Crusher Lubrication Container. The container had limited ventilation.

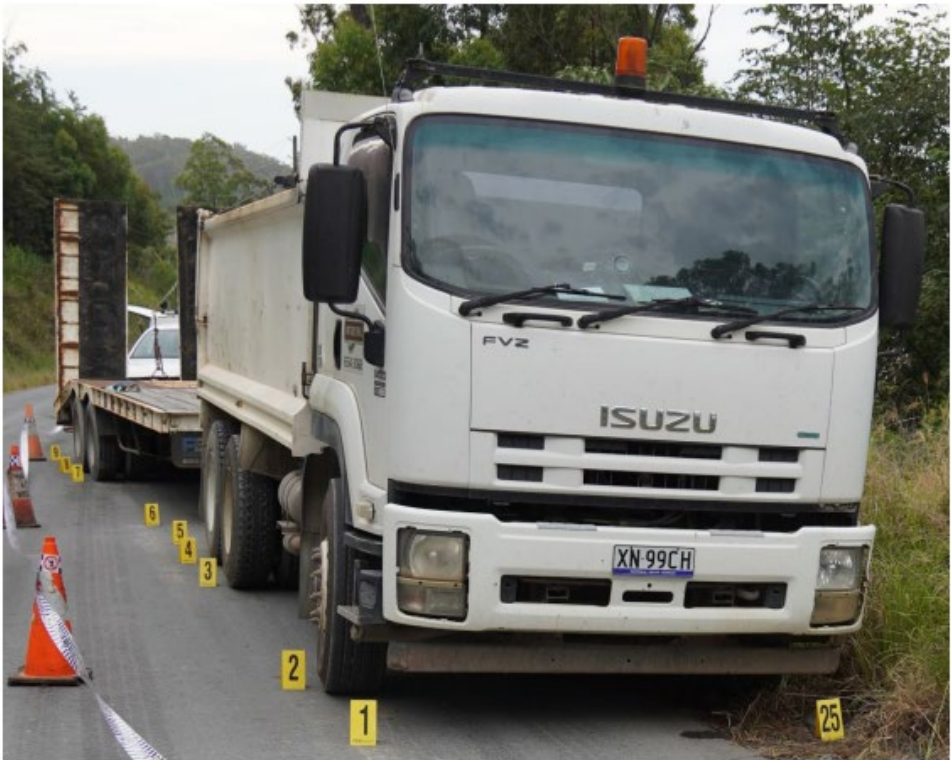
Figure 1: The truck and trailer involved in the incident

A worker suffered multiple serious injuries when a truck trailer that he was working under rolled onto him.

A contract worker was tasked by his supervisor to drive a road-registered truck and trailer up the inbound access road to a laydown area. The truck configuration was an Isuzu 3 axle rigid with a dual axle, double-wheeled trailer. The front nearside wheelset of the trailer was locked on and was being dragged along the bitumen road surface as the truck travelled up the inbound haul road. The worker stopped the truck on the haul road and the quarry's manager entered the cabin to try and release the locked trailer brake. The quarry manager drove the truck a short distance but was unable to release the brake. He parked the truck on the side of the roadway and asked the quarry's mechanic to attend the location to release the trailer's brakes.

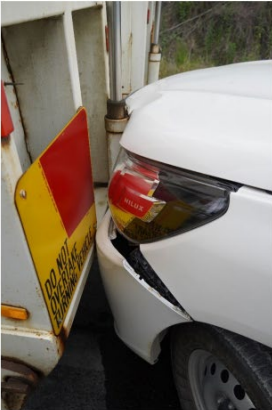
Figure 3: Collision between the trailer and the utility

The mechanic was airlifted to John Hunter Hospital where he was admitted. He was treated for injuries to his collarbone, ribs, pelvis and leg - which included surgery.
