Investigation information release

Workers injured by suspected gas and rock burst at underground coal mine

Incident date: 6 April 2025

Location: Appin Colliery, Douglas Park Road, Douglas Park, NSW 2569

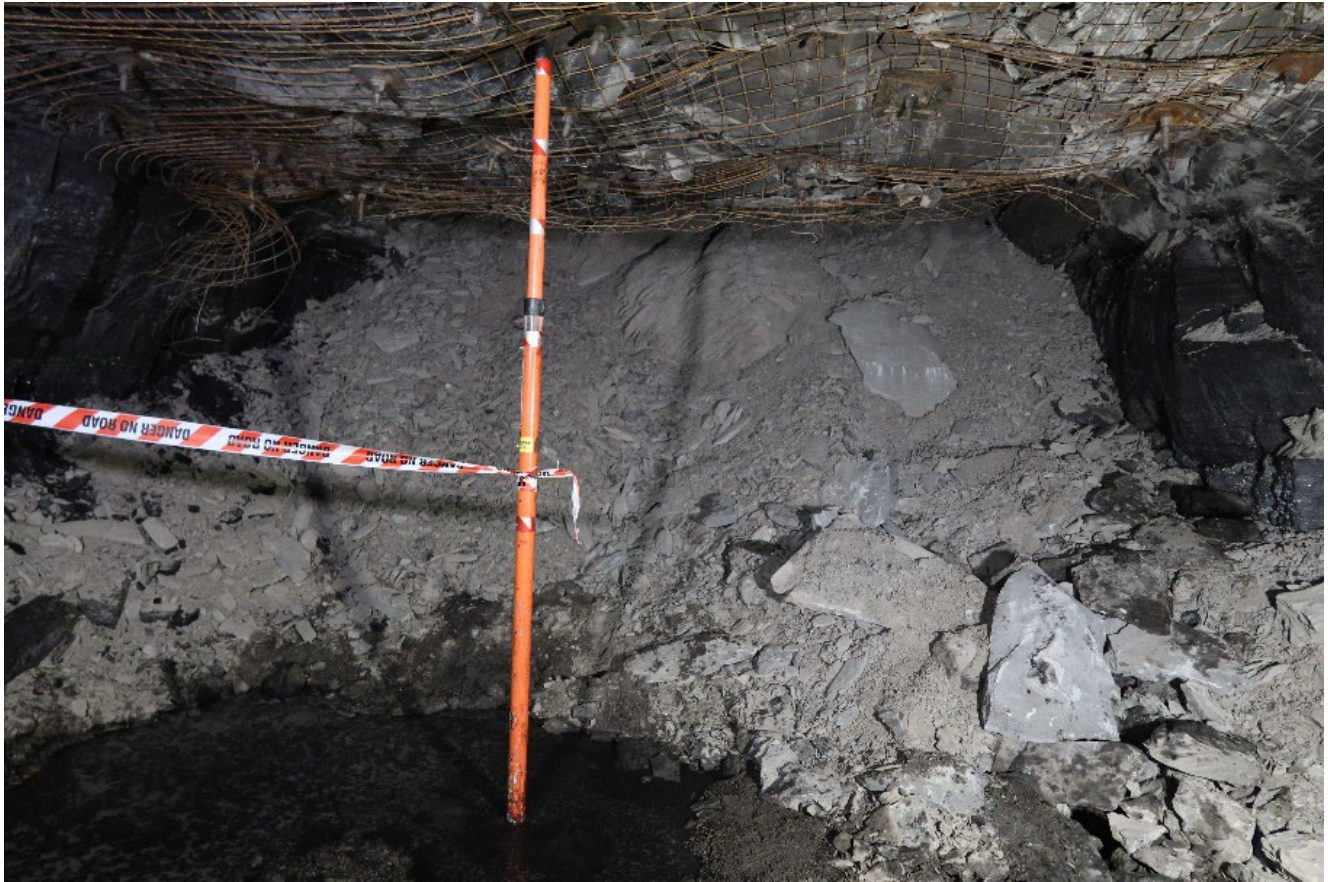
Figure 2: A pile of ejected rock after recovering the continuous miner from Razorback Mains B heading 11-12 cut-through

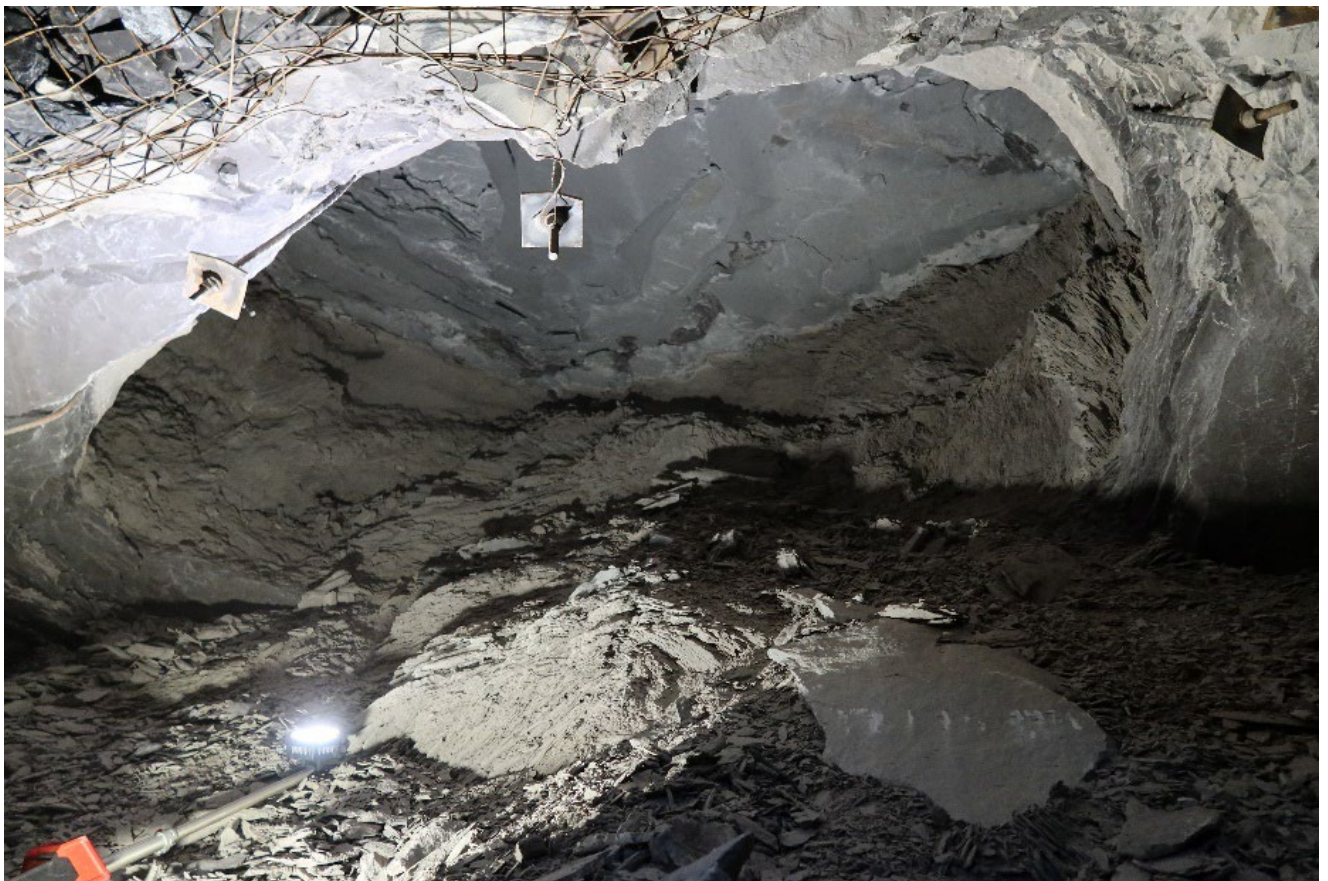
Figure 3: The void above the coalface in Razorback Mains B heading 11-12 cut-through
