## **Investigation report**

# Serious injury to a worker conducting maintenance work on a mobile screen

*May 2025*

Published by the Department of Primary Industries and Regional Development

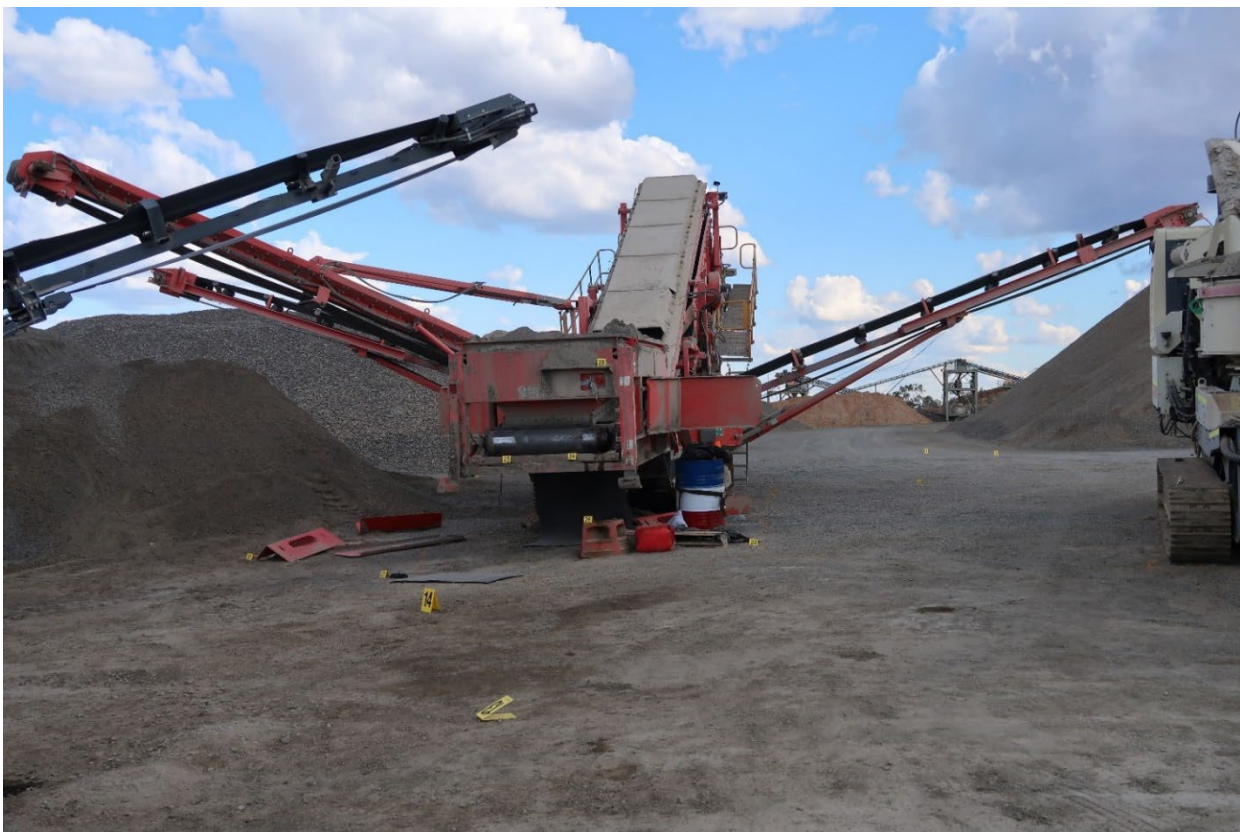
Figure 1: Depicts the rear view of the mobile screen at the incident scene (Note: items were placed under the right rear of the machine with additional panels and guards removed following the incident to assist in rescue efforts)

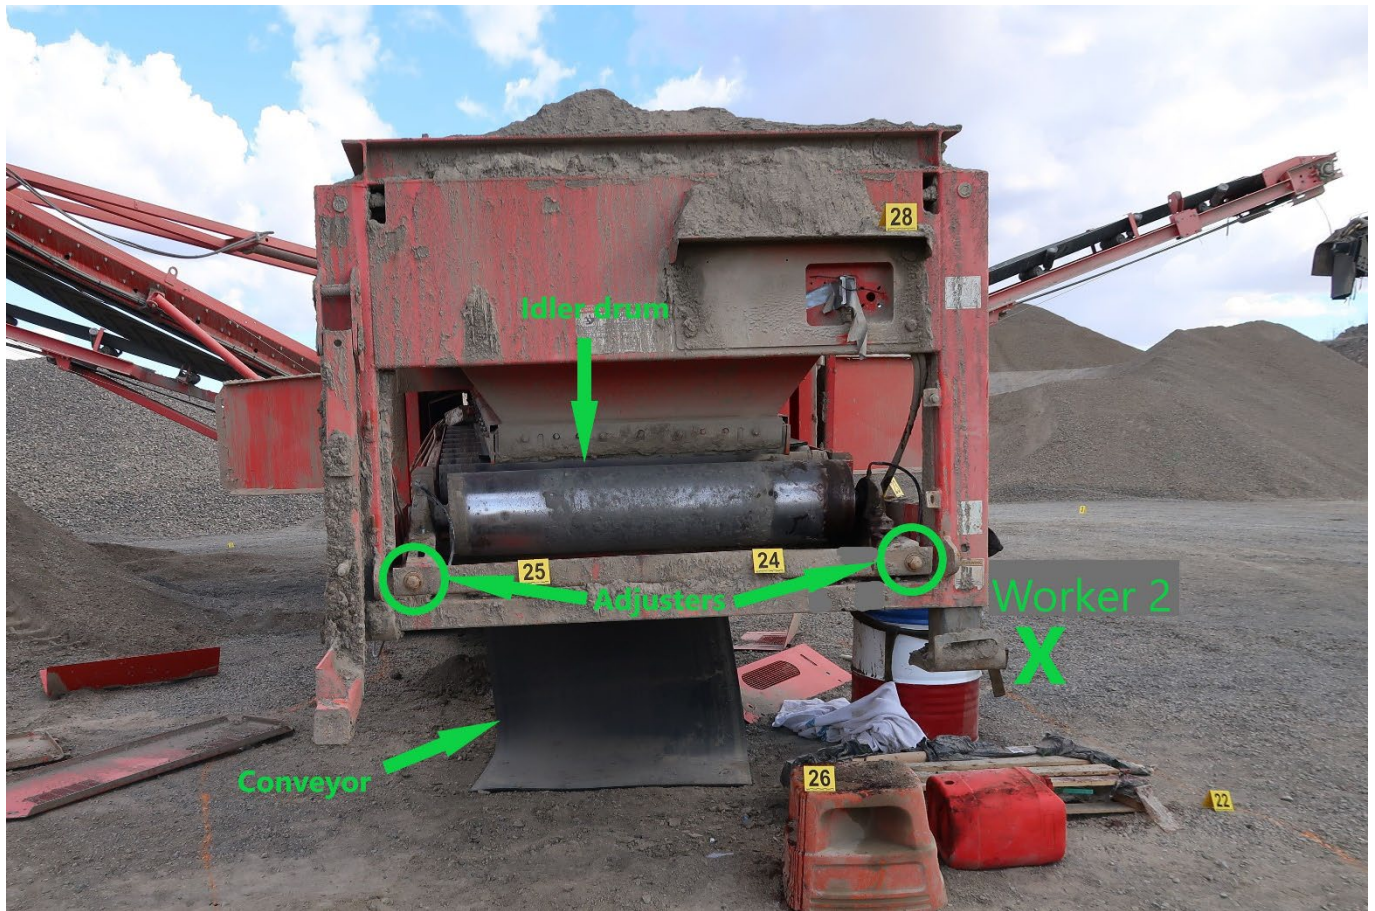
Figure 2: Depicts the rear view of mobile screen with relevant parts identified and the approximate location of worker 2 at the time of the incident labelled (Note: the conveyor belt was cut during rescue efforts)

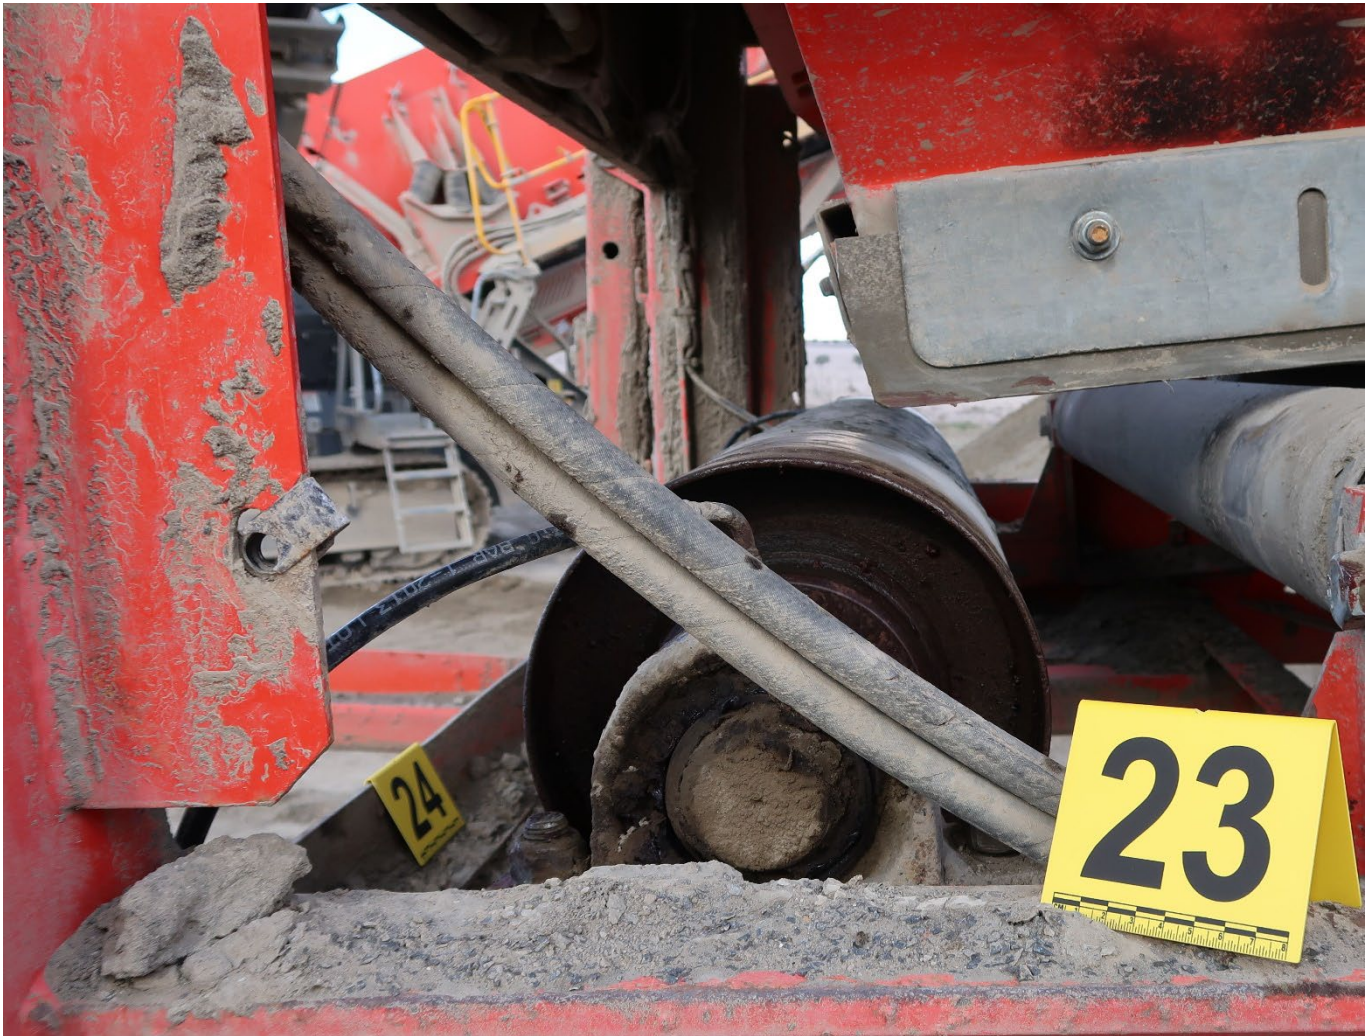
Figure 3: Depicts a close-up view of the tail drum taken through right-hand guard door where the injured worker was positioned

- an internal guard originally fitted over the tail drum immediately inside the rear panel was missing from the machine.
- There was no safe work procedure for tracking conveyor belts on the mobile screen and the OEM's user manual (which contained a procedure for belt tracking) was not made available to workers.

- applying the hierarchy of controls including:
  - ensuring, to the extent it is reasonably practicable to do so, that all guards are securely fixed in place during maintenance (including belt tracking) work
