# Weekly incident summary

## Week ending 23 May 2025

This incident summary provides information on reportable incidents and safety advice for the NSW mining industry. To report an incident to the Resources Regulator: phone 1300 814 609 24 hours a day, 7 days a week.

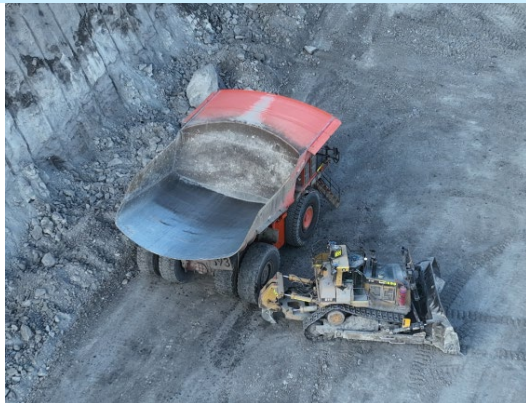
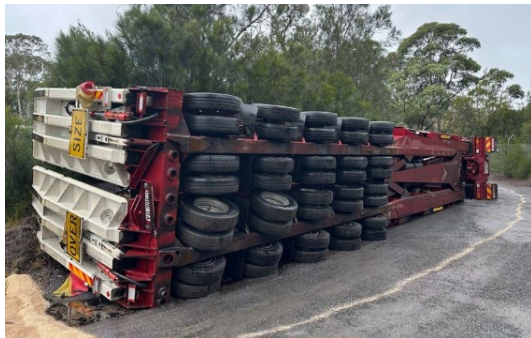
</div><div><p>Dangerous incident IncNot0049141</p><p>Underground coal mine</p><p>Roads or other vehicle operating areas</p><div>

</div></div></div> <div><p>An old shearer body (with no counterweight or ranging arms) was loaded onto a heavy haulage truck using a forklift.</p><p>The left and right shearer haulage sprockets and trapping shoes were positioned on the gate end/transition pans that have a larger clevis arrangement on the back of the pan set.</p><p>Once the load was dogged down and cleared for transport, the truck was driven about 300 metres and rolled, while driving at slow speed on flat ground around a left-hand corner.</p><p>The driver was uninjured.</p><p>Two gate/transition pans were used instead of run-of-face (ROF) pans for the sprockets to sit on. This shifted the load towards one side, shifting centre of balance.</p><div>

</div></div> <div><p>Operators must identify the risk of loads shifting due to an imbalance, especially when there is steel-on-steel contact.</p><p>Mine operators should have a procedure for transporting shearers that specifies the appropriate pans to use for transport purposes. Secure loading should not be the sole responsibility of the transport driver who may not be familiar with the equipment.</p><p>In this instance, the load was well secured but the centre of balance was off.</p></div>
