Resources Regulator

Investigation report

Worker seriously injured while refuelling pressure cleaner

June 2025

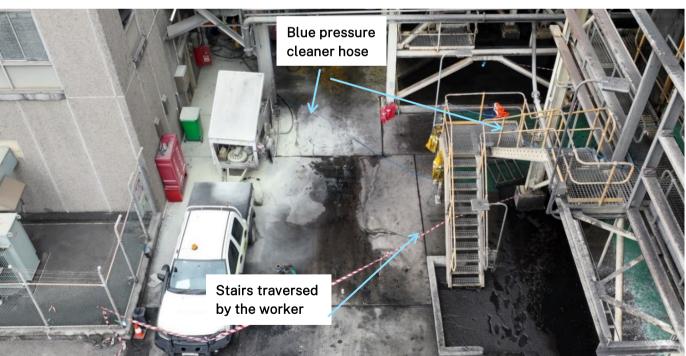
Figure 1: Incident site with IAPL work ute and trailer containing pressure cleaner

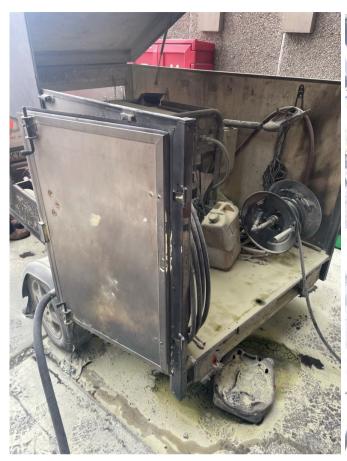
After the transfer of fuel began, the worker noticed that the breather/airlock on the fuel container was closed. Upon opening it during the refuelling process, petrol unexpectedly released. Around the same time, the spout also became detached from the jerry can. Petrol splashed onto the hot engine and exhaust components.

The elevated temperatures of the surfaces caused the petrol to ignite, resulting in a fire that engulfed both the fuel container and the worker's clothing. The worker immediately left the trailer while still holding the fuel container, which he dropped at the back of the trailer.

Figure 2: Rear of trailer and damaged fuel container on ground

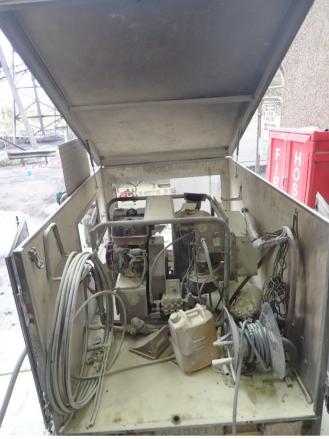
The worker proceeded to refill the fuel tank of the pressure cleaner, which was positioned atop its Honda petrol engine and adjacent to the engine's exhaust. The worker detached the fuel container cap and fitted the integrated spout attachment. Refuelling commenced using the spout attachment.

Figure 3: Rear of trailer, pressure cleaner and equipment
