# Weekly incident summary

## Week ending 30 May 2025

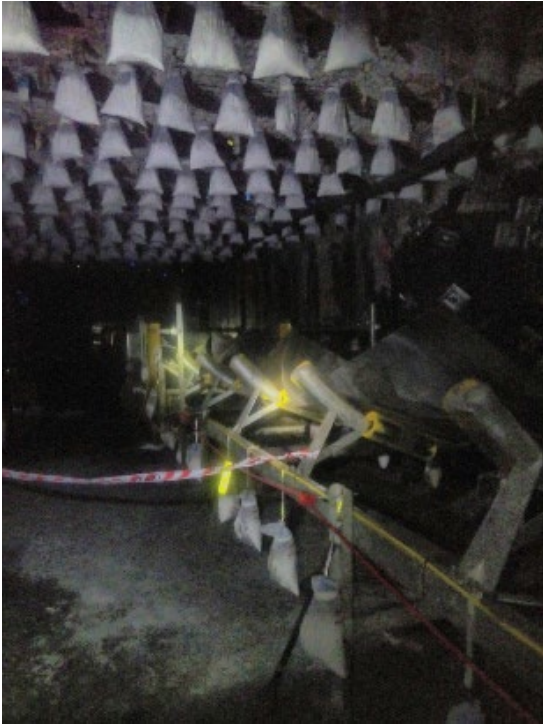
Incident type	Summary	Comments to industry
Dangerous incident IncNot0049184 Underground coal mine	<p>During the installation of conveyor belting onto a newly installed drift conveyor system, a winching system was configured to wind belting through a transportable conveyor drive and loop take-up assembly.</p> <p>As the belt was winched into the loop take-up, the synthetic sling (used to rig the winch rope to the belt pulling tongue) failed.</p> <p>This resulted in a loss of friction to the drive drum, which allowed the belt to slip back through the drive and loop take-up and begin travelling inbye along the carry side.</p> <p>The belting gradually accelerated down the drift until the inbye end made contact with a roll of belt hung just inbye of the bootend. The belting continued to travel and concertina inbye of the bootend.</p>	<p>Mechanical engineering control plans must set out the control measures for risks associated with the unintended release of mechanical energy by considering safe work systems for people dealing with plant or structures.</p> <p>Mine operators should review how workers and supervisors are trained to recognise the potential hazards associated with all energy sources, including the load introduced by winching equipment.</p> <p>This is especially important when there is the potential for stored energy to be released without warning.</p> <p>When using slings, operators must ensure that they are appropriately</p>

Incident type	Summary	Comments to industry
	<p>The inertia of the remaining belt mass on the drift caused another section to concertina about 150 metres outbye of the bootend.</p> <p>The cause appeared to be the failure of the synthetic sling connecting the winch rope to the belt-pulling tongue.</p> <p>The work team set out specific control of access to all areas inbye of the winch before the commencement of the task. This was physically verified by the undermanager before the start of the task, and additional sentries were positioned in adjacent roadways to further prevent access to the drift where the winching activities were to be conducted.</p> <p>Nobody was exposed to the uncontrolled belting or the failure of the rigging equipment.</p>	<p>rated for the job, fit-for-purpose and free of any wear and tear.</p>
