Weekly incident summary

Week ending 6 June 2025

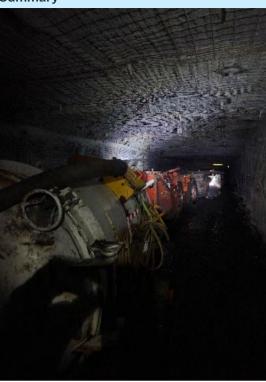
Incident type	Summary	Comments to industry
Dangerous incident IncNot0049222 Underground coal mine Roads or other vehicle operating areas	A stationary load haul dump machine (LHD), with a Brain tank trailer attached, was hit by a travelling LHD that caused the stationary LHD to be pushed backwards. A worker was hit on the shoulder by the Brain tank as the stationary LHD was pushed back.	When operating an LHD, the implement should be positioned to maximise the operator's vision. Plant parked in roadways should be visually delineated to minimise the risk of collision with other plant.

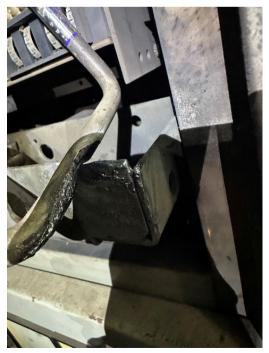
Dangerous incident IncNot0049224 Underground coal mine While trying to close a breaker on a distribution board, an electrician suffered burns from an arc flash.

A racking handle that was used to operating the racking mechanism of the circuit breakers made contact with a phase and the enclosure frame (i.e. earthed), causing a phase-to-earth fault and a subsequent arc blast.

This incident is under investigation.
