Investigation report

Two workers injured by catastrophic truck tyre failure

July 2025

Published by the Department of Primary Industries and Regional Development

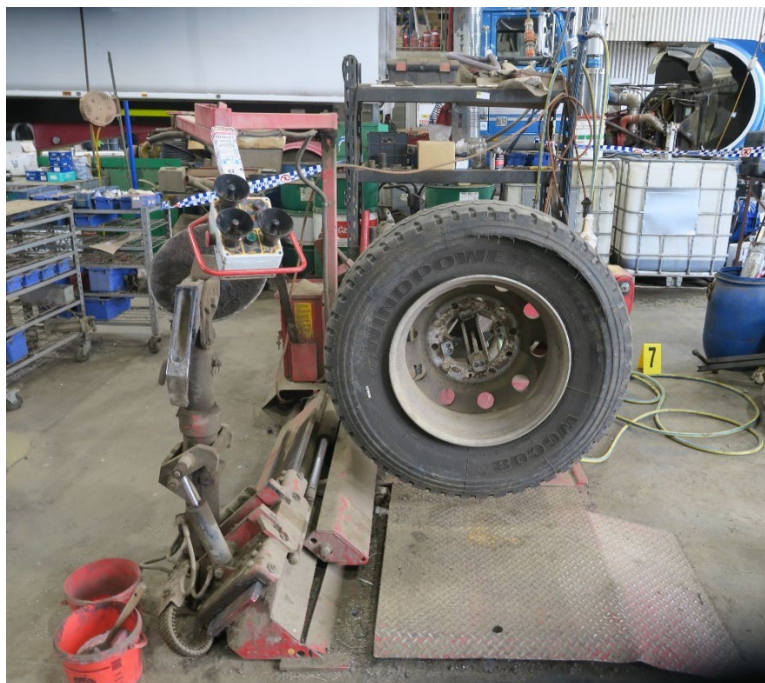
Figure 1: Front view of tyre and wheel assembly fitted to the tyre-fitting machine after the incident

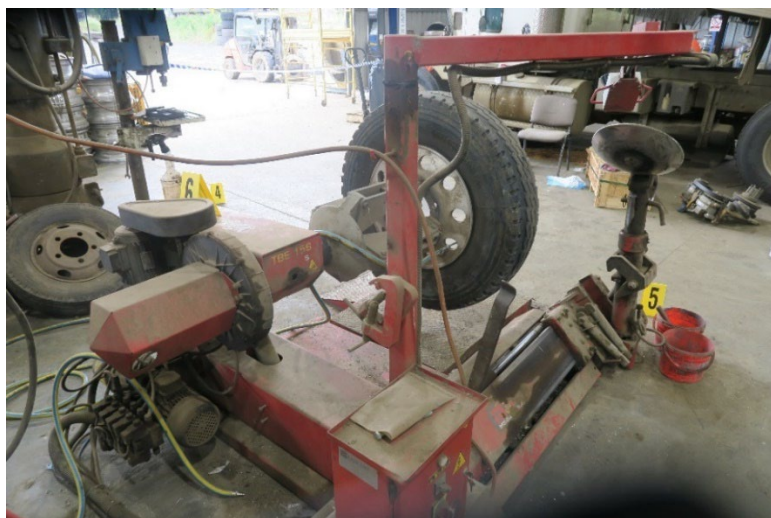
Figure 2: Rear view of tyre and wheel assembly fitted to tyre-fitting machine after the incident

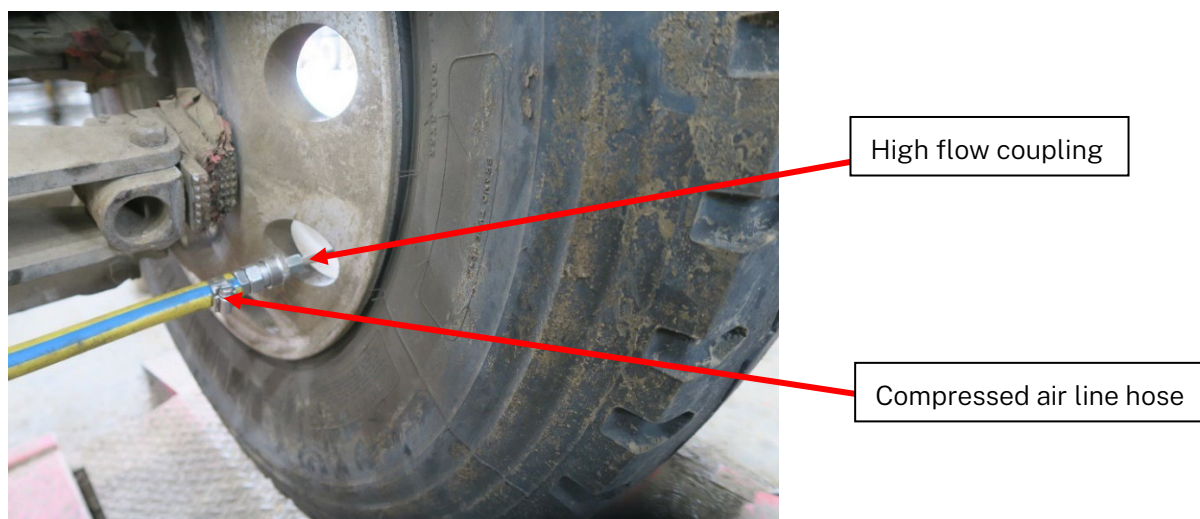
Figure 3: Compressed air line hose and high-flow coupling fitted to the tyre and wheel assembly

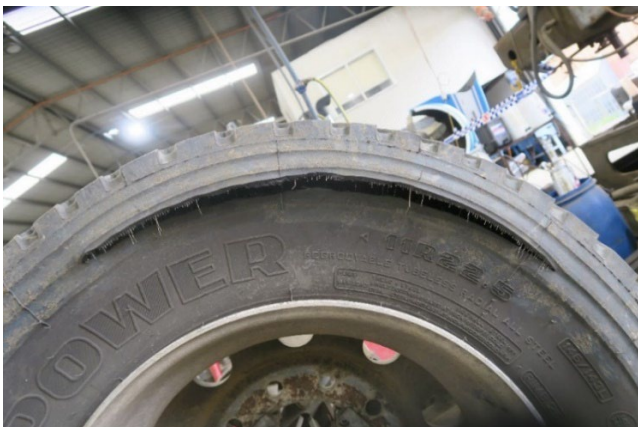
The investigation determined that the catastrophic tyre failure occurred when the sidewall of the tyre failed and violently tore open while it was being inflated (see Figure 4). This type of tyre failure is referred to as a zipper failure, which is often caused by the tyre being run while overloaded, under-inflated or flat. In these circumstances, over time, the structural integrity of the tyre's sidewall becomes weakened making it prone to rupture. Post-incident examination of the internal and external parts of the tyre identified visible signs that it had likely been run while underinflated or flat.

Figure 4: Front view of tyre showing side wall failure

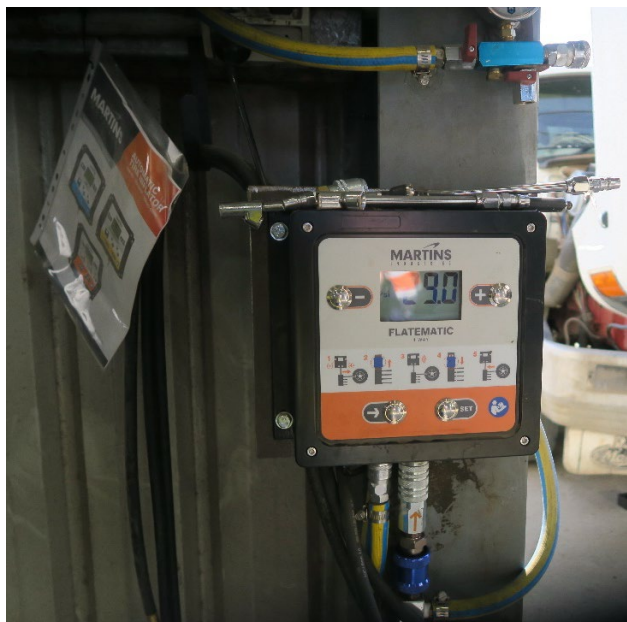
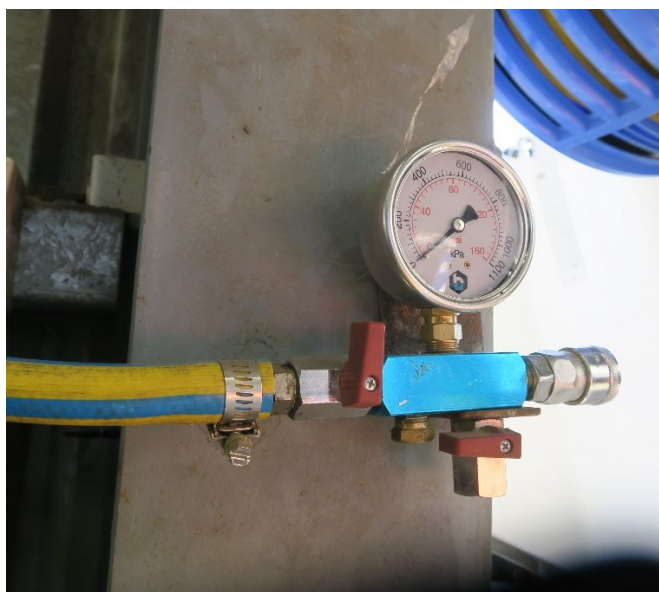
3. The compressed air line system used to inflate tyres was not fitted with a device, such as an in-line pressure gauge/digital display and inflation control device(s) (see Figure 5 and 6) that enabled workers to continuously monitor the tyres' air pressure and manually control the level of inflation from a safe distance, clear of the line-of-fire, in the event of tyre failure.
4. During inflation, tyres were not suitably restrained in a cage or similar device that provided a physical barrier to protect workers from projectiles, debris and air blasts generated in the event of a tyre failure (see Figure 7 and 8).

- compressed air line systems that:
 - allow continuous monitoring of tyre air pressures and control of inflation levels from a safe location, clear of the potential line of fire. For example, the use of an inline pressure gauge/digital display and inflation control device (see Figure 5 and 6), fitted to a long air hose of at least three metres of length (after the gauge/digital display and control device), that connects and locks onto the tyre's air valve
