Safety Alert

Date: July 2025

Worker seriously injured after being trapped in ventilation doors

Safety Alert SA25-03

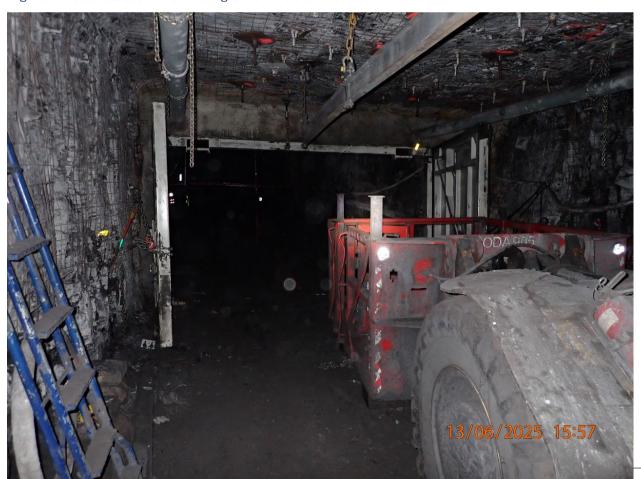
Figure 1: The double doors at an underground mine site

The first (outbye) set of doors were opened and secured. Workers were in the process of opening the second set of doors. The right-hand door was opened by chaining the door to the man cage of an LHD and reversing the machine backwards to break the seal. The left-hand door was opened and appeared to be chained to the rib. While the team was in the process of unchaining the right-hand door from the LHD, the left-hand door unexpectedly became unsecured and closed rapidly, trapping a worker between the 2 doors.

- No formal procedure existed for safely opening and securing double doors in instances when both doors were required to be open at once.
- No clearly defined exclusion zones or controls were in place to prevent workers from entering hazardous line-of-fire positions during the task.
- The method used to secure the left-hand door was improvised and not confirmed to be effective
 or stable.
- The pressure acting on the doors was not fully accounted for in the task planning or risk assessment. It should be noted the risk also existed when closing the doors.

- Develop formal, documented procedures for securing double doors in instances where both doors are required to be open at once.
- Identify and control line-of-fire hazards associated with high-pressure ventilation infrastructure through defined exclusion zones and task sequencing.
- Ensure door restraints and securing methods are engineered, fit-for-purpose, and verified before work begins.
- Train relevant personnel in using any mechanical aids, securing devices, and safe work practices for handling high-pressure ventilation systems.
- Include hold points in procedures to verify critical controls are in place before progressing through each stage of the task.

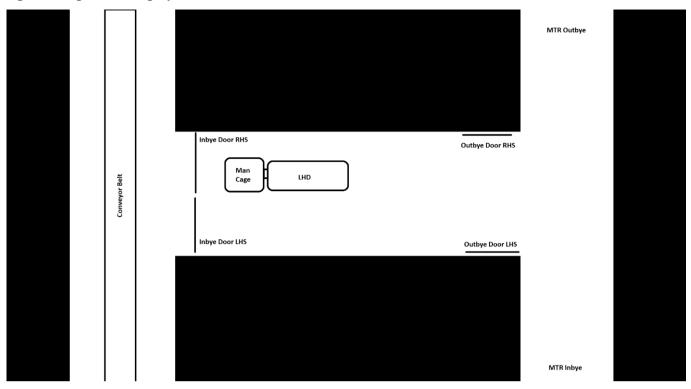
During a planned ventilation change at an underground coal mine, workers were tasked with opening a set of double machine doors to redirect airflow. Due to significant pressure on the doors, mechanical assistance using a load haul dump (LHD) and man basket was required to open the inbye doors on the belt-road side.

Figure 2: Diagram showing layout of incident site
