# Weekly incident summary

## Week ending 4 July 2025

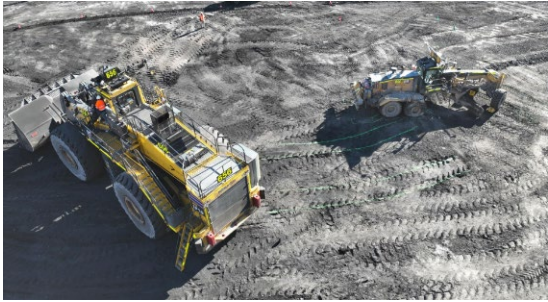
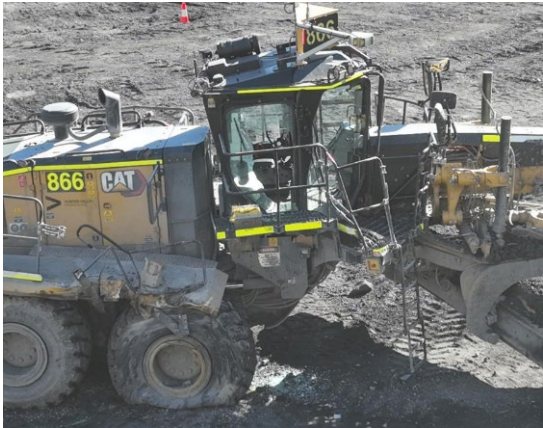
Incident type	Summary	Comments to industry
Dangerous incident IncNot0049392	A loader and grader collided when both reversed directly towards each other.	Lack of positive communication (pos comms) has been the root cause of many incidents at mine sites and mine operators must consider higher-order controls including proximity detection over administrative controls (such as pos comms).
Open cut coal mine Roads or other vehicle operating areas

<p>Tyre position 4 of the loader made contact with the front right-hand drive tyre and mudguard on the grader causing the tyre to burst. The bump stop on the rear right-hand corner of the loader made contact with the emergency stop and access platform on the grader, bending the support and shattering the right-hand side cabin window.</p> <p>In the process of turning behind the loader, the grader operator tried to call the loader using the two-way radio. The loader operator did not acknowledge the call but the grader operator continued to complete the turn regardless.</p> <p>At the same time, the loader operator, unaware of the grader in the immediate work</p>	<p>Mine operators should consider periodic refreshers in pos comms protocols for operators using mobile equipment.</p> <p>To achieve positive communication, a clear, direct message must be given. Additionally, the person receiving the message must actively reply with a clear understanding of the message.</p> <p>Supervisors should be continually monitoring positive communications</p>

<p>compliance during every radio call on their shift.</p> <p>Transport management plans should take into consideration road repairs being undertaken in production areas.</p>
<p>Dangerous incident IncNot0049399 Underground coal mine Fire or explosion</p>

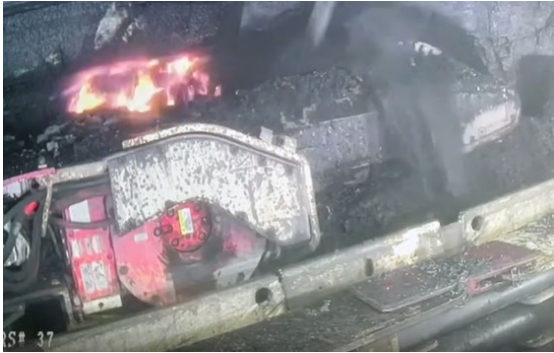
<p>An ignition occurred on a longwall while mining through a fault. The crew observed a flame and immediately stopped the longwall. A fire extinguisher was used to put out the flame.</p> <p>Gas monitoring indicated readings within expected tolerances.</p> <p>The cause appeared to be frictional ignition because of picks striking hard sandstone material.</p>

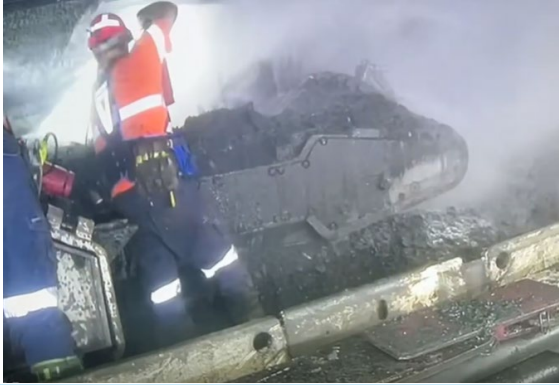
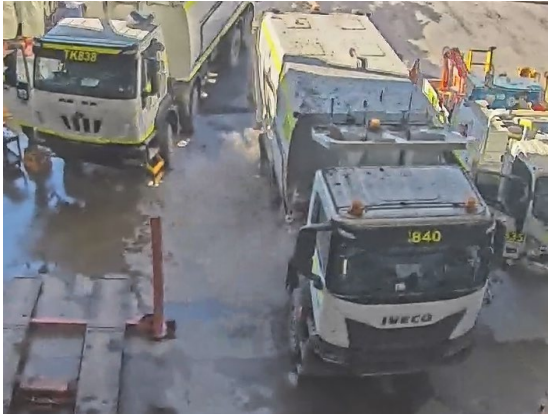
High potential incident IncNot0049373 Open cut coal mine	<p>A service truck was parked in a maintenance workshop when the inside wall of the right-hand rear tyre failed, rapidly deflating.</p> <p>Maintenance personnel were walking in the vicinity just before the tyre burst. At the time of the burst, the maintenance personnel were not in direct line-of-fire but were behind other equipment in the workshop.</p> <p>Rock damage to the inside wall of the right-hand rear tyre caused the separation and failure of the shoulder. The tyre failed at this point.</p>

<p>An exploding tyre can have catastrophic consequences.</p> <p>Tyres should be inspected as part of pre-use inspections to include checking for rocks stuck between dual tyres.</p> <p>Operators should receive training to assist them to identify tyre defects.</p>
