Weekly incident summary

Week ending 15 August 2025

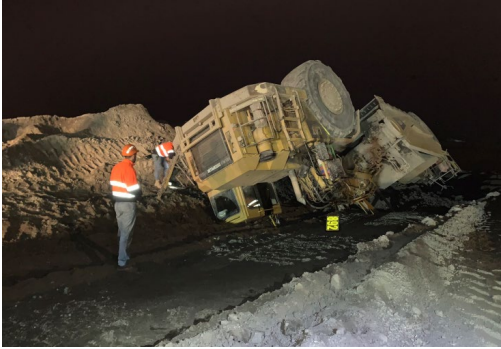
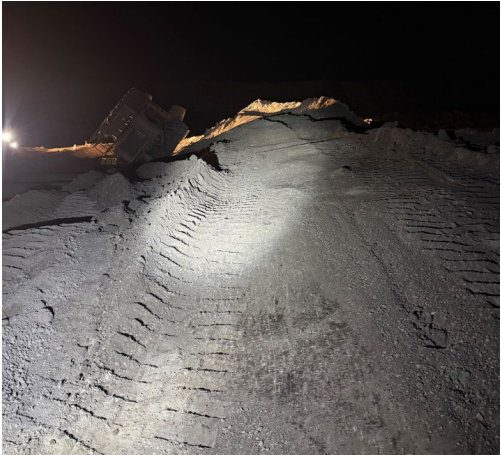
Incident type	Summary	Comm to industry
Dangerous Incident IncNot0049647 Open cut coal mine	A scraper was in the process of filling up with gravel when the material at the rear wheels of the scraper slumped causing the scraper to slide down the stockpile. The scraper slid approximately 3m and rolled onto its roof.	Before starting work, supervisors and equipment operators should inspect and assess the work area to determine hazards, such as the potential for material collapse.
Roads or other vehicle operating areas	The driver exited through the front windscreen using the emergency exit. The driver sustained a minor injury. The operator was wearing a seatbelt at the time of the incident.	<p>The operating environment should be examined to ensure:</p> <ul style="list-style-type: none">the ground beneath the working area is stable and free from faults, fractures and soft areasthere is no moisture or water present in the earth or rock below the equipmentwork is not carried out close to the edge or in a zone of influence of an excavation or any previously disturbed ground.

<p>The circumstances of this incident underpin the importance of wearing seatbelts as a mitigating control.</p>
<p>Dangerous Incident IncNot0049652 Underground coal mine Fire or explosion</p>	<p>An operator walking the longwall conveyor belt observed a 300mm flame and a glowing hot return roller.</p> <p>The operator stopped the belt and doused the roller with water.</p> <p>The long flat return roller was positioned directly behind the jib pulley for the purpose of flattening the belt line to improve scraper contact.</p>

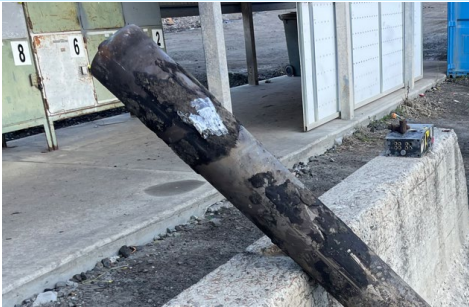
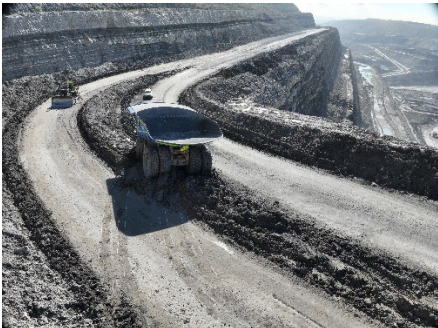
Dangerous Incident IncNot0049655 Open cut coal mine Roads or other vehicle operating areas	<p>A haul truck lost traction on an active haul road and slid into the centre bund.</p> <p>The operator was attempting to assist graders by rolling mud into the haul road.</p>

<p>This incident highlights the importance of having appropriately designed and maintained roadways.</p> <p>Engineering controls that minimise the risk of loss of control should be considered, including the use of speed-limiting devices, speed monitoring and alarms.</p> <p>The Resources Regulator has published a technical reference guide (TRG) to assist mine operators with developing their principal hazard management plan for roads or other vehicle operating areas.</p> <p>For further information refer to TRG: <u>Roads or other vehicle operating areas – principal hazard management plan for surface mining operations</u></p>
