Weekly incident summary

Week ending 8 August 2025

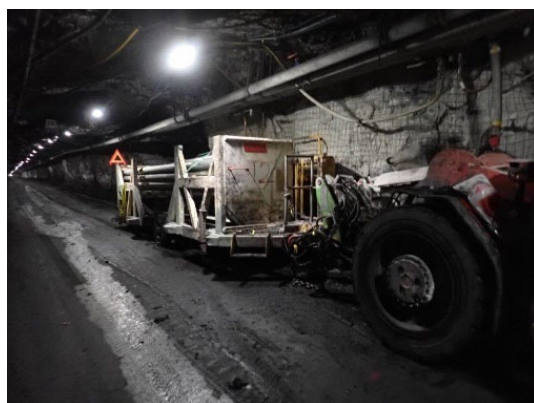
Incident type	Summary	Recommendations to industry
Dangerous incident IncNot0049587 Underground coal mine Roads or other vehicle operating areas	<p>A load haul dump (LHD) machine was exiting a drift with a fully loaded pipe trailer when the machine lost traction. The operator applied the service brake, but the LHD and pipe trailer slid backwards 18 metres and jack-knifed into the rib line. The operator was not injured.</p> <p>The surface was moist and slippery.</p>	<p>Principal hazard management plans for roads or other vehicle operating areas (ROVOA) should consider the impact of road design and characteristics, including grade, camber, surface, radius of curves and intersections for the vehicles using the roadway.</p> <p>When developing control measures to manage the risks of ROVOA, consideration must be given to the potential for interaction between mobile plant and fixed structures.</p> <p>Mine operators should conduct frequent physical inspections of mine roadways to ensure they are</p>

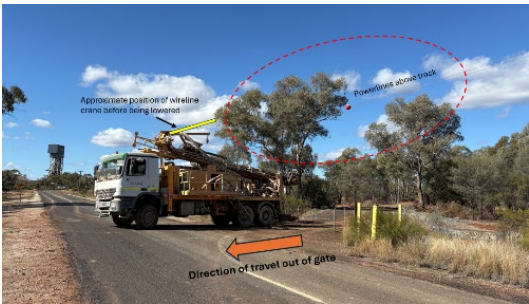
<p>Dangerous incident IncNot0049609 Underground metals mine</p>	<p>A surface drill rig was demobilising and travelling toward a main road on site when the mast made contact with, and broke an 11 KV overhead line.</p> <p>The jib arm on the mast was in the upwards position and had not been completely</p>	<p>Wherever power lines cross a road, consideration should be given to installing signs on each side of the power lines on both sides of the road identifying the voltage of the power line and the clearance.</p>

lowered. Contact was made with one of the 3 overhead powerlines.

An elevated, clearly visible boom should be positioned where each pair of signs is located. The height of the boom should be set at the safe clearance below the power lines. Consider controls such as visual or audible warning devices that will automatically stop or inhibit the movement of a truck while the boom is in the raised position.
