Weekly incident summary

Week ending 1 August 2025

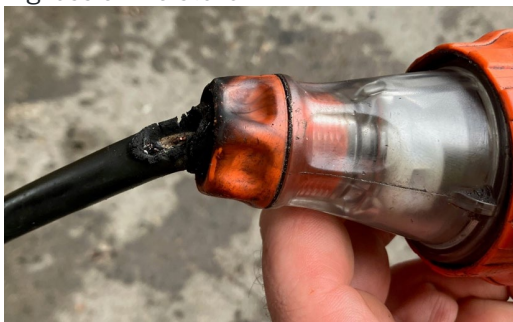
Incident type	Summary	Recommendations to industry
Dangerous incident IncNot0049555 Open cut coal mine	<p>A worker suffered an electric shock while handling a damaged lead from a portal hydraulic pump. He was connecting the damaged lead to an energised extension lead.</p> <p>While holding the plug, an arcing fault occurred, resulting in an electric shock and burns to his right hand.</p> <p>The cable gland was damaged allowing ingress of moisture.</p>

<p>Mine operators should seek every opportunity to apply the hierarchy of controls while managing electrical equipment in harsh environments.</p> <p>Using extra low voltage electrical equipment and field devices considerably reduces the risks associated with electric shock.</p> <p>Where this control cannot be applied, the maintenance of the ingress protection (IP) rating for the electrical equipment should be paramount.</p> <p>Refer to safety bulletin: <u>SB20-03 Electric shocks in the mining industry</u></p>

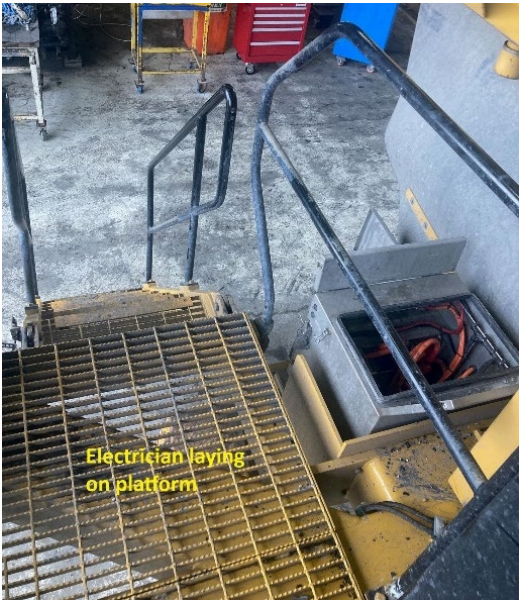
Incident type	Summary	Recommendations to industry
Dangerous incident IncNot0049548 Open cut coal mine	<p>A maintenance worker narrowly avoided being crushed by the ladder of a haul truck when the ladder began to retract, unknown to the worker. The electrician was repairing defects on the battery/starter motor isolator box at the time. This work was outside the scope of the live testing process.</p> <p>Three workers were in the maintenance party – the live test coordinator (seated inside the truck cabin), a mechanical worker and an electrician.</p> <p>During testing, the live test coordinator released the park brake causing the retractable access ladder to move up automatically. The electrician was unaware that the ladder was moving.</p> <p>The mechanical worker saw the situation and called out to alert the electrician who quickly moved to avoid being crushed by the ladder handrail.</p>

<p>Where a powered retractable ladder system is fitted, it should meet the following requirements:</p> <ul style="list-style-type: none"> • Ladder movement shall stop when the control is released. • The ladder is to be visible from the control location. • The ladder should have a control station fitted at both the top of the system and ground level. • It should be interlocked with the machine to inhibit movement when not in the stored position. • It should be able to be lowered without power where no other means of egress exists. <p>If live testing is being performed a detailed scope of work should be developed and implemented. Any changes to the scope should require the team to cease the process, review and update scope where applicable.</p>
