Weekly incident summary

Week ending 25 July 2025

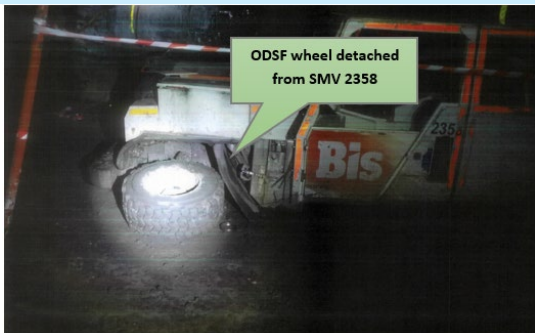
Incident type	Summary	Recommendations to industry
Dangerous incident IncNot0049513 Underground coal mine	<p>A SMV Driftrunner, dry hired, was operating underground when a mechanical failure occurred. The vehicle's front left wheel assembly suffered a structural failure and detached from the machine.</p> <p>The vehicle was moving slowly and had one person onboard, the operator.</p> <p>The detached wheel assembly remained contained within the vehicle's wheel arch, posing no further risk to surrounding workers or equipment.</p>	<p>Mine operators should thoroughly inspect critical joints and assemblies, especially following intrusive maintenance.</p> <p>When conducting a review of control measures after incidents, mine operators should verify that hazards identified are not present across other similar vehicles on site and update relevant procedures and training of maintenance personnel.</p>

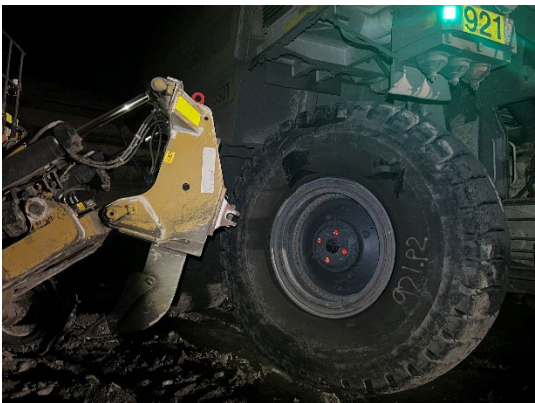
<p>Multiple dangerous incidents</p> <p>Surface and underground operations</p> <p>Roads or other vehicle operating areas</p>

<p>Five separate heavy vehicle collisions occurred in the reportable period. In all instances, the vehicles were working within confined spaces such as underground roadways, surface dumps or load-out facilities. In all 5 instances, workers reported losing situational awareness of their surroundings while operating the vehicles.</p> <p>Key contributing factors:</p> <ul style="list-style-type: none"> • Restricted visibility and manoeuvring space. • Monotonous or repetitive tasks reducing alertness. • Distractions from radio communications or nearby activity. • Mental fatigue or tunnel vision during extended shifts.

<p>Mine operators should consider a layered defence approach to help achieve safe operating states for mobile plant.</p> <p>Including:</p> <ul style="list-style-type: none"> • mine design and site standards • effective road conditions • organisational requirements • traffic management • potential for interactions between vehicles, pedestrians and fixed plant • operator requirements • assistance from technology • process to implement and maintain vehicle interaction controls. • fatigue management, and • situational awareness of operators.

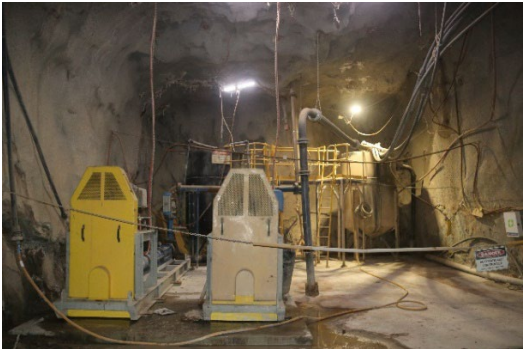
<p>Dangerous incident</p> <p>IncNot0049494</p> <p>Underground metals mine</p>	<p>A cable bolt combi plate was found dislodged on the floor of the pump station by a pump fitter during routine day shift inspections. The plate was not present the previous day, and the area remained</p>	<p>Mine operators are recommended to undertake regular ground support inspections for water impacts and corrosion. Corrosion of ground support limits its effectiveness in protecting workers from falls of</p>

Incident type	Summary	Recommendations to industry
	<p>unattended between blasting and discovery.</p> <p>Initial inspection by the shift supervisor confirmed the failure and severe corrosion of cable bolt strands behind the barrel and plate.</p> <p>It is believed that ground vibration from production firing in a stope, about 55 metres above, contributed to the failure. A subsequent inspection and evidence collection were carried out by the geotechnical engineer, with findings documented in a geotechnical event record.</p>	<p>ground and may need rehabilitation and secondary support installation. In areas where workers are on foot a system of inspection needs to be in place to identify corroded or damaged ground support, bagging mesh and loose ground support to ensure there is no risk of an object falling from height onto a worker.</p>
