Quarterly safety report

April to June 2025

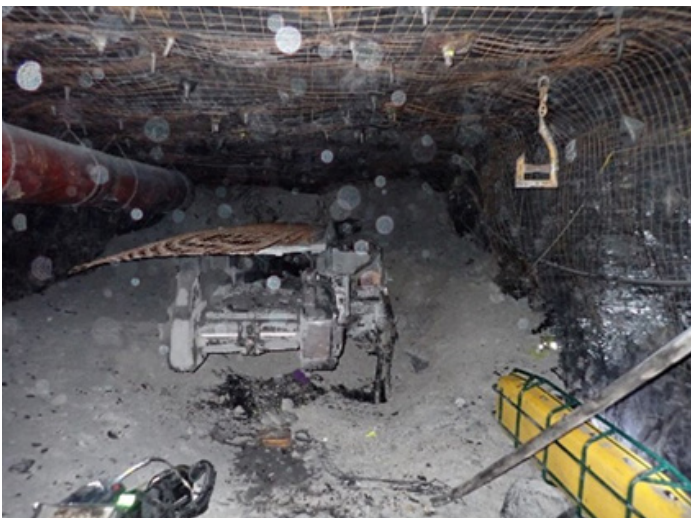
Picture 1.
Pulverised material after incident

Dangerous incident | IncNot0048887 – Workers engulfed after energy release

Summary: Four workers were engulfed in pulverised material following an unexpected dynamic energy release from stone in a mine roof. The workers were standing on a continuous miner work platform at the time and were pushed off the platform by a pressure wave. Three of the workers were partially buried and material had to be moved to free them. The workers were all taken to hospital for treatment.

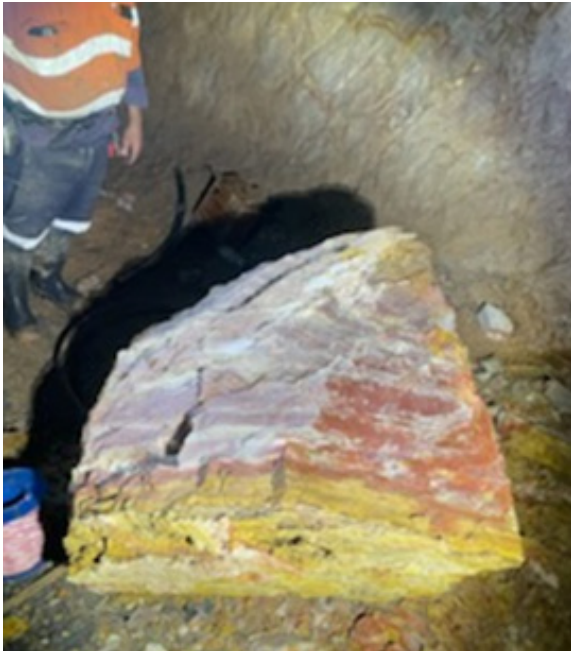
Picture 2.
Fallen rock

Summary: Two workers were charging a face when a large rock around 2 to 3 tonnes dislodged from a height of about 2.5 metres, grazing one worker's head, and striking him on the shoulder. The face was scaled prior to work commencing.

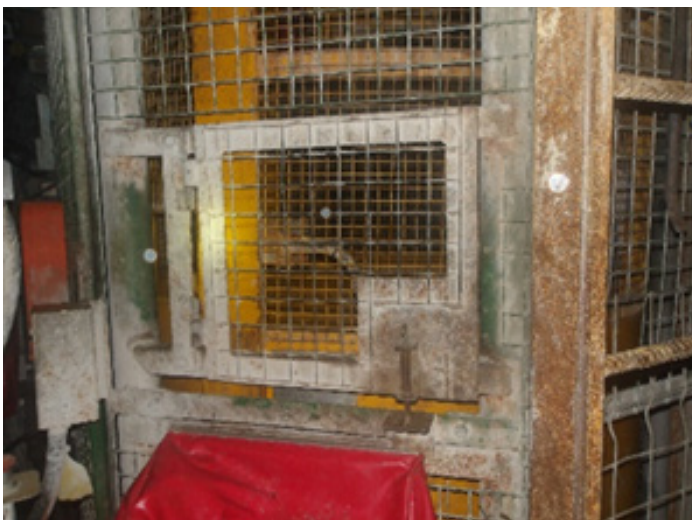
Picture 3.
The cage involved in incident

Severe incident | IncNot0049070 – Worker struck by man cage

Summary: A worker was struck on the head by a man cage as it travelled through the work stage in the shaft. The worker placed his head and shoulders through a hatch into the kibble well to communicate with the mucker operator below him. The worker was struck when the man cage was being lowered through the stage, with the chamfered edge of its base colliding with the worker's hard hat. The worker rapidly pulled his head back scraping his neck on the hatch sill causing a small abrasion, and neck soreness.

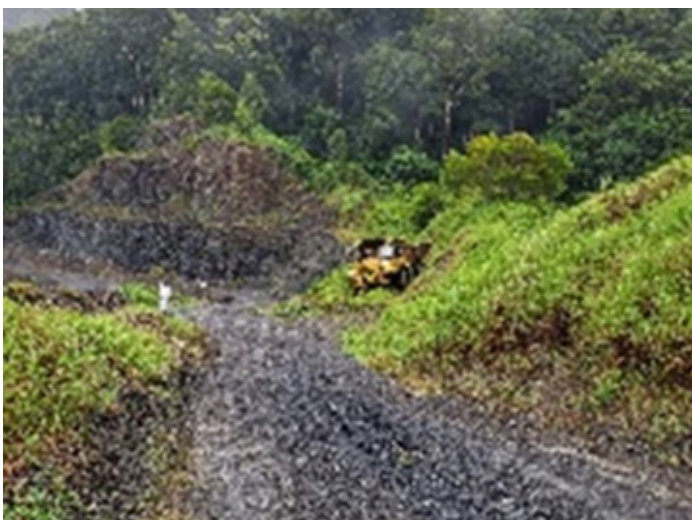
Picture 4.
Haul truck on bench

Dangerous incident | IncNot0048820 – Haul truck rolled backwards after losing power

Summary: A haul truck lost power on a ramp and rolled 30 metres backwards before coming to rest on a bench. The operator had stopped on the ramp with the motor running, waiting for another task to be completed. When the task was completed, the operator put the truck in gear, released the handbrake and took his foot off the footbrake to accelerate. The engine cut out and the truck began rolling backward. The operator pumped the footbrake and pulled the retarder up and down multiple times with no result. He couldn't use the secondary retarder as he was trying to steer the truck. He managed to steer the truck over a water diversion bund and bring it to a halt. The cause of the failure is being investigated.

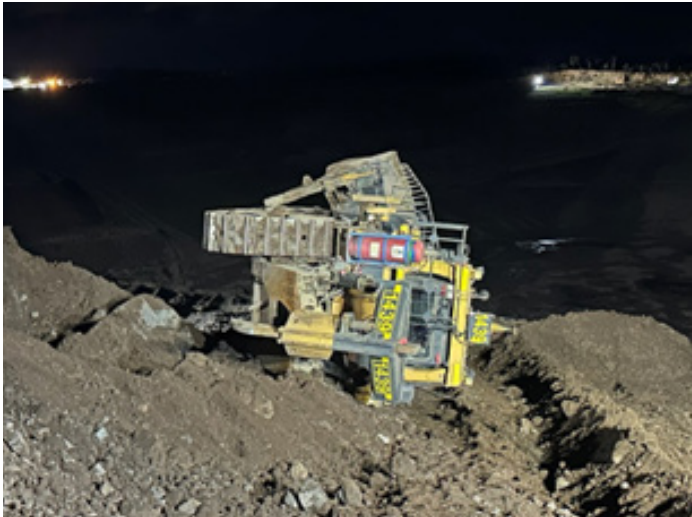
Picture 5.
Dozer on side after incident

Summary: A dozer rolled onto its side when travelling over wet material on one track and mounted a large rock with the other track. The operator was able to exit the dozer and was unharmed.

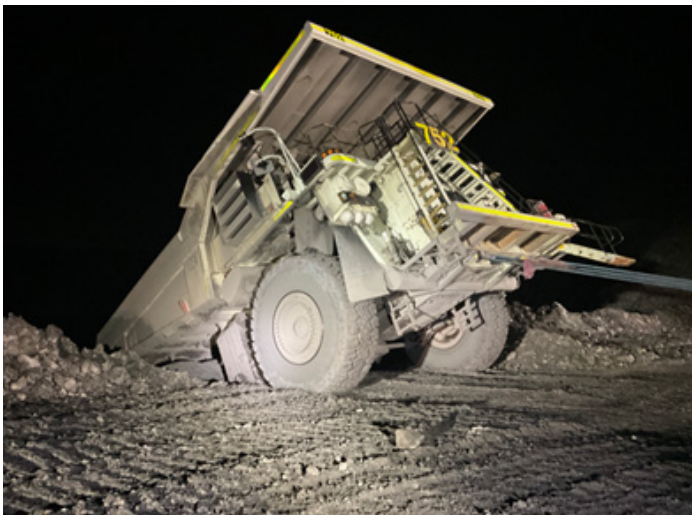
Picture 6.
Sunk truck at tip head

Summary: While dumping a load at a tip head, the ground gave way beneath a Load Haul Dump (LHD) truck, causing the back of the truck to sink up to the axle.

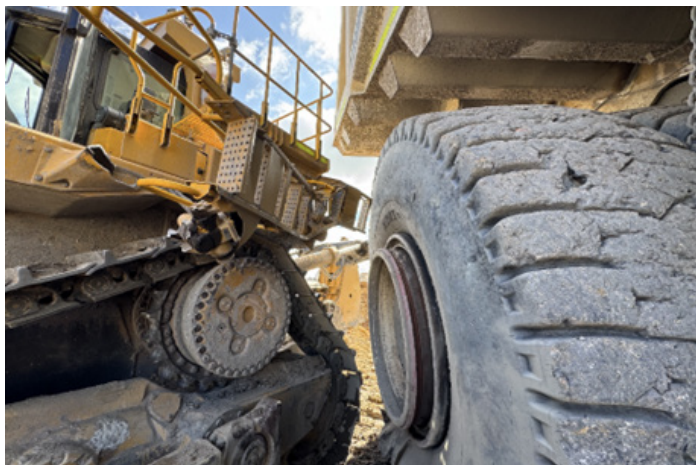
Picture 7.
Damaged tyre following collision

Summary: A dozer collided with the position 6 tyre of a loaded haul truck on an active dump causing the tyre to blow out. The dozer operator expected the truck operator to dump on the left-hand side of the tip face. The truck operator went to the right-hand side of the tip face following a previous truck dump position. There was no communication between the operators on the correct dump position for the truck. The dozer operator was aware the truck was on the dump.

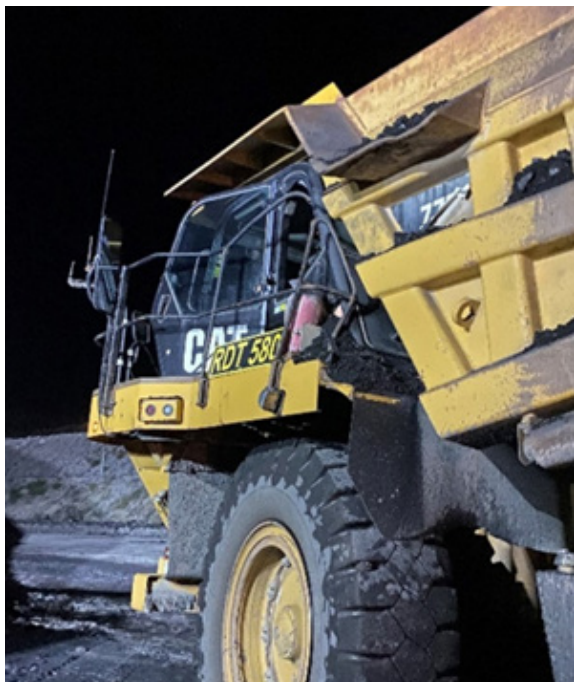
Picture 8.
Damaged truck handrail and window

Summary: A wheeled loader was loading a rear dump truck with coal when the bucket hit the truck body and a handrail. Coal material tipped from the bucket and broke the cab window. The operator was uninjured. The incident occurred on night shift and there was no lighting plant in operation at the time of the incident.

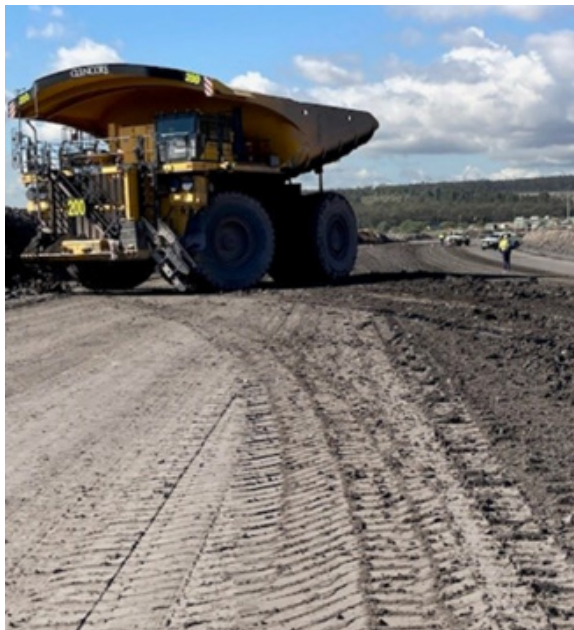
Picture 9.
Spun truck on haul road

Summary: While travelling on a wet section of road, an empty haul truck lost traction as a mobile manufacturing unit (MMU) was passing on the opposite side. The haul truck slid along the road and crossed the centre line before ending up at 180 degrees from the intended direction of travel. The haul truck missed colliding with the MMU by about 8-9 m.

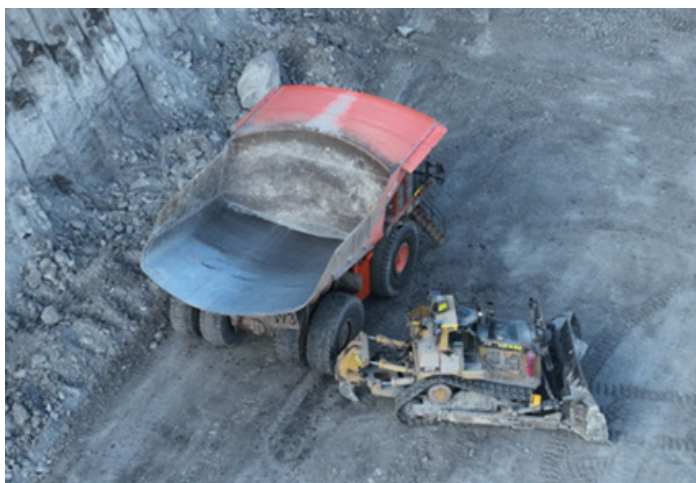
Picture 10.
Contact between dozer and dump truck

Summary: A dozer was doing a clean-up for an excavator while the excavator was loading a dump truck. A second dump truck entered the area and went into the queue about 30 metres from where the truck was being loaded. The dozer operator reversed to turn and leave the work area and collided with position 6 tyre of the queued truck. The dozer operator had not identified that the second truck had entered the work area.

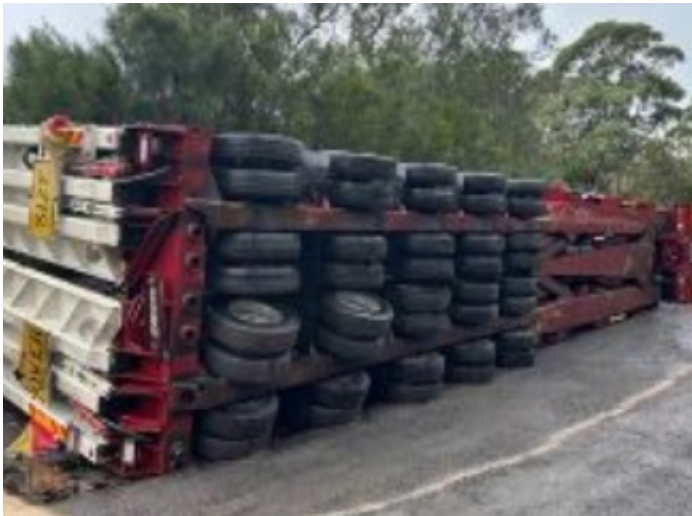
Picture 11.
Rolled truck

Summary: An old shearer body (with no counterweight or ranging arms) was loaded onto a heavy haulage truck using a forklift. The left and right shearer haulage sprockets and trapping shoes were positioned on the gate end/transition pans that have a larger clevis arrangement on the back of the pan set. Once the load was dogged down and cleared for transport, the truck was driven about 300 metres and rolled, while driving at slow speed on flat ground around a left-hand corner. The driver was uninjured. Two gate/transition pans were used instead of run-of-face (ROF) pans for the sprockets to sit on. This shifted the load towards one side, shifting the centre of balance.

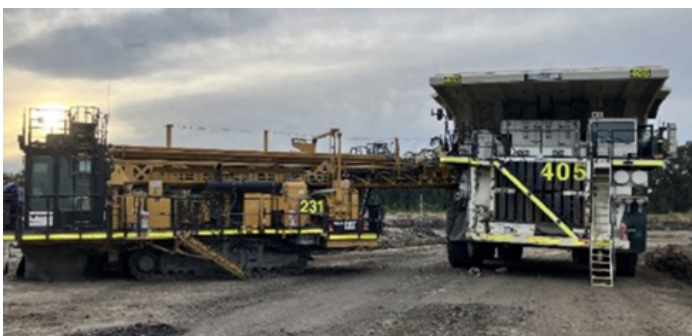
Picture 12.
Scene of truck and drill rig collision

Summary: A haul truck was passing a drill rig that was tramming along a haul road when the position 2 tyre and the mast of the drill rig collided. The truck operator saw an indicator light flash on the drill rig and assumed that it was a signal to pass.

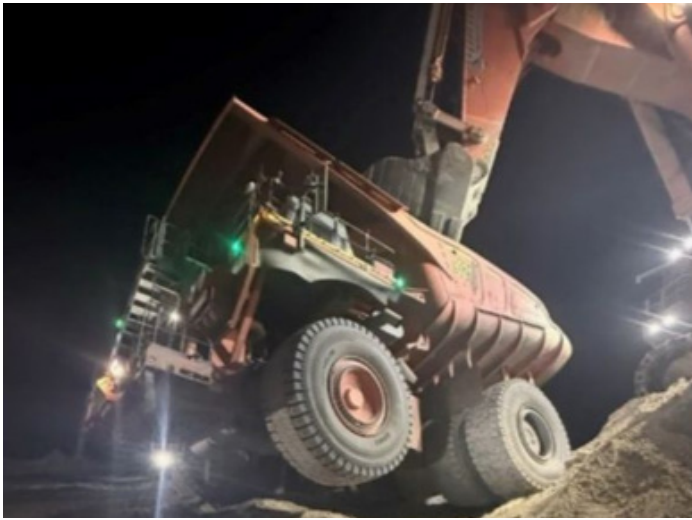
Picture 13.
Stricken truck with lifted tyre

Summary: As a loaded haul truck attempted to move forward out of a loading bay, the ground under the position 5/6 tyre slumped, causing the load to shift in the tray. The truck slid backwards into a hole, resulting in the position one tyre lifting off the ground. The excavator operator quickly used the bucket to secure the truck and prevented it from overturning. Weak, weathered material slumped underneath position 5/6 tyre and, in combination with the uneven floor at the rear of the loading bay, resulted in position 5/6 slumping back into a hole and shifting the load of the truck, unbalancing it and lifting position one tyre.

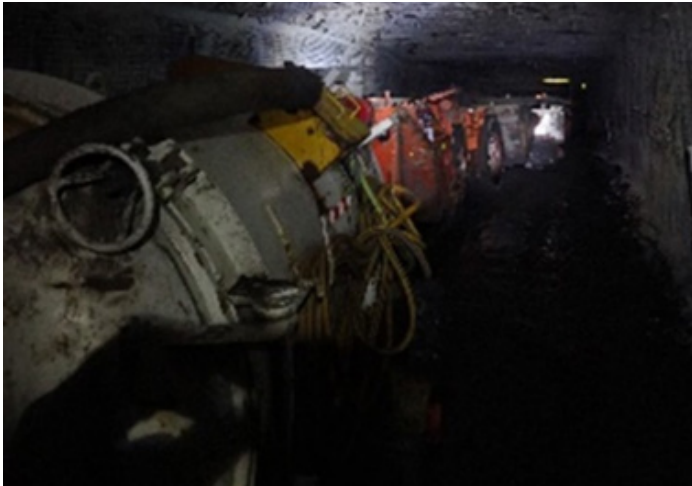
Picture 14.
Scene of incident

Summary: A stationary load haul dump machine (LHD), with a Brain tank trailer attached, was hit by a travelling LHD that caused the stationary LHD to be pushed backwards. A worker was hit on the shoulder by the Brain tank as the stationary LHD was pushed back.

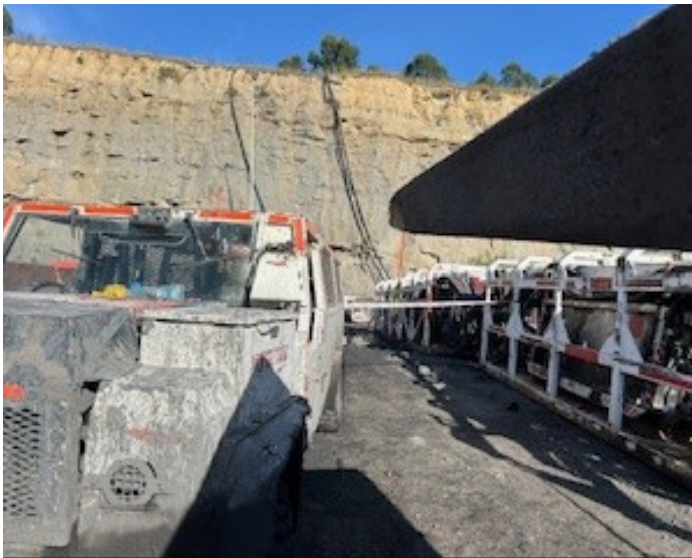
Picture 15.
Transporter at scene of incident

Summary: A personnel transporter (SMV) was exiting a mine portal when it collided with a roof support that was stored near the portal. When exiting the portal, the SMV operator saw a second SMV stopped on the roadway near a washdown pad. The operator believed there was adequate room to pass the stationary SMV but collided with the roof support in the process. The SMV operator failed to see the stored roof support.

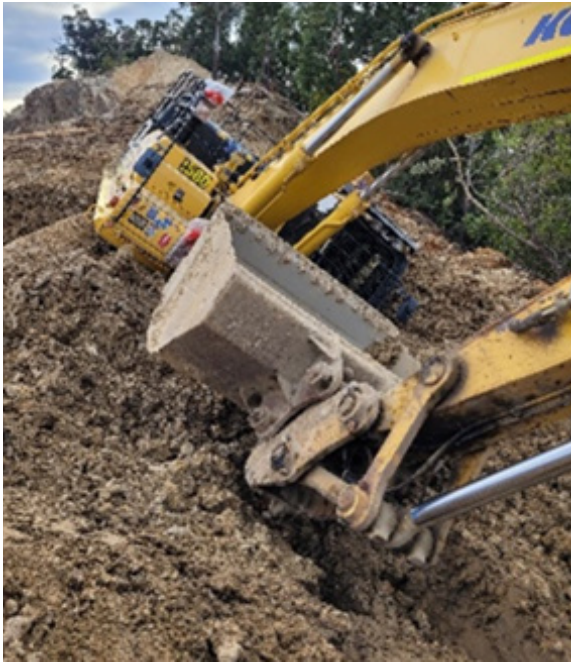
Picture 16.
Bogged truck

Summary: An excavator operating in a weathered zone became bogged and the machine slid about 3 metres. The operator was working on saturated overburden when the machine bogged. The operator slewed the excavator, and the counterweight went over the downward slope causing the track to sink further.

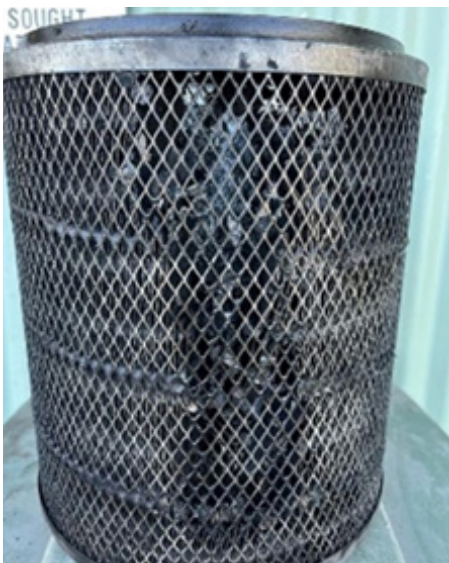
Picture 17.
Damaged exhaust after incident

Dangerous incident | IncNot0048960 – Sparks, embers and smoke from LHD exhaust

Summary: A dry scrubber load haul dump machine (LHD) was tramming underground in a coal mine when the operator noticed sparks, embers and thick smoke coming from the exhaust. The LHD was shut down. The incident was notified as a failure of explosion-protected characteristics on explosion-protected plant, and the scene was not held. While an investigation is underway, the cause seems to be either the ignition of the glycol coolant that may have leaked into the exhaust, or the combustion of the exhaust particulate filter from excessive exhaust back pressure. The photograph below shows a burnt exhaust filter. The original equipment manufacturer (OEM) had communicated design improvements, but these had not been made to this LHD at the time of the incident.

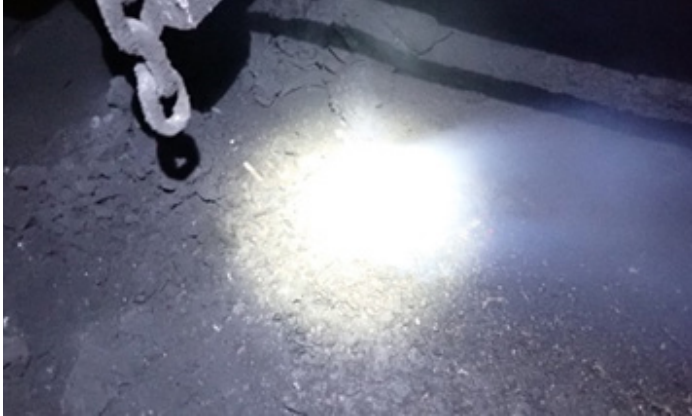
Picture 18.
Heat location underneath conveyor belt

Summary: While undertaking a conveyor and thermography inspection, a deputy noticed haze and smoke coming from the ground. There was a glow from the ground and the thermography camera measured 264 degrees at that point. It was discovered that the return conveyor belting was rubbing on the return structure frame. The conveyor was shut down and the area was doused with water.

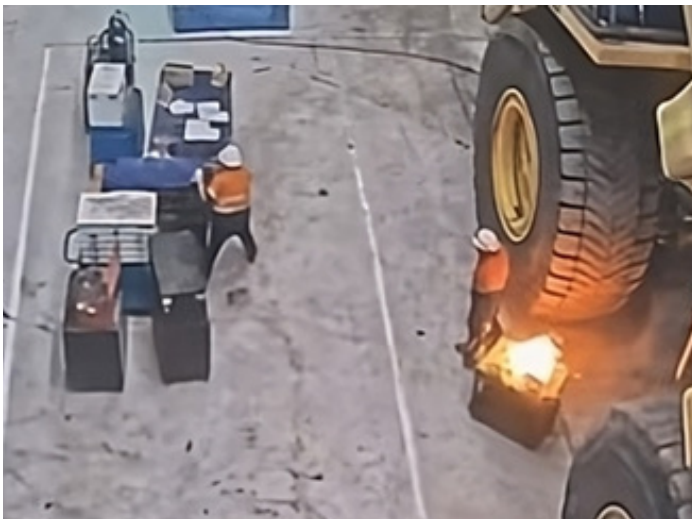
Picture 19.
Trolley mounted tray on fire

Summary: A boilermaker was using a grinder while working on the chassis rails of a dump truck. The sparks from the grinder ignited a trolley-mounted tray containing brake-cleaning fluid that was beneath the truck. One worker moved the trolley clear of the truck and 2 workers attempted to smother the fire with cloths. Unfortunately, this only added fuel to the fire. The trolley was wheeled outside the workshop and tipped over, allowing the burning liquid to spread across the ground. Another worker used a dry chemical powder extinguisher to put out the fire. Nobody was injured during the incident, although workers were exposed to smoke, extinguishing medium and the fire.

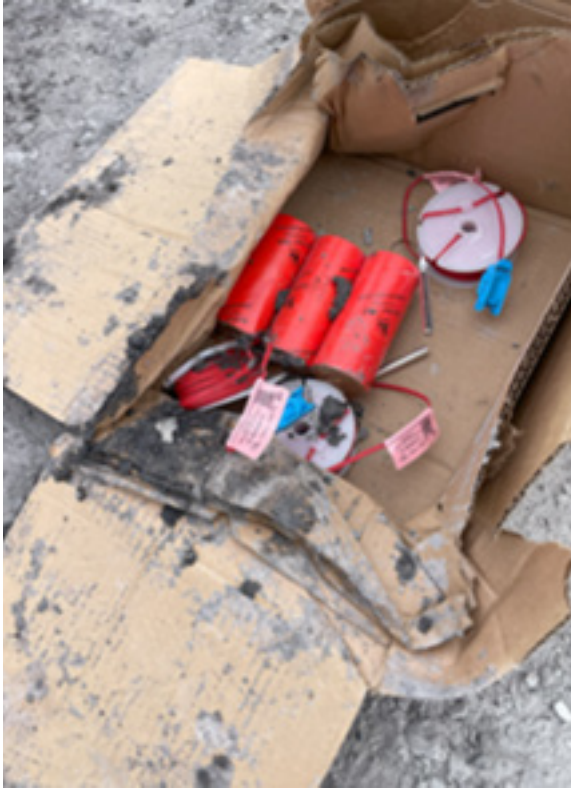
Picture 20.
Damaged boosters

Summary: A loader inadvertently ran over and damaged 2 boosters that were on the ground while exiting a shot pattern.
