Safety Alert

Date: September 2025

Electric shock from 11kV ethylene propylene rubber (EPR) insulated cable

Safety Alert SA25-04

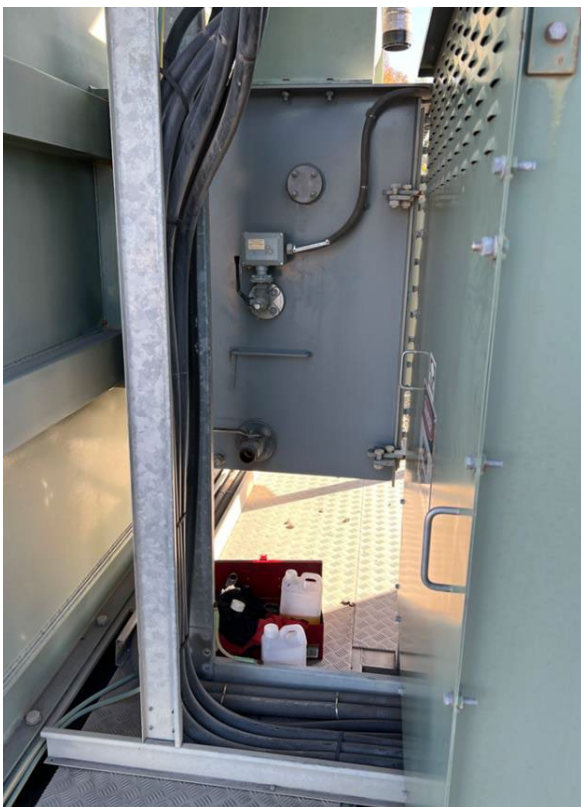
A contract worker took oil samples on a 66kV/11kV transportable substation at an open-cut coal mine in the Hunter region on 23 June 2025. After taking a sample from the automatic tap changer, the worker repositioned and their arm made contact with the cable tray and cable sheath simultaneously, resulting in an electric shock.

Figure 1: 11kV EPR insulated cable installed between the transformer bushings and an adjacent 11kV switchboard

The mine's investigation identified a peak open circuit voltage of 812VAC measured between the external cable sheath and the earthed cable tray.

The mine repeated the open circuit voltage test with a 1.25k Ω resistor installed in parallel to earth, to simulate the impedance of a human body. This simulation dropped the open circuit voltage to 1.1VAC with a measured current of 2mA.

- HVPW cable installed external to metallic housed switchgear or substations.
- HVPW cable installed exposed to the elements/sunlight.
- HVPW cable installed touching other conductors or metallic structures (e.g. cable trays).
- HVPW cable installed in applications with more than 10 metres in length.
- Inadequate earthing of the semiconductive extruded layer.
- Use of unsuitable support systems for the HVPW cable.
- HVPW cable installed with bends exceeding the minimum bending radius.
- HVPW cable damaged during installation i.e. with indents or scuffing of the semiconductive extruded layer or with air pockets/bubbles in the EPR layer or between layers.

- review the mine’s high voltage cable installations to confirm the cable types used
- assess the risk of high voltage cable installations and ensure that controls are implemented to manage risk as low as is reasonably practicable.
- Where HVPW cable is installed, review the installation against the manufacturer’s requirements.

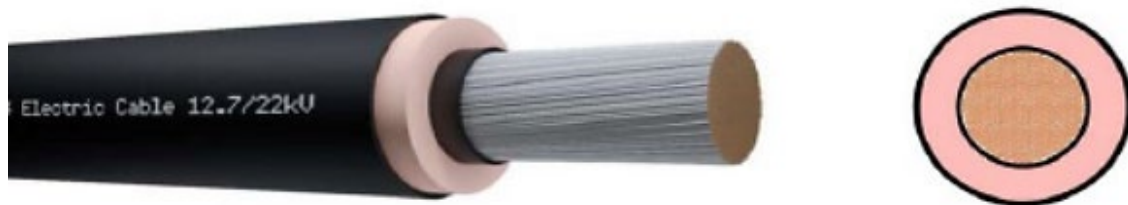
The cable involved in this incident was a single core 120 mm² ethylene propylene rubber (EPR) insulated panel wire 12.7/22kV, also known as a HVPW cable.

The key design feature of this HVPW cable is the semiconductive extruded layer, which is outer black covering that is used as a conductor screen. The purpose of this layer is to help distribute electrical stress evenly and prevent stress points forming, which could lead to cable failure.

Figure 2: Example illustration of a single core 120 mm² ethylene propylene rubber (EPR) insulated panel wire 12.7/22kV
