Weekly incident summary

Week ending 29 August 2025

Weekly incident summary week ending 29 August 2025

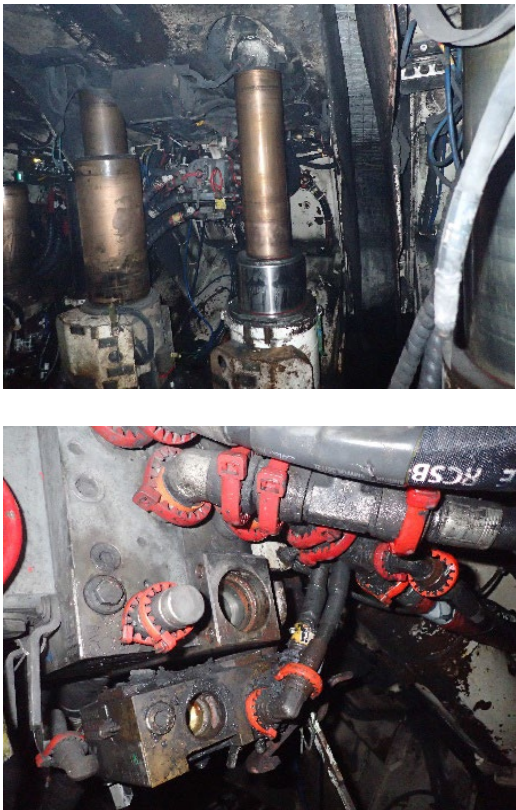
Incident type	Summary	Recommendations to industry
	<ul style="list-style-type: none">The pressure gauge does not give any indication of the pressure in the circuit of concern – the return circuit. <div>

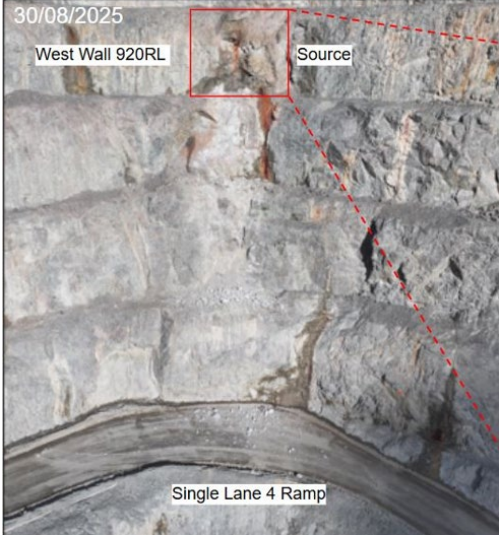
Incident type	Summary	Recommendations to industry
	<div><div>30/08/2025</div><div>West Wall 920RL</div><div>Source</div><div>Single Lane 4 Ramp</div>

</div>	<p>A rockfall occurred from an identified geotechnical hazard with material from the rockfall filling the catch benches below and some debris landing on the haul road.</p> <p>The haul road was operational during the time of the incident, however there were no workers or machinery in close proximity.</p>	<p>All mines with highwalls should complete geotechnical assessments to determine the design of the highwall. All geological and geotechnical issues need to be considered and highwalls designed accordingly.</p> <p>Mine operators are reminded that when developing the control measures to manage the risks of ground or strata failure, consideration must be given to:</p> <ul style="list-style-type: none">the means by which water may enter the minethe procedures for removing water from the minehow those procedures influence rock stability over timethe geotechnical characteristics of the rocks and soil, including the effects of water on rock support and stability. <p>Refer to the safety bulletin:</p>

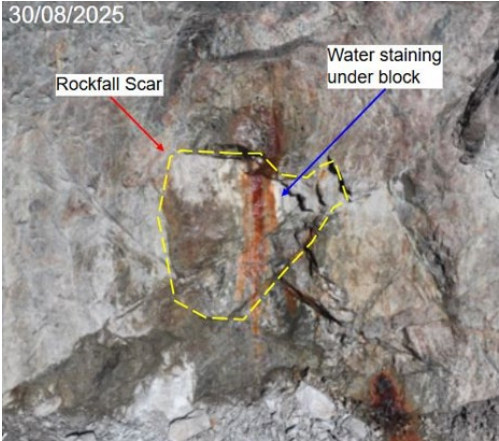
</div> <div><div>30/08/2025</div><div>Rockfall Scar</div><div>Water staining under block</div>

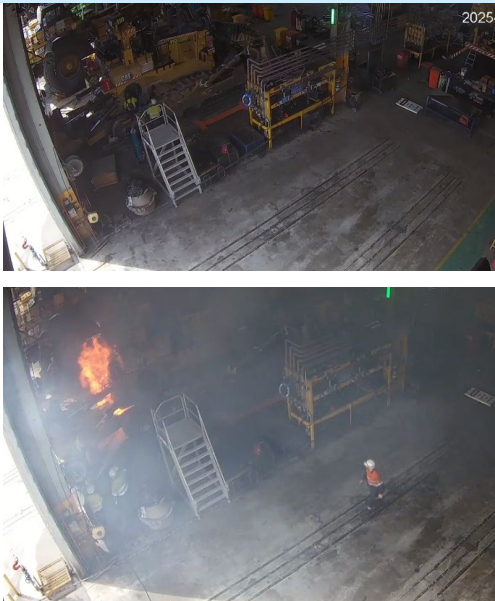
</div>	<p>A fire occurred underneath a dozer while weld repairs on the transmission piping within the bevel gear housing were being undertaken.</p> <p>Hot material caused hydrocarbons beneath the dozer to catch fire. A boilermaker went under the dozer to try to pull oil trays out but was forced to retreat because of the flames.</p> <p>The fire was extinguished using fire water hoses and extinguishers.</p> <p>When water was applied to the fire the flames increased.</p>	<p>Mine operators must have processes in place to ensure that the controls identified within site procedures and permits are implemented. Work procedures should not allow for flammable materials to be in the vicinity of hot work.</p> <p>Workers must be trained regularly about how to respond in an emergency such as a fire. Workers should be aware of the location of emergency equipment and mine operators should conduct regular emergency response training.</p>
