Weekly incident summary

Week ending 5 September 2025

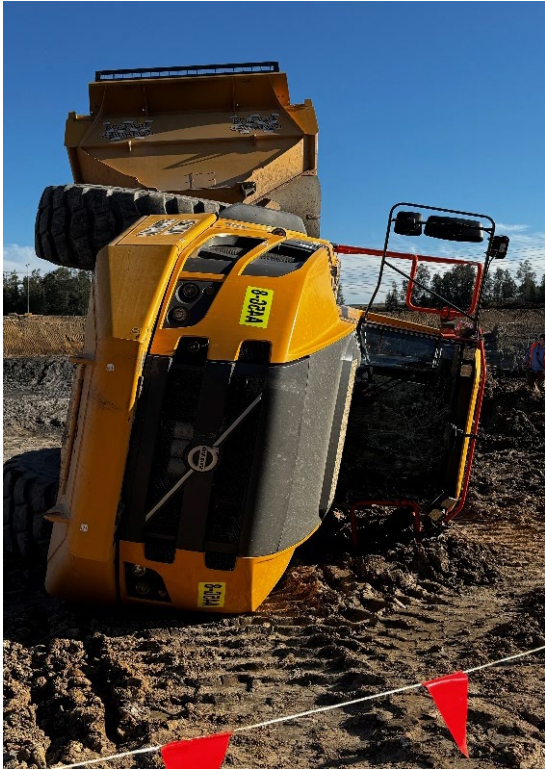
Incident type	Summary	Recommendations to industry
Dangerous incident IncNot0049744 Construction materials Roads or other vehicle operating areas	<p>An articulated truck was in the process of dumping material when the front wheels lifted off the ground, causing the cab to tip onto its side.</p> <p>Wet materials became stuck in the tray and slipped and hit the tailgate while the dump truck was moving forward.</p> <p>This caused the cab to lift off the ground and then spin as a result of the engine driving back through the tail shaft.</p> <p>The loading operator was not aware the material was too wet.</p> <p>The operator was able to exit the vehicle unaided and did not sustain any injuries.</p>	<p>The stability of articulated vehicles is a known risk that needs to be managed at mine sites. When developing control measures to deal with the risks associated with articulated trucks consideration should be given to factors such as</p> <ul style="list-style-type: none">• speed of operation• operating grades• uneven surfaces (holes, rocks, foreign material)• tipping of loads• hang-up of loads• movement of loads.

<p>Mine operators should consider the most appropriate truck type for the material being transported.</p> <p>The Resources Regulator has published a technical reference guide (TRG) to assist mine operators with developing their principal hazard management plan for roads or other vehicle operating areas.</p> <p>For further information refer to TRG: <u>Roads or other vehicle operating areas – principal hazard management plan for surface mining operations.</u></p>
<p>Dangerous incident IncNot0049767 Open cut coal mine Roads or other vehicle operating areas</p>

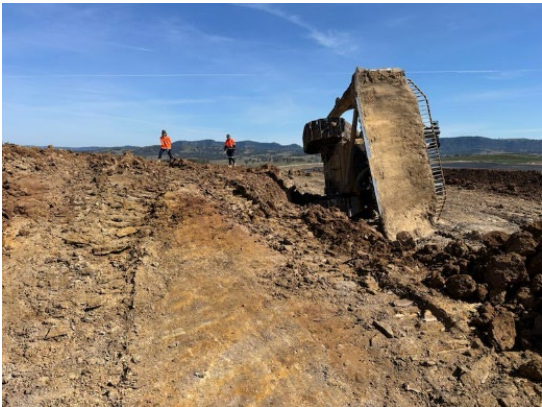
<p>While constructing a haul road, a dozer overturned while reversing out of a slot. The operator was reversing and turning to move to an adjacent slot, which was on a lower level (about 1.6 metres).</p> <p>During the manoeuvre, the left track dropped over the edge causing the right track to lift and the dozer to slowly roll onto its side.</p> <p>The operator failed to identify the open edge while reversing.</p> <p>The operator was wearing a seatbelt and was uninjured.</p>

<p>When developing risk assessments for dozer operations, mine operators should confirm that all reasonably foreseeable operating conditions and practices have been included and assessed.</p> <p>Ensure that the controls identified have been implemented, and they are monitored for effectiveness on an ongoing basis.</p> <p>Operators should conduct pre-task inspections of work areas to identify and manage the hazards present. This practice must be monitored and confirmed by supervisors.</p> <p>Refer to the safety bulletin: <u>SB19-01 Rise in dozer incidents putting operators at risk.</u></p>

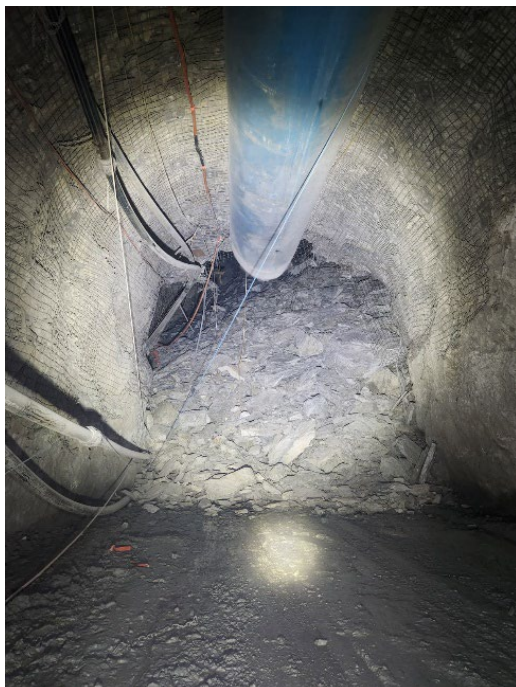
Incident type	Summary	Recommendations to industry
High potential incident IncNot0049721 Underground metals mine Ground or strata failure	<p>A fall of ground occurred in an underground rehab stockpile.</p> <p>The incident occurred during a shift change and increased in length after the first observation to about 20 metres in length.</p> <p>Ground support had been damaged when using the area as a stockpile.</p> <p>No workers were in the vicinity at the time of the fall.</p>	<p>Mine operators are required to have a principal hazard management plan for ground or strata failure and to ensure that the plan is implemented as designed.</p> <p>Mine operators must ensure that regular inspections are undertaken to ensure that ground support is intact and undamaged. Where damage has occurred, remediation should be carried out as soon as possible, in particular where there is a risk of an egress being compromised.</p> <p>Refer to:</p> <p><u>NSW code of practice - Strata control in underground coal mines.</u></p>
