# Weekly incident summary

## Week ending 17 October 2025

# Weekly incident summary week ending 17 October 2025

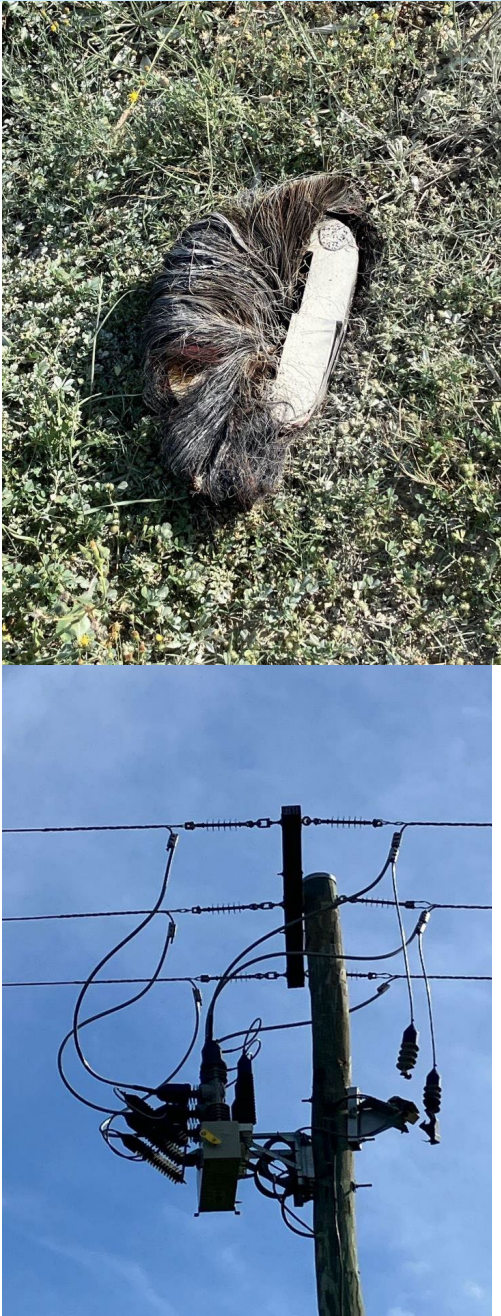
| Incident type | Summary | Recommendations to industry |
|---|---|---|
| <p>High potential incident<br/>IncNot0050045<br/>Surface coal mine</p> | <p>An electrician was implementing a high voltage access procedure. After closing 11 KV ABS (RF11 ABS 1) and proceeding to the associated recloser (RF 11 2REC 1), he heard arcing or crackling sounds, which were shortly followed by a loud explosion or bang. Protection devices upstream of the fault tripped immediately. At this time, an object was seen falling from the pole to the ground. The electrician saw the object was burning. The electrician retrieved a portable fire extinguisher from a light vehicle to extinguish the fire.</p> <p>The cause was a component failure due to an incorrect secondary termination.</p> | <p>The operator of a mine or petroleum site must manage risks to health and safety associated with electricity at the mine or petroleum site.</p> <p>In managing risks to health and safety associated with electricity, the operator must ensure that the electrical installation work at the surface is carried out in accordance with the wiring rules and before a circuit is first energised at the mine or petroleum site, or is first energised following the circuit being recommissioned the circuit is tested in accordance with the</p> |

| Incident type | Summary | Recommendations to industry |
|---|---|---|
| | | wiring rules by a competent person. |
