Weekly incident summary

Week ending 26 September 2025

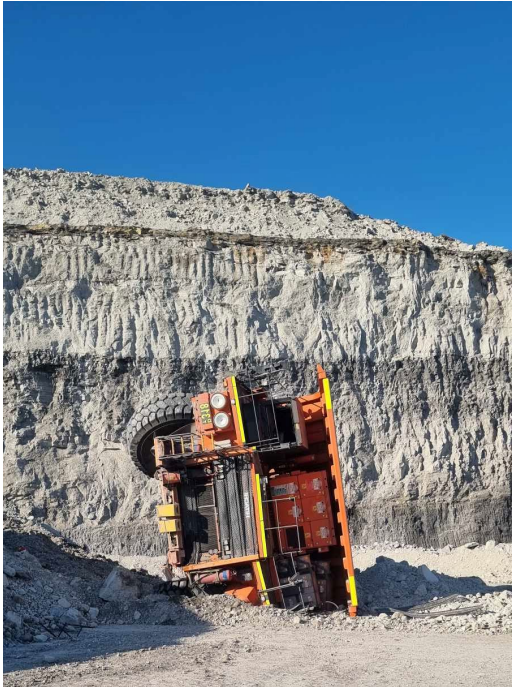
Incident type	Summary	Recommendations to industry
Dangerous incident IncNot0049952 Open cut coal mine Roads or other vehicle operating areas	A dump truck crossed a centre bund and rolled onto its side. The operator was rescued using an elevated work platform and did not suffer any injuries.	<p>Vehicle operators are reminded that they must follow procedures related to roads and other vehicle operating areas including speed requirements on ramps and crests.</p> <p>Mine operators should conduct regular audits to determine if there is a need to install crest and ramp speed monitoring and implement it where necessary.</p> <p>Mine operators should also regularly examine information from speed monitors to identify any non-compliance to ramp and crest speeds.</p> <p>This incident highlights the importance of wearing a seatbelt at all times when operating vehicles.</p> <p>The Resources Regulator has published a technical reference guide (TRG) to assist mine operators with developing a</p>

<p>principal hazard management plan for roads or other vehicle operating areas. For further information refer to:</p> <p>TRG: <u>Roads or other vehicle operating areas – principal hazard management plan for surface mining operations.</u></p>
<p>Dangerous incident IncNot0049874 Underground coal mine Ground or strata failure</p>

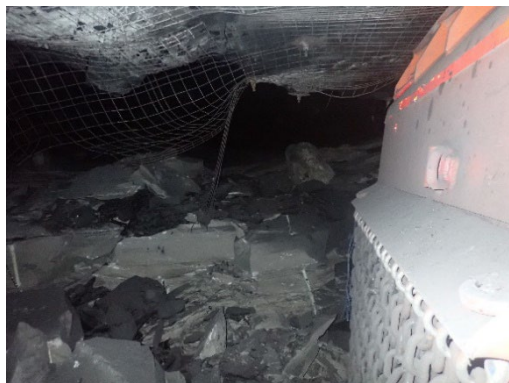
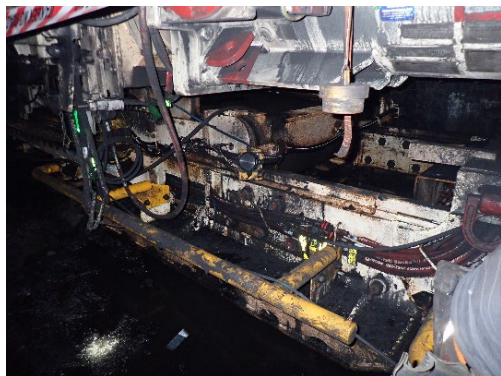
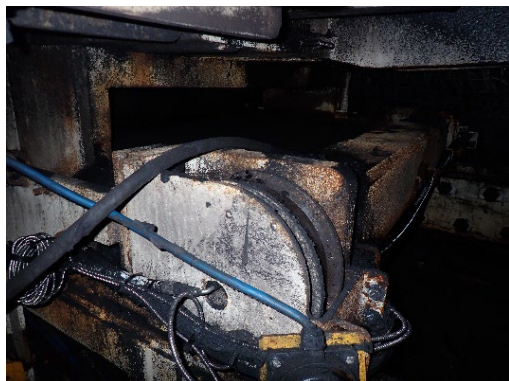
</div> <p>A fire occurred on the tail pulley of a longwall conveyor. A burning smell was identified by tradesmen and a 300 mm flame was seen in the vicinity of the off-walk side tail pulley bearing.</p> <p>Workers isolated the tail pulley area to remove foreign material around the tail pulley in the hours leading up to the event. They suspected this was the cause of the heating/smell of burning that was reported.</p> <p>Once the belt was restarted, within a few minutes of restarting, temperatures spiked, and the flame was seen from the off-walk side of the tail pulley and was extinguished.</p> <div>

Mine operators must develop effective controls to ensure operation and maintenance of the longwall conveyor bootend does not result in a bearing failure and fire in the hazardous zone.

Where necessary, mine operators should conduct a design review of the longwall bootend to determine if it is fit-for-purpose.

Mine operators must have a system to identify and change-out worn or damaged bearings. People conducting inspections must be aware of the increased risk of bearing failure at high tension areas.
