Weekly incident summary

Week ending 3 October 2025

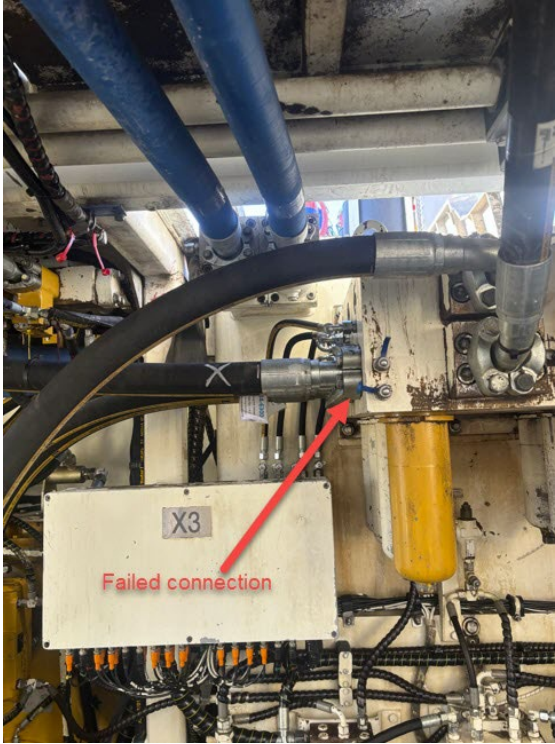
Incident type	Summary	Recommendations to industry
 	<p>excavator with the E-stop at the entrance to the pump room where oil was seen spraying and dripping from the high-pressure manifold block mounted between the power packs.</p> <p>The operator returned to the engine bay and saw flames over the right-side engine and activated the fire suppression system.</p> <p>An initial investigation identified a blown rubber seal in a flange-type connection of a high-pressure pump delivery hose to the pump distributor block. The wrong type of seal was installed in the hose end fitting.</p>  	<p>quality control of maintenance and repair activities.</p> <p>The person with management or control of plant at a work place must ensure that the maintenance, inspection and, if necessary, testing of plant is carried out by a competent person.</p> <p>The maintenance must be carried out in accordance with the manufacturer's recommendations where available.</p>
