# Weekly incident summary

## Week ending 14 November 2025

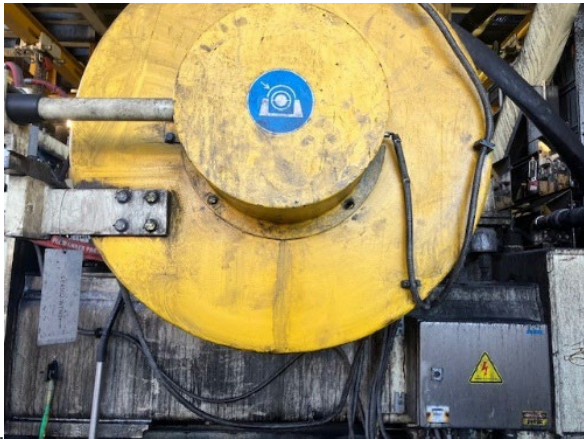
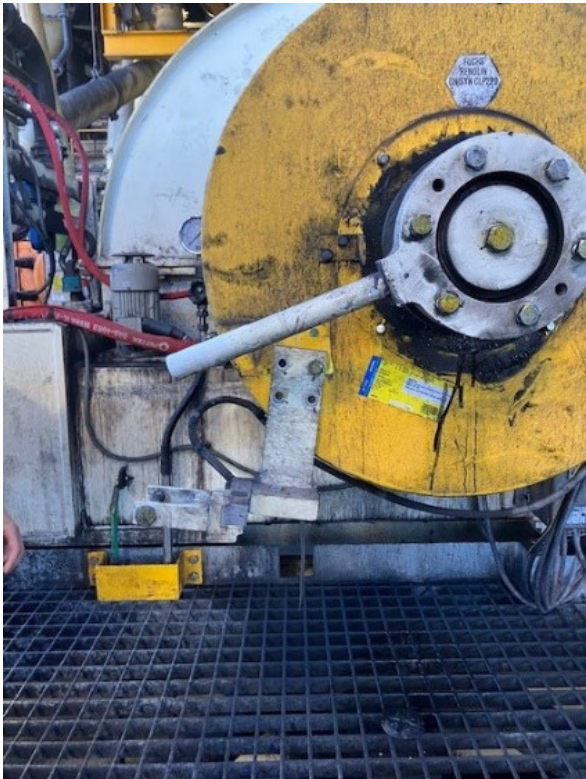
| Incident type | Summary | Recommendations to industry |
|---|---|---|
| <p data-bbox="124 1839 368 1919">Dangerous incident<br/>IncNot0050197</p> <p data-bbox="124 1944 328 2011">Coal processing plant</p> | <p data-bbox="411 1839 995 2011">A screen bowl centrifuge guard, weighing 4.6 kg, was damaged and ejected from its mounting position and travelled about 12 m across the screen bowl centrifuge flooring level into an accessible area.</p> | <p data-bbox="1034 1839 1414 1977">Plant and equipment must be maintained in accordance with Work Health and Safety Regulation 2025 section 213</p> |

| Incident type | Summary | Recommendations to industry |
|---|---|---|
| | <p>The cause of the incident was the failure of 3 out of 4 mounting bolts that held the torque arm strain gauge mounting bracket in position.</p> <p>The clutch was designed to disengage in high torque scenarios, however in this circumstance, the clutch did not disengage, loading up the bolted arrangement of the strain gauge mounting bracket, causing the bolts to fail.</p> | <p>Maintenance and inspection of plant.</p> <p>Non-destructive testing (NDT) inspections should be scheduled at pre-determined intervals to minimise the risk of equipment failure.</p> |
