Weekly incident summary

Week ending 5 December 2025

This incident summary provides information on reportable incidents and safety advice for the NSW mining industry. To report an incident to the Resources Regulator: phone 1300 814 609 24 hours a day, 7 days a week.

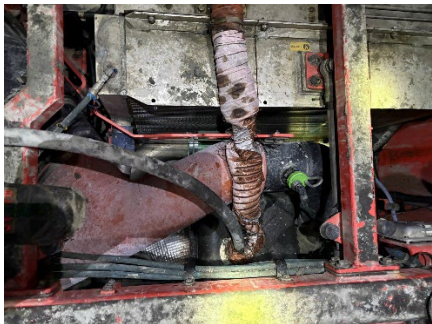
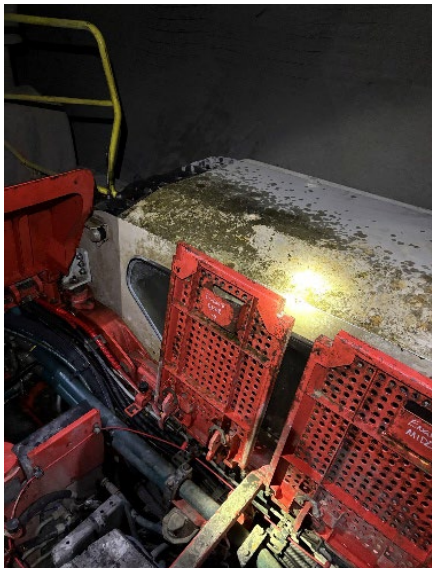
Incident type	Summary	Recommendations to industry
	<p>Incident 2 (30 Nov) A second coal burst occurred at shield #151 within a designated hazard zone. All stand-off and wait-time controls were in place and effective. No exposure to personnel occurred.</p> <p>Incident 3 (30 Nov) A third coal burst occurred approximately 0.8 m from the previous event location. Only a small volume of fine coal (about 2 × 20 L buckets) was ejected, with no large fragments.</p>	
<p>Dangerous Incident</p> <p>IncNot0050327</p> <p>Underground metals mine</p> <p>Fire or explosion</p>	<p>An underground truck was tramping up the decline in a metalliferous mine when the operator heard an odd noise and observed fluid spraying from the engine bay. The fluid subsequently ignited. The operator was parking the truck when the onboard fire system automatically activated. The operator called an emergency on the radio, parked, isolated the truck and proceeded to extinguish the fire with assistance from other workers using handheld fire extinguishers and a water hose.</p>

<p>Mine operators must undertake rigorous fire risk assessments and, wherever practical, seek to eliminate the hazard, such as potential fuel and ignition sources.</p> <p>Mine operators must not merely rely on fire suppression and detection systems, which are mitigation controls and do not eliminate or minimise the risk of a fire occurring.</p> <p>Identified controls must be effectively implemented and regularly monitored.</p> <p>Refer to the following for further guidance:</p> <p><u>Fires on mobile plant position paper</u></p> <p><u>MDG15 guideline for mobile and transportable plant for use at mines other than underground coal mines</u></p>

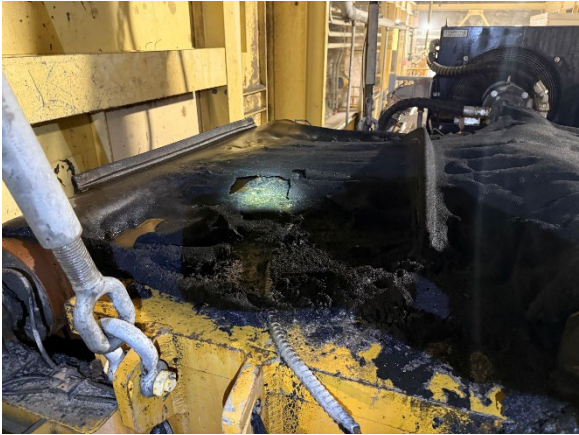
Incident type	Summary	Recommendations to industry
<div>Dangerous Incident</div> <div>IncNot0050313</div> <div>Underground metals mine</div> <div>Leave blank</div>	<p>A fire occurred on a self-cleaning magnet located in a collection conveyor area at an underground metalliferous mine. The flames were first observed by an operator, who immediately notified the control room and initiated emergency procedures.</p> <p>Video monitoring indicated that the fire self-extinguished approximately 10 minutes after ignition.</p>

<p>Mine operators must ensure:</p> <ul style="list-style-type: none">adequate inspection regimes are in place for conveyor systems.adequate controls are in place as part of the design of plant to mitigate the risk of falling objects from magnets coming into contact with grease lines, creating a fire hazard.
