Safety Alert

Date: March 2026

Fall from excavator breaks worker's legs

Safety Alert SA26-02

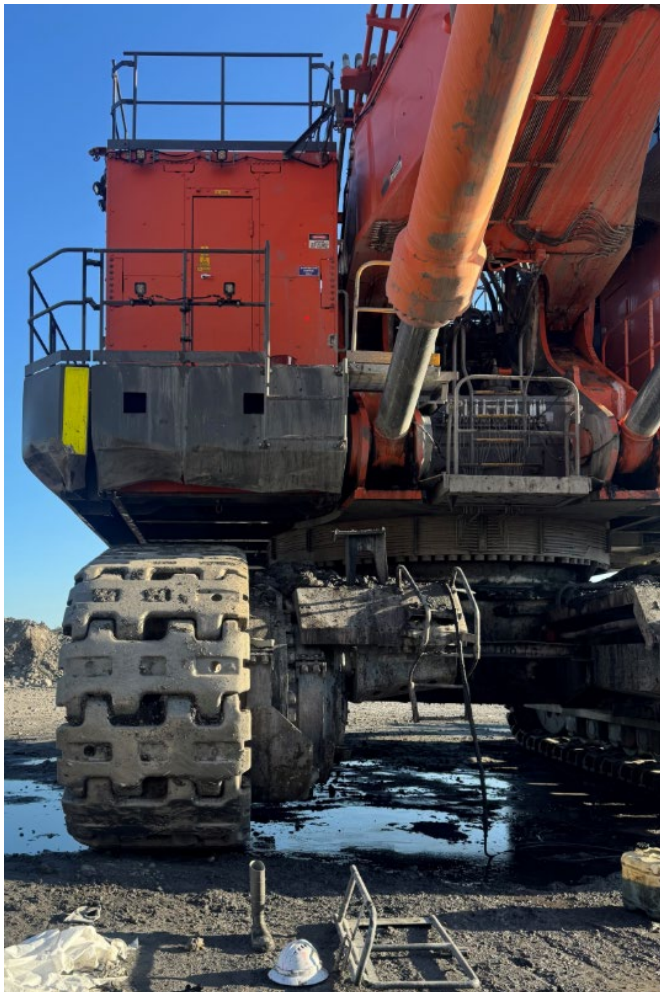
Figure 1: Hitachi 5600-6 Excavator EX316 with failed guardrail/gate assembly

A contractor was pressure washing near the right-hand boom cylinder on a platform at the front of the EX5600-6 about 5:20 am on 22 September 2025. While cleaning the boom cylinder mount, and in contact with the access ladder gate, the stanchion post failed at the base, and the worker fell to the ground. The worker suffered multiple fractures to the legs, and other injuries.

5. A crack or weld flaw in the weld attaching the gate stanchion post to the base plate allowed the gate stanchion post to fail when the worker put weight on it.

1. inspections and associated defect management of access gates, guardrail systems, and ladder handrails
2. design specifications for access gates, guardrail systems, and ladder handrails
3. suitability of access gates, guardrail systems, and ladder handrail locations with regard to ongoing operational damage
4. management of change where modification to guard railing and access systems associated with working at heights is being considered
5. failure modes of support stanchions or posts and processes to assess the weld quality between the support stanchions or posts and base plates
6. risk management, such as job hazard analysis (JHA), Take 5, work authorisation documentation, for completeness and suitability
7. engineering verification of completed modifications
8. management of excavator pre-maintenance cleaning processes
9. control of the access point and use by workers

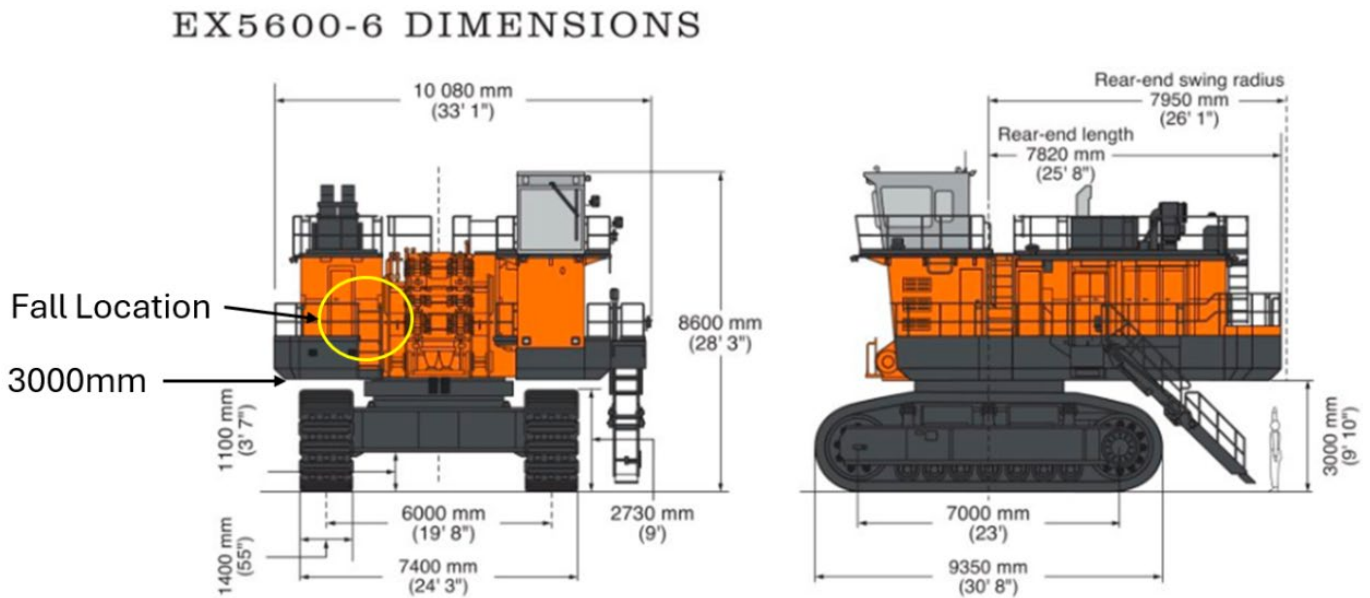
The failed section of guardrail/gate was adjacent to the right hand boom cylinder and also supported an aftermarket access platform.

Figure 2: Fall location and dimensions of Hitachi EX5600-6

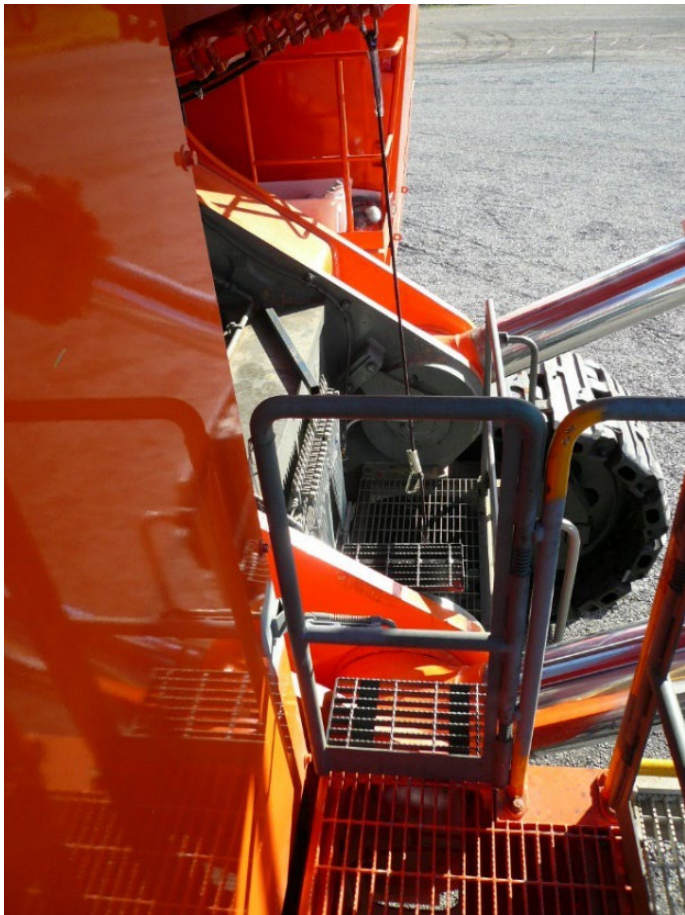
1. Modifications to the access platform from the original equipment manufacturer’s (OEM) design resulted the removal of one of the two stanchion posts.

Figure 3: Original OEM guardrail and gate assembly during machine commissioning

Two stanchion
guardrail supporting
access gates

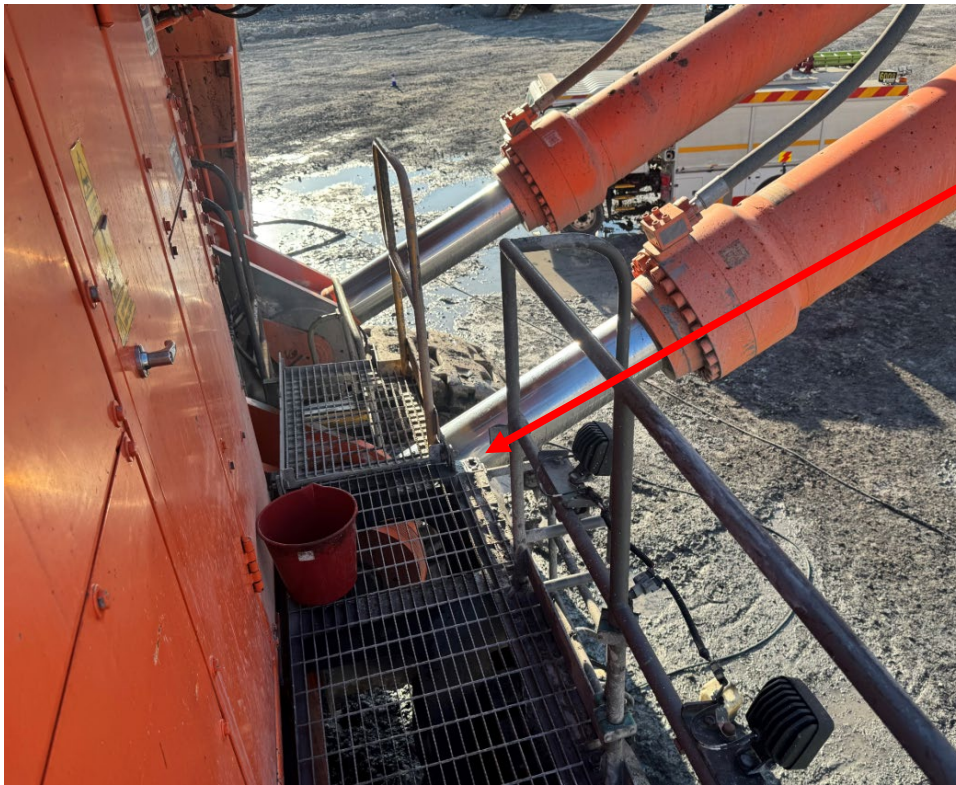
7. The platform gate and ladder for maintenance access were positioned where rocks regularly impacted the excavator structure. At the time of the incident, the ladder was damaged and missing at least 2 lower rungs, although the ladder had not been placed out of service.

Figure 4: Location of failed handrail section on the excavator
