# Weekly incident summary

## Week ending 22 May 2026

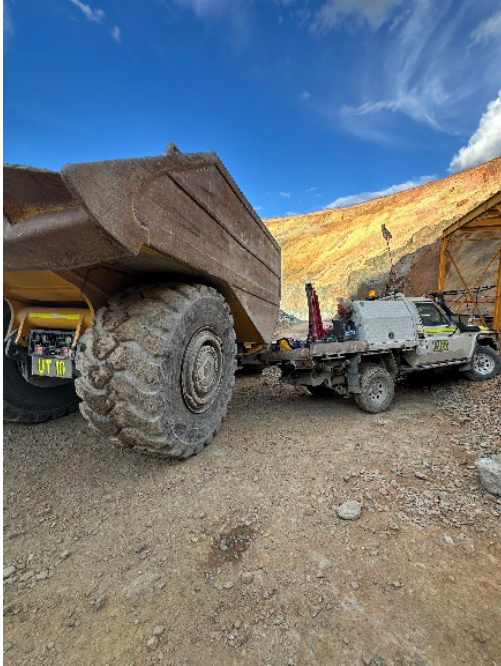
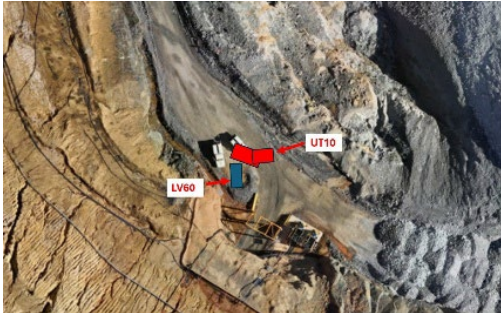
| Incident type | Summary | Recommendations to industry |
|---|---|---|
| Dangerous Incident<br>IncNot0051320<br>Underground<br>metals mine<br>Roads or other<br>vehicle operating<br>areas | <p>A dump truck was reversing near a portal when the truck collided with the rear left of the tray of a light vehicle (LV) parked in the LV parking area.</p> <p>The LV started and moved forward up the bund as far as they could but couldn't avoid the collision. The LV had two occupants in it at the time.</p> <p>The LV was on the trucks off-side, and the truck operator was not aware the LV was there. The truck operator was a trainee with the trainer in the dickie seat at the time.</p> | <p>Designated light vehicle parking areas that are in close proximity to operating mobile plant should have adequate protection in the form of berms or windrows.</p> <p>The berms or windrows should be constructed using suitable, solid materials and be of height, density and profile to enable an effective barrier. The minimum height required is generally half the wheel height of the largest vehicles using the road.</p> <p>Refer to Layer 2 of the layered defence approach in the Resource Regulator's technical reference guide: <a href="#">Surface ROVOA</a>.</p> <p>Layer 2 focuses on vehicle separation control measures. These control measures are designed to physically separate vehicles from potential hazards and should include berms, earth mounds or barriers.</p> |

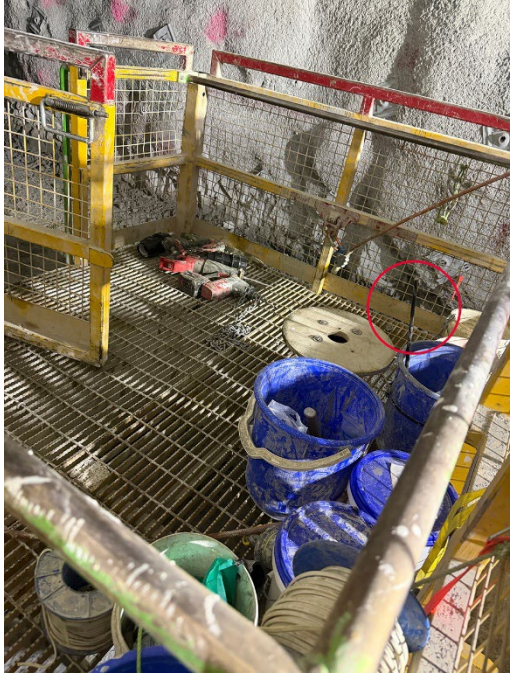
| Incident type | Summary | Recommendations to industry |
|---|---|---|
| <p>Dangerous incident<br/>IncNot0051384<br/>Underground<br/>metals mine<br/>Leave blank</p> | <p>A service crew worker was working out of a man basket attached to a loader when he lost his balance and fell backwards onto a length of reinforcement bar (Reo) sticking out of a bucket.</p> <p>The piece of Reo impaled the worker for a brief period causing an internal cut requiring 4 stitches.</p> <p>The elevated basket was being controlled by another worker on the ground who had the radio handpiece held between his legs and the cord of the handpiece was wrapped around the loader joystick. When the worker moved, the cord engaged the joystick and the basket moved quickly without warning, causing the worker in the basket to lose his balance.</p> | <p>Mechanical engineering control plans must set out the control measures for the unintended operation of plant.</p> <p>When work is required to be done using a raised platform, mines should consider the appropriate plant for the circumstances, considering the risks for workers on the platform arising from unintended movement.</p> <p>Consideration should be given to the use of fit-for-purpose equipment, where reasonably practicable, such as elevated work platforms (EWPs) specifically designed for working at heights.</p> <p>Workers must be trained and competent in the use of equipment that is under their control and always keep their attention on the task at hand.</p> <p>Workers should pay attention to housekeeping and ensure that items placed</p> |

| Incident type | Summary | Recommendations to industry |
|---|---|---|
| | | in buckets do not protrude and pose a risk to others. |

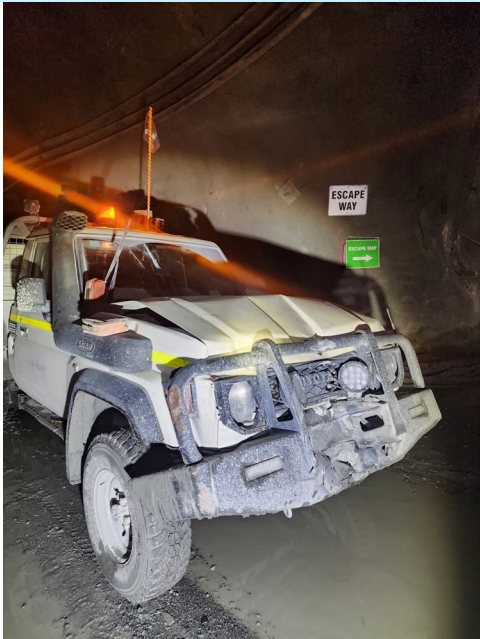
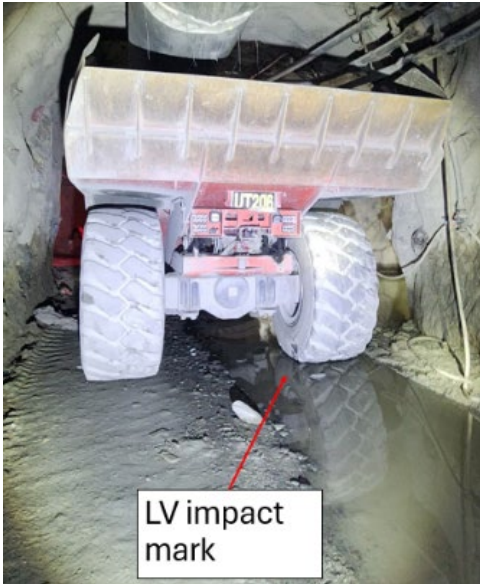
| Incident type | Summary | Recommendations to industry |
|---|---|---|
| <p>Dangerous Incident<br/>IncNot0051373<br/>Underground<br/>metals mine<br/>Roads or other<br/>vehicle operating<br/>areas</p> | <p>A haul truck was tramping down a decline and stopped when the operator got a call from another truck coming up the decline. The haul truck was intending to reverse out of the way of the oncoming truck when he saw a light vehicle (LV) coming down the decline behind him. The truck remained stationary waiting to see where the LV was going but it didn't slow down and collided with the position 4 tyre of the haul truck.</p> <p>The LV operator sustained minor injuries and was taken to hospital for scans and treatment.</p> | <p>Inattention and distraction while driving can have fatal consequences. Drivers should remain focused on the task at hand and not be distracted while driving. This includes staying alert, being aware of their surroundings, and maintaining control of the plant and machinery they operate.</p> <p>Fatigue policies require workers to arrive at work rested and ready for a full shift and report fatigue events as they occur.</p> |
