# Weekly incident summary

## Week ending 7 August 2026

This incident summary provides information on reportable incidents and safety advice for the NSW mining industry. To report an incident to the NSW Resources Regulator: phone 1300 814 609 24 hours a day, 7 days a week.

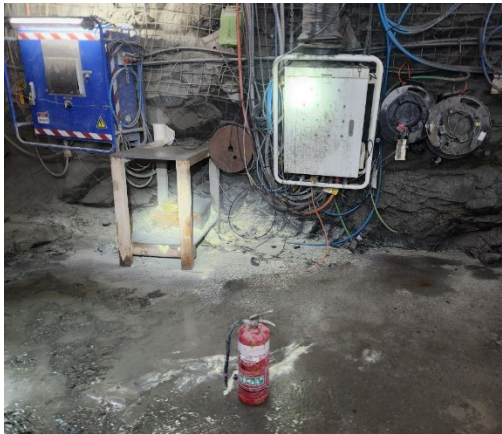
| Incident type | Summary | Recommendations to industry |
|---|---|---|
| <p>Dangerous incident<br/>IncNot0051808<br/>Underground metals mine<br/>Fire or explosion</p> | <p>A small fire occurred underground involving combustible materials located at the base of a data box. Initial investigation identified rags and cardboard present in the area at the time of the incident. A 415V cable that had previously supplied a tele-remote barrier, which had since been removed from service, remained energised and had not been isolated. It is believed the energised cable was the ignition source for the fire.</p> <p>The fire was identified and extinguished with no injuries reported. The area was made safe and an investigation commenced to determine the circumstances that led to the cable remaining energised following removal of the associated equipment.</p> | <p>Mine operators should ensure:</p> <ul style="list-style-type: none"> <li>electrical installations, modifications, and maintenance activities comply with AS/NZS 3000 Wiring Rules in surface and metalliferous operations. Pay particular attention to Clause 1.5.11.4 (Voltage in Unused Conductors) to ensure all disconnected, redundant, or unused conductors associated with energised circuits are terminated and protected at both ends as if live, preventing injury, equipment damage, and fire from induced or residual voltages</li> <li>all redundant electrical cables are removed or isolated</li> <li>housekeeping standards prevent combustible materials accumulating near electrical equipment.</li> </ul> |

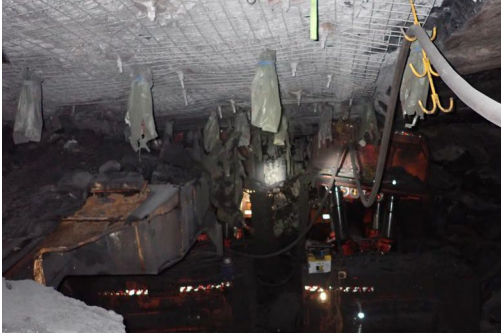
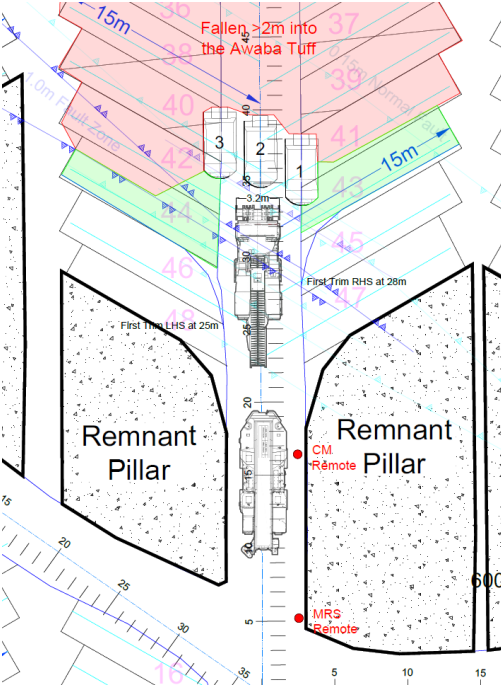
| Incident type | Summary | Recommendations to industry |
|---|---|---|
| <p>Dangerous incident<br/>IncNot0051811<br/>Underground coal mine<br/>Ground or strata failure</p> | <p>While undertaking pillar extraction with a continuous miner a secondary goaf fall caused an overpressure event (windblast) that injured 3 workers near the production face.</p> <p>The injured workers were assisted from the mine by members of the production crew.</p> | <p>The matter is currently under investigation. In the interim, mine operators should:</p> <ul style="list-style-type: none"> <li>regularly review and maintain Windblast TARPs to ensure they remain current and effective</li> <li>ensure decisions regarding assigned TARP levels are supported by appropriate analysis and documented rationale</li> <li>ensure that the mine's permit to mine or authority to mine effectively manages hazards identified</li> <li>ensure verification processes are in place to support the implementation</li> </ul> |

| Incident type | Summary | Recommendations to industry |
|---|---|---|
| | <div></div> <p>Incident scene, looking inbye from shuttle car to continuous miner and mobile roof support.</p> <div></div> <p>Location drawing for face equipment at time of incident.</p> | <p>and ongoing effectiveness of hazard controls.</p> |
