## Investigation report

Report into the death of Mark Daniel Galton at  
Boggabri Coal Mine on 21 May 2014

Report prepared by the NSW Mine Safety  
Investigation Unit

Published report date: August 2015

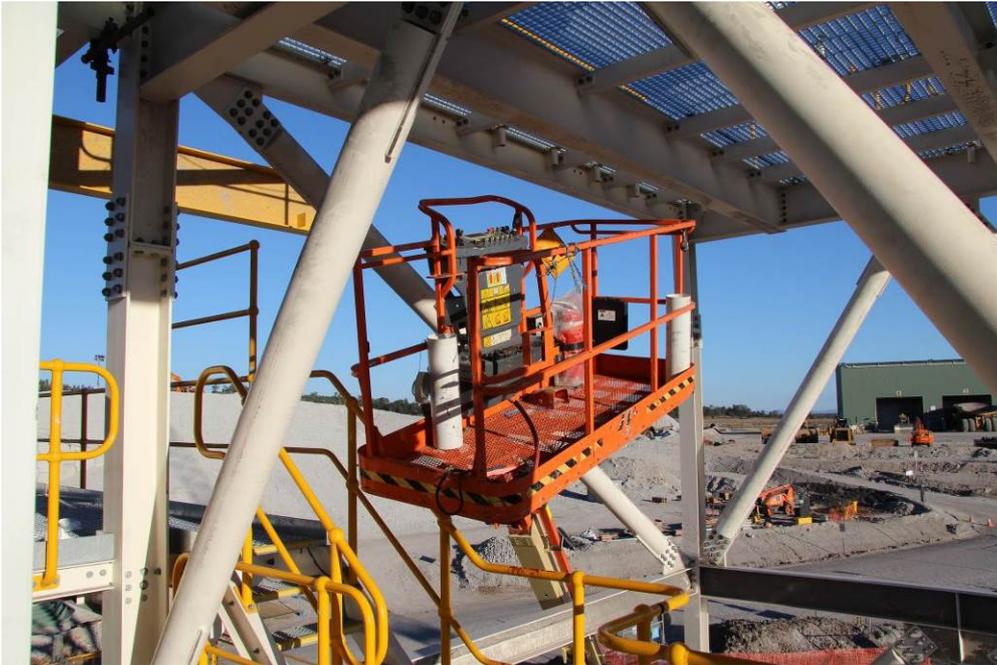
Figure 1. Position of the MEWP after the recovery of Mr Galton inside the ST202 structure.

Mr Galton, 51, was relocating the platform to ground level after tightening bolts on the structure. During the movement of the platform over walkway handrails, a crush point was created between the platform frame above the control console rising towards the steel beam. Mr Galton was alone in the platform.

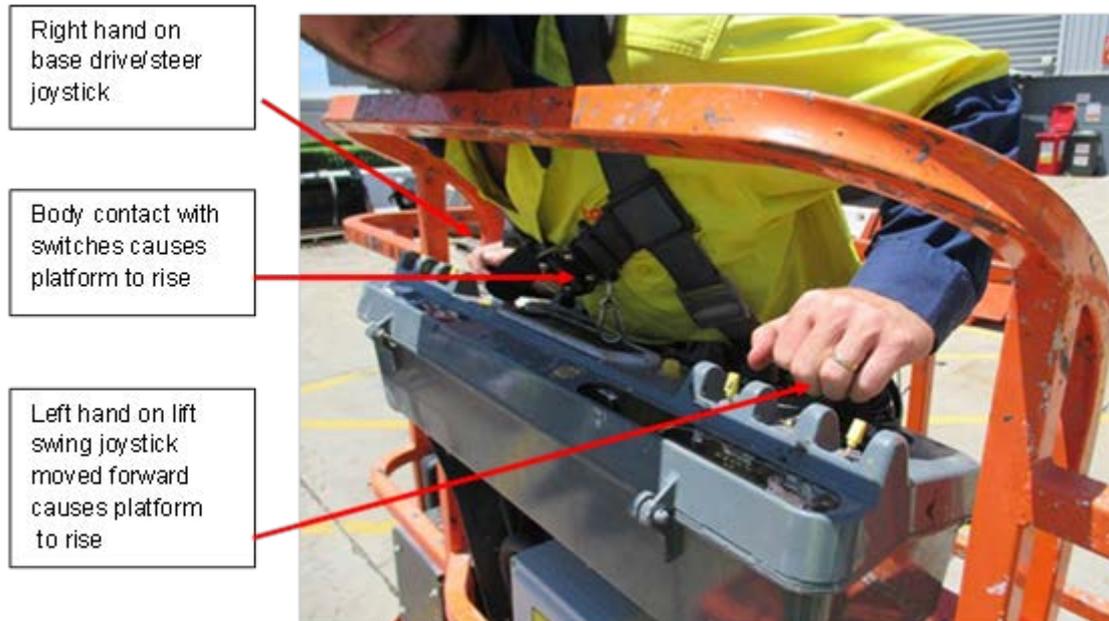
1. **An unintended platform rise** caused by Mr Galton coming in contact with one or more control switches on the platform console, which activated the platform rise functions. In this scenario the main rise control device (the lift swing joystick) was not activated by Mr Galton however the covered footswitch was activated enabling a seven-second window for potential machine movement.

Figure 2. Simulation of an operator in a forward leaning position with his body in contact with control switches that can activate platform to rise. In this position the left hand can apply forward motion to the lift swing joy stick and activate platform to rise. The right hand can be placed on the base drive/steer joystick. The operator's right foot was able to activate the footswitch to permit platform control function.

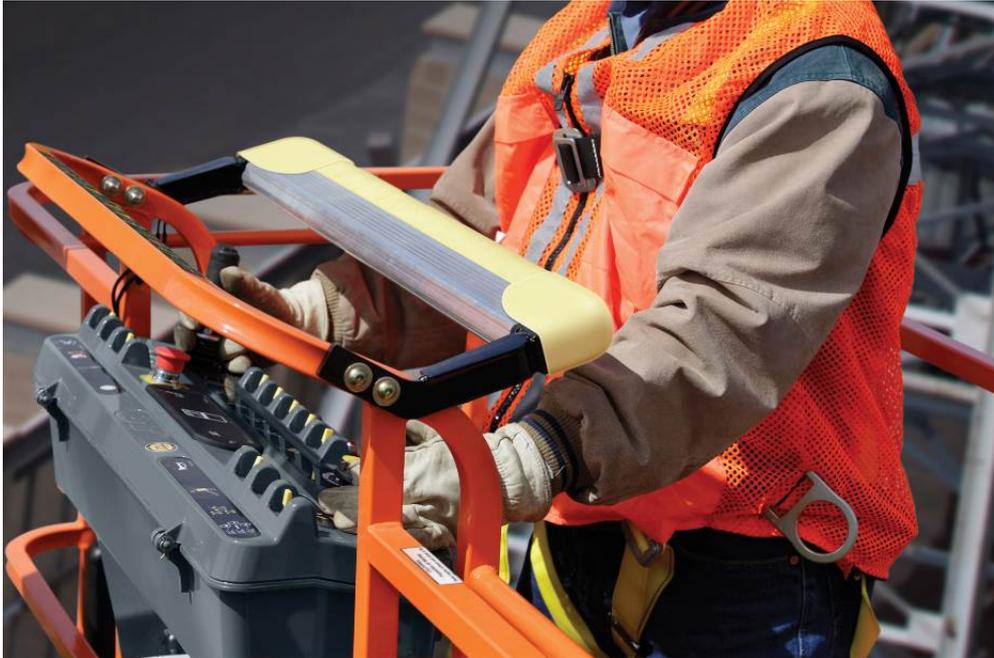
Figure 3: JLG SkyGuard® secondary protection device fitted above a JLG platform control console. ADR received for SkyGuard® by JLG on 31 May 2014.<sup>8</sup>

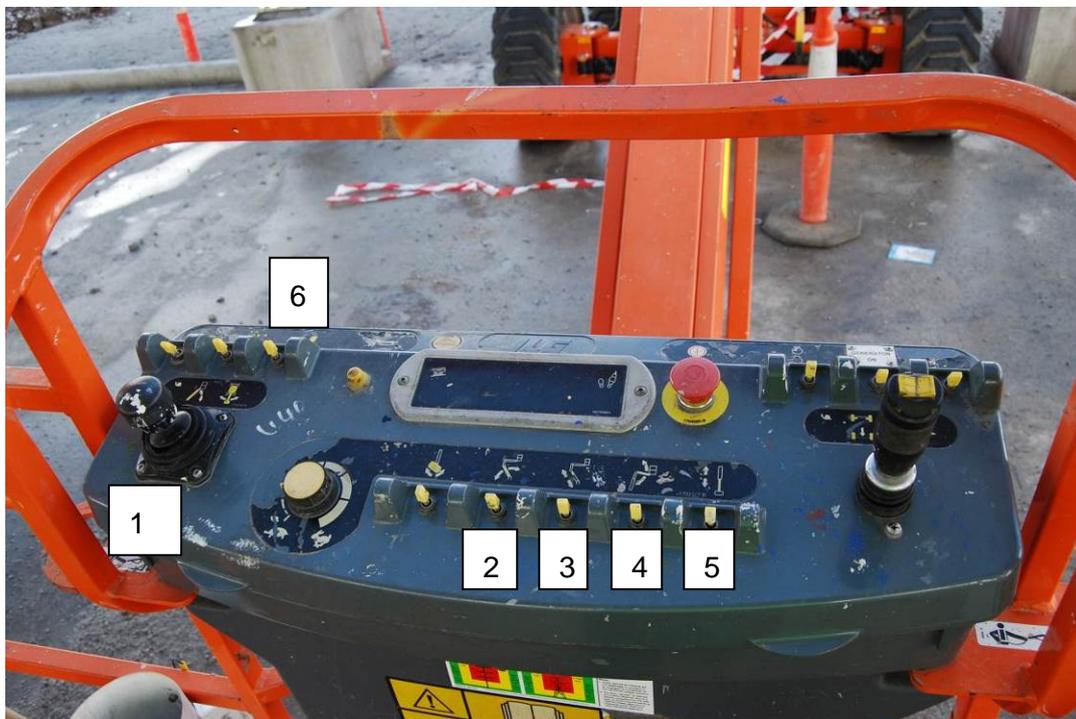
Figure 18: Identification of the six platform raise controls on the platform control console

JLG identified six individual platform console controls that cause a rise in the platform.

1. Main lift swing joystick move **forward**
2. Tower lift toggle switch to **forward position**
3. Tower telescope toggle switch **to forward position**
4. Jib toggle switch **to forward position**
5. Telescope toggle switch **to backward position**
6. Platform levelling over ride switch **to forward position**

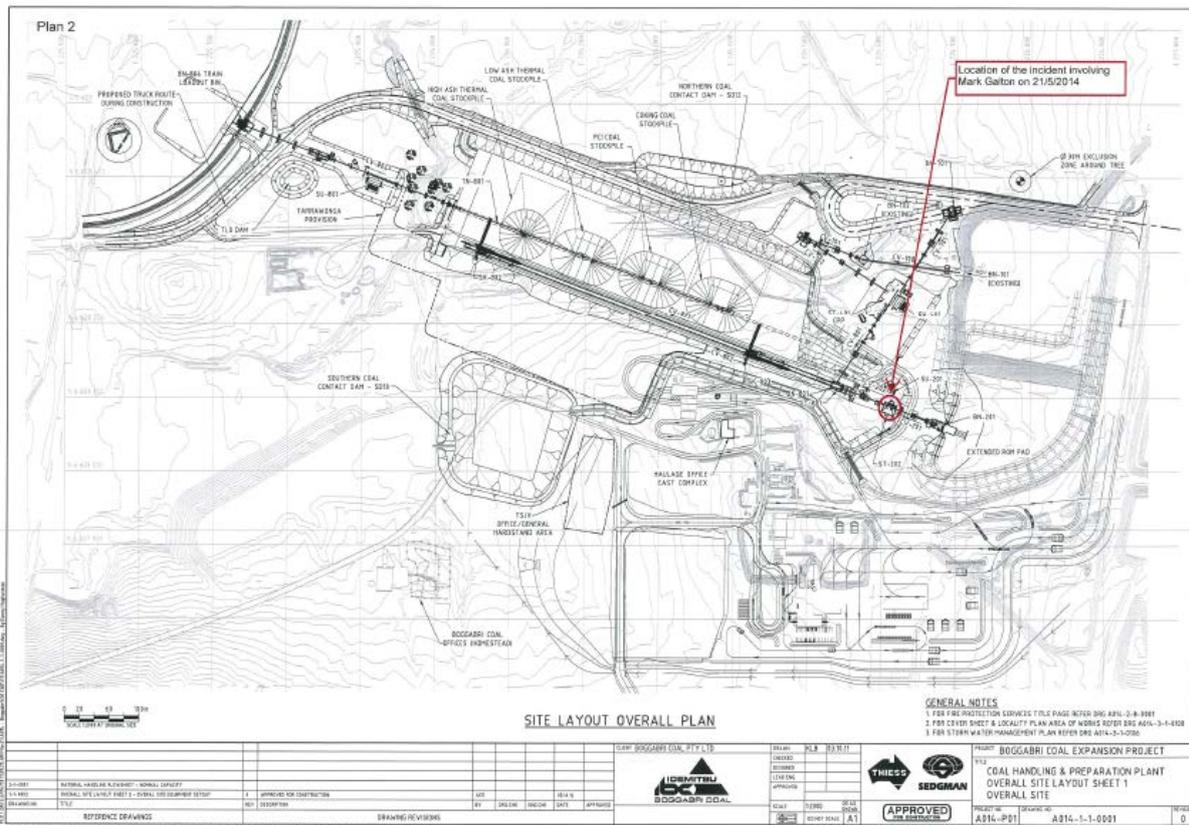
Figure 19: The incident site known as ST202.

ST202 was partly constructed to three floors comprising structural steel, steel mesh, steel stairways and conveyor equipment. Mr Galton was working under the third floor section comprised of four steel beams and covered by a mesh floor.

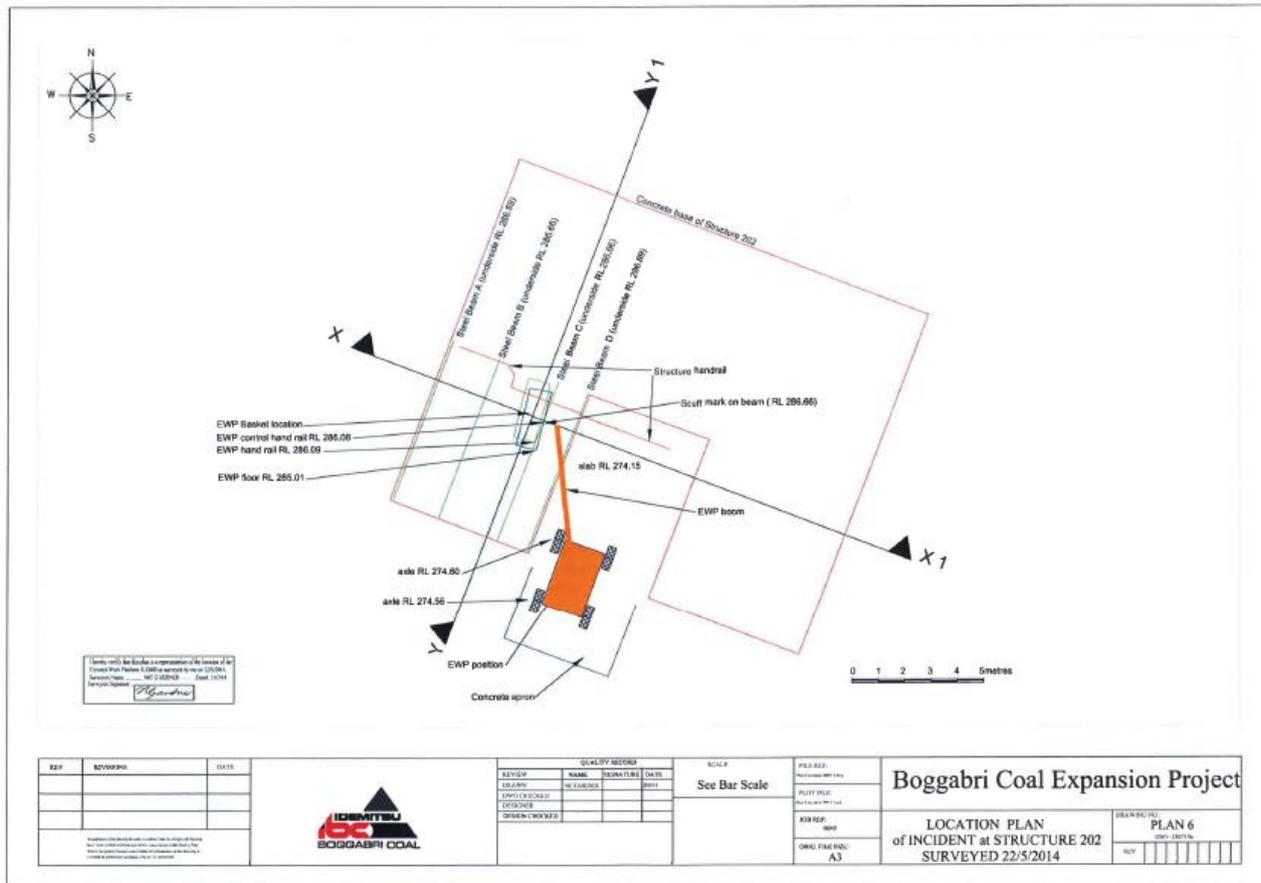
Figure 20: Incident site – top view.

The left hand side of the platform was observed after the incident to be over the handrail of the second floor walkway.

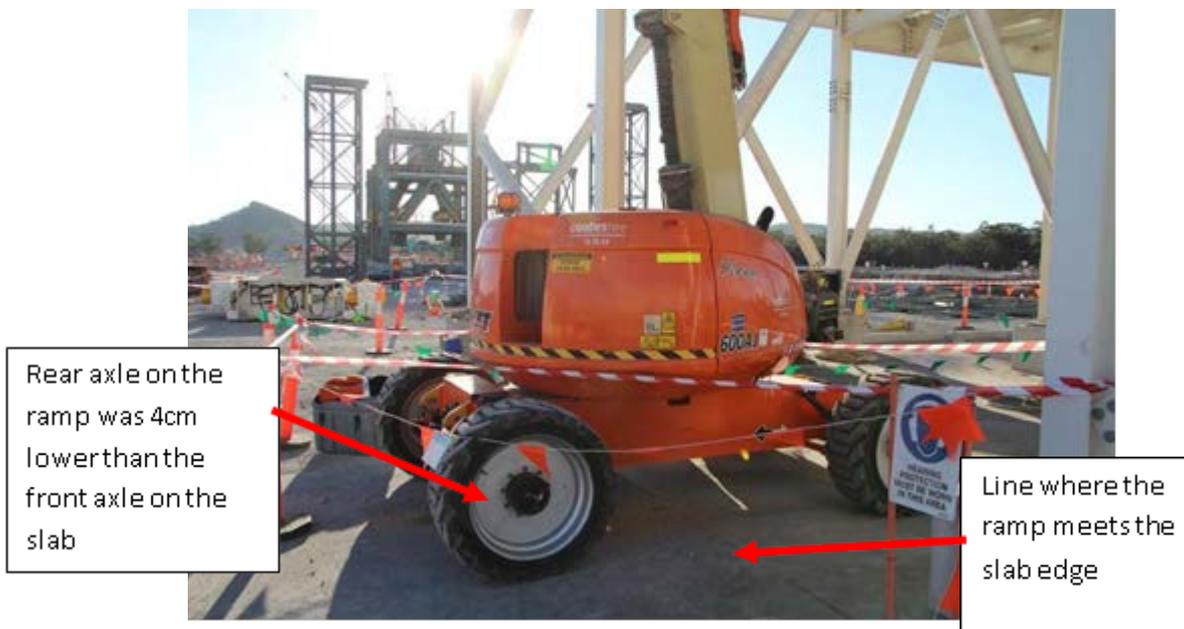
Figure 26: MEWP base on concrete floor.

There was no evidence that any of the MEWP tyres had failed or deflated causing instability on the raised platform.

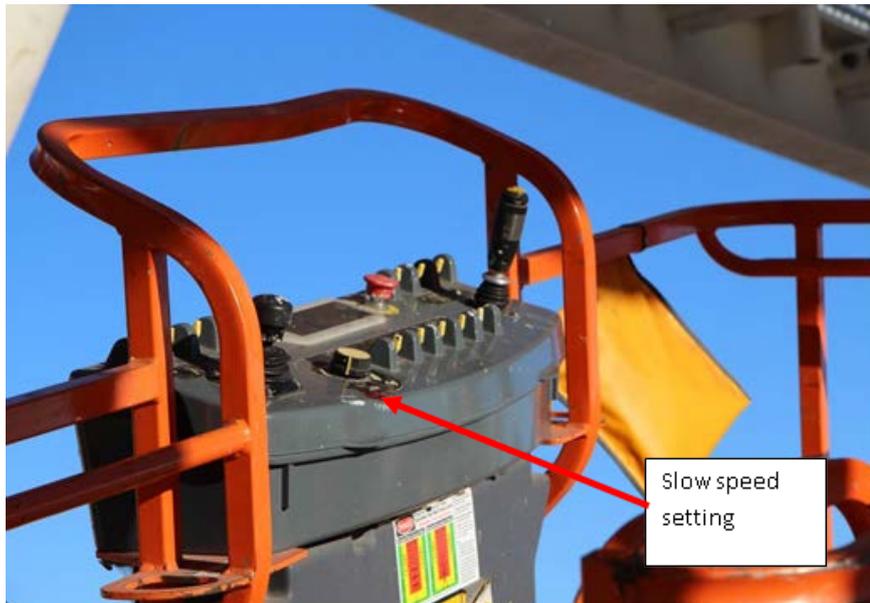
Figure 32: Platform control console position at 5.07pm on 21 May 2014.

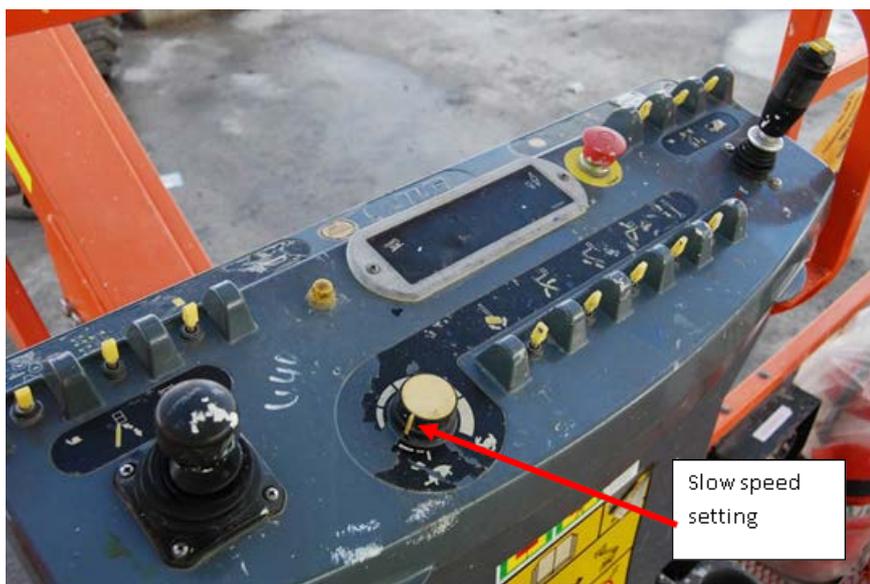
Figure 33: Platform control console at 2.12 pm on 23 May 2014 when returned to ground level.

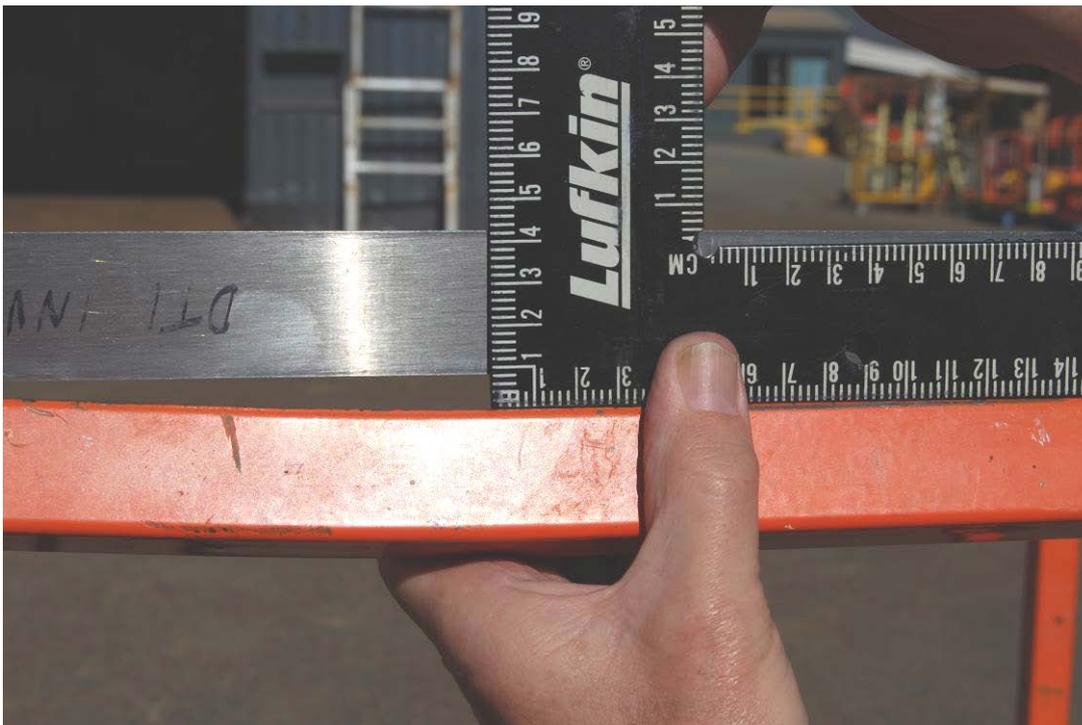
Figure 43. Measurement of the 8mm downwards deflection on the platform control console protection bar.

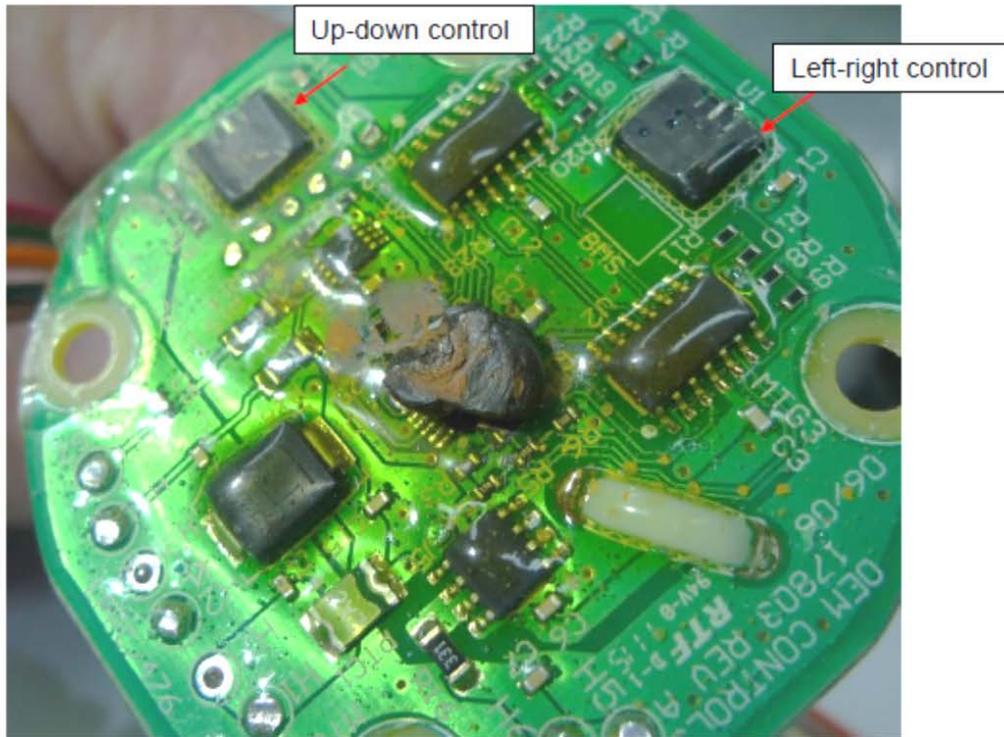
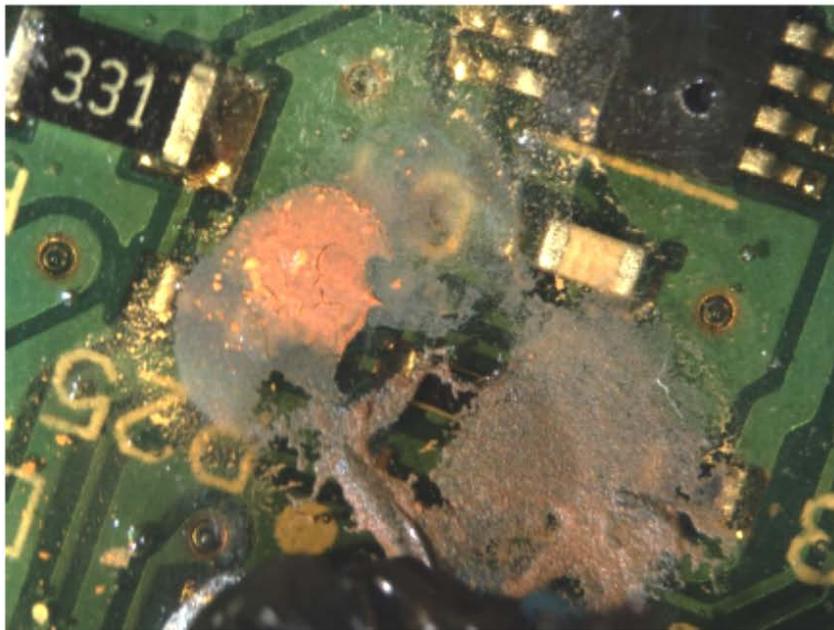
Figure 45: Extract of Bureau Veritas report – Figure 6.

Figure 6 Views of the magnetic gate and the hall-effect sensor on the circuit board, note the difference in clearance between the two components.

Figure 9 The used circuit board condition, note the presence of corrosion and grease deposit.

- Operators and maintainers of MEWPs should ensure close inspection of the rubber protective covers of platform controls to identify deterioration such as cracking and splitting, which can allow dust and water ingress and cause corrosion on electrical control circuit boards.

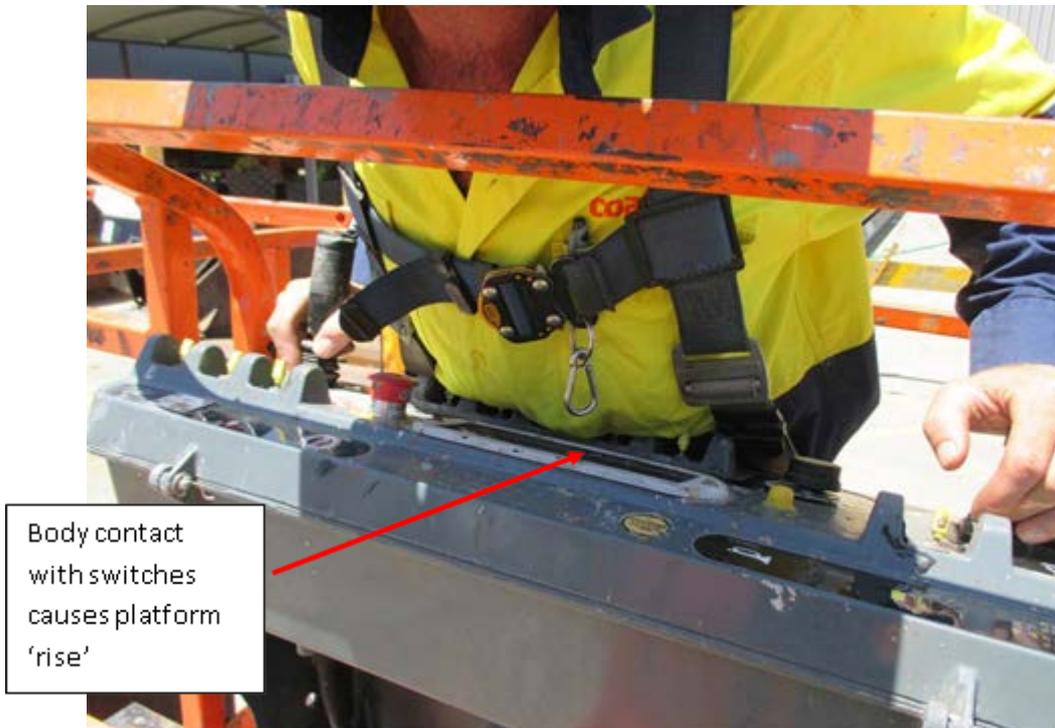
Figure 47: Simulation of an operator in forward leaning position and bodily contacting platform switches can activate platform 'rise'. In this position the left hand can apply forward motion to the lift swing joystick and activate platform 'rise'. The right hand can be placed on the drive/steer joystick. The operator's right foot was able to activate the footswitch to permit platform control function.

The platform lift/swing joystick control device (when the detent device is lifted on the joystick) is moved in a 'forwards' direction to achieve a 'rise' in the platform.

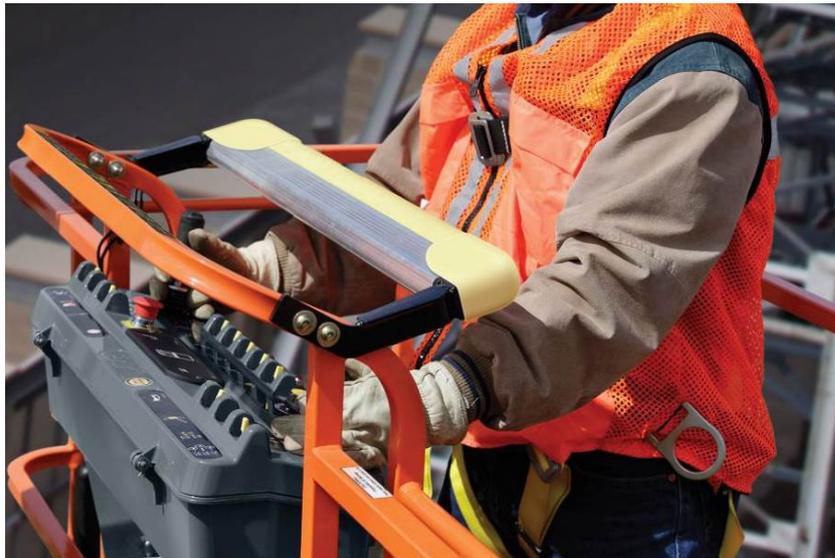
Figure 48: JLG SkyGuard® secondary protection device<sup>24</sup>
