# **Investigation report**

Report into the serious injury of a worker at the Mt Arthur  
Coal Mine on 10 August 2017

Title: Investigation Report: Report into the serious injury of a worker at the Mt Arthur Coal Mine on 10 August 2017

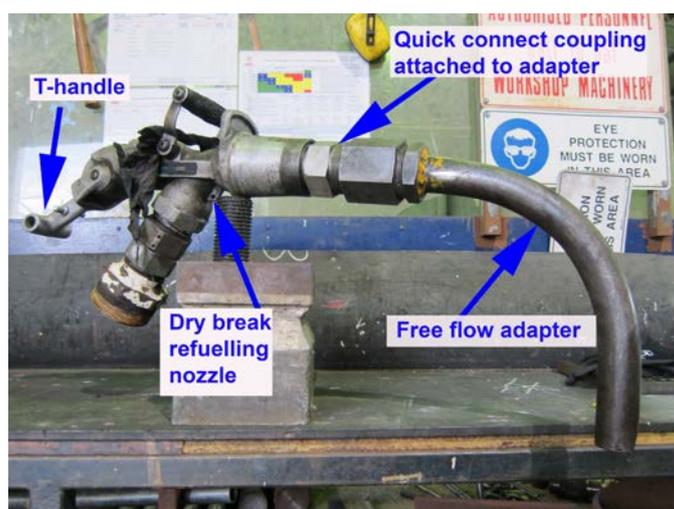
The worker exited the tyre handler and entered a small shed at the refuelling station where he obtained a free flow adapter nozzle connected to a quick connect coupling. The tubular portion of the adapter was 440.0 mm long and had a diameter ranging in size between 40.4 mm and 42.8 mm. The worker had obtained the adapter from the same location on previous occasions and used it to refuel a tyre handler. The worker returned to the tyre handler and inserted the adapter into the filling neck of the tyre handler.

Image 3.4 - Hose and nozzle assembly with free flow adapter nozzle attached.

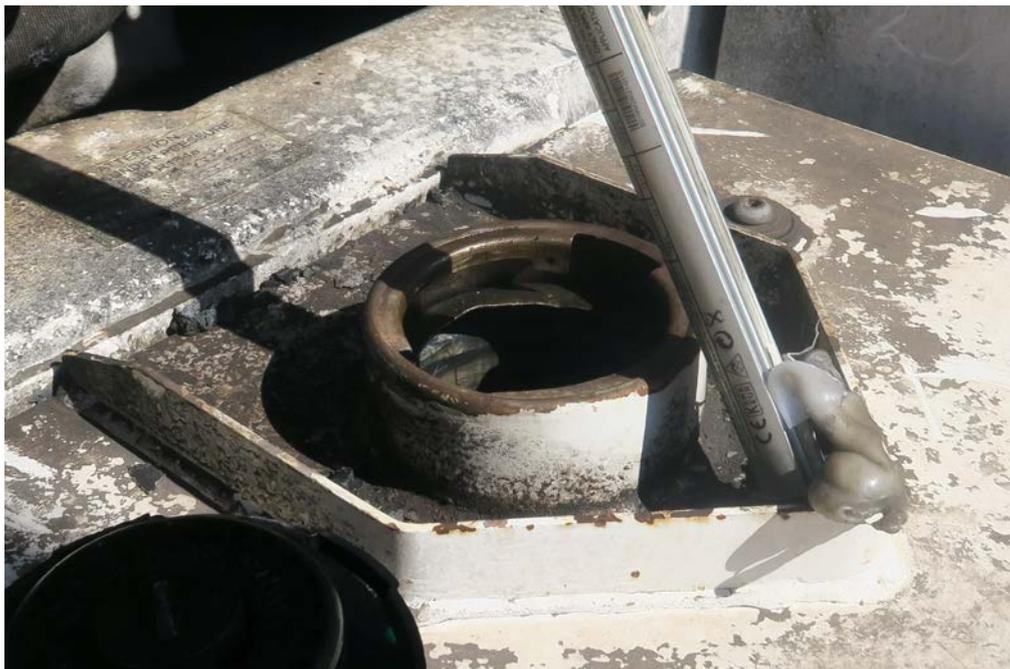
The tyre handler's fuel tank has a capacity of 305 litres. Its filling neck consists of a short tube that protrudes above and below the surface of the fuel tank. It did not have a quick connect fitting. The interior diameter of the filling neck is 60 mm. The interior of the tank is fitted with a series of baffles as shown below.

Image 3.5 - Filling neck of Hyster 25-9 tyre handler.

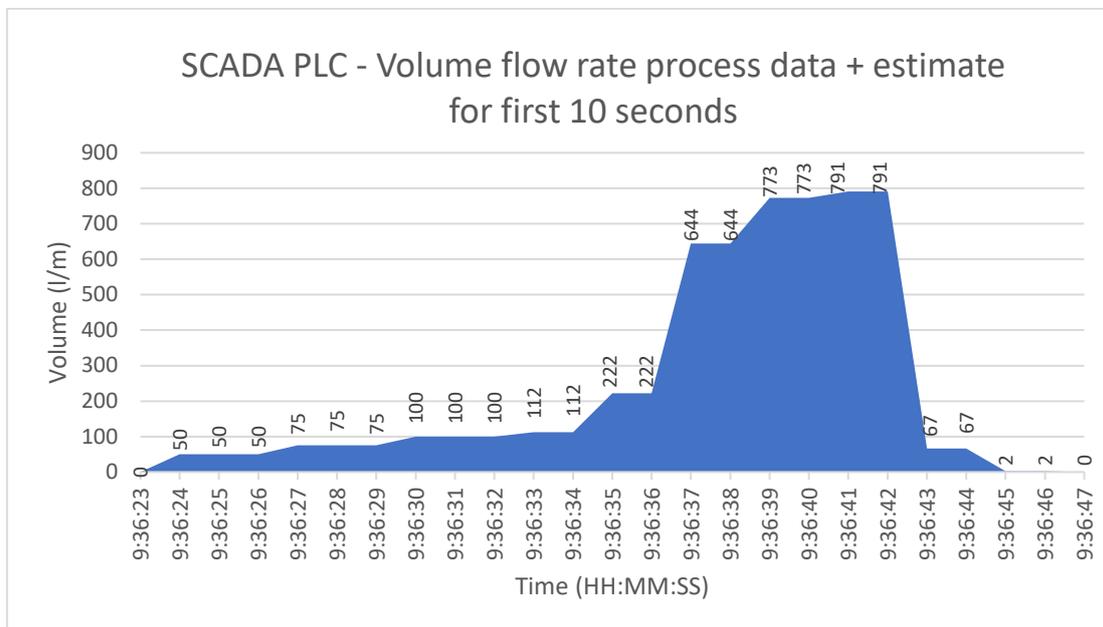
The flow rates described above are shown in the following graph. The data shown for the first 10 seconds has been estimated. The figures for the remainder of the period shown is data taken from the refuelling facility’s logic control system.

Image 3.7 - Diesel flow rates at the time of the incident.

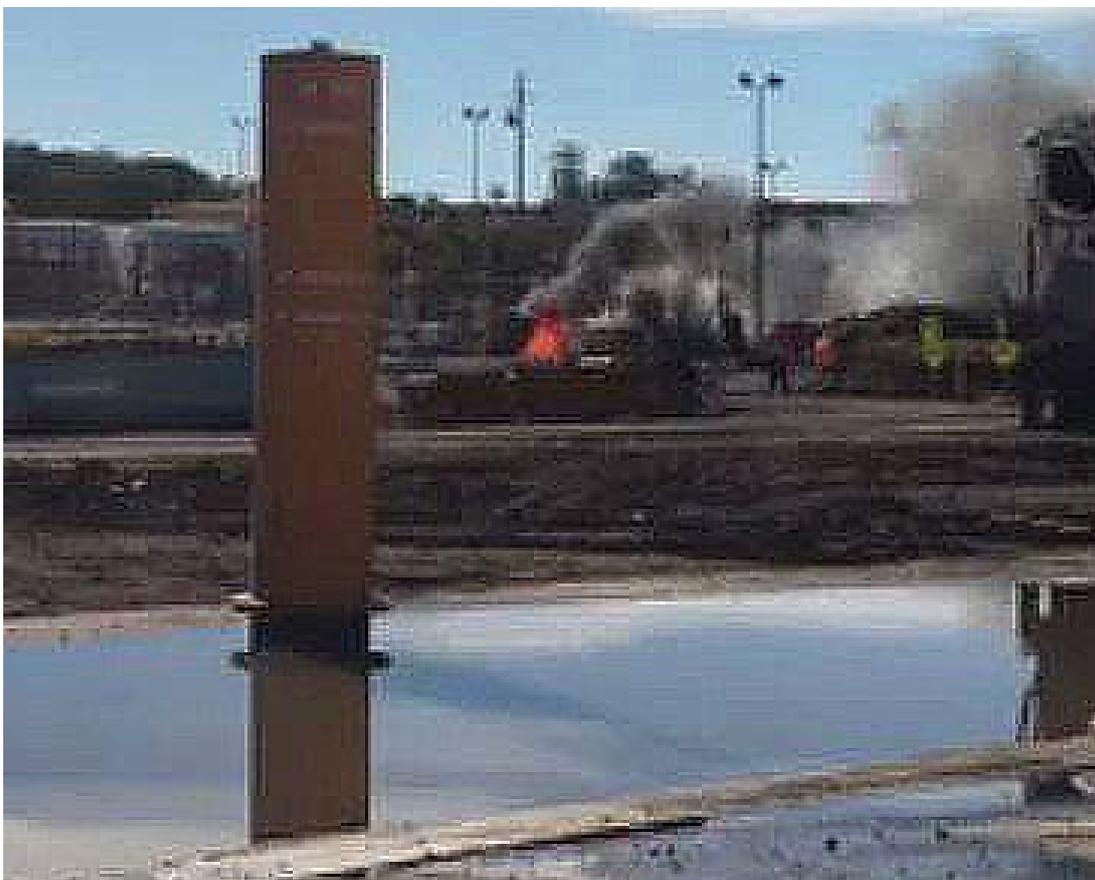
The specific points of ignition were not determined. The most probable ignition points were the exhaust manifold, turbo clamp and housing. Diesel continued to flow from the hose at a rate of 791 lpm at the time of ignition.

**Image 3.8 - View of fire taken from workshop area.**

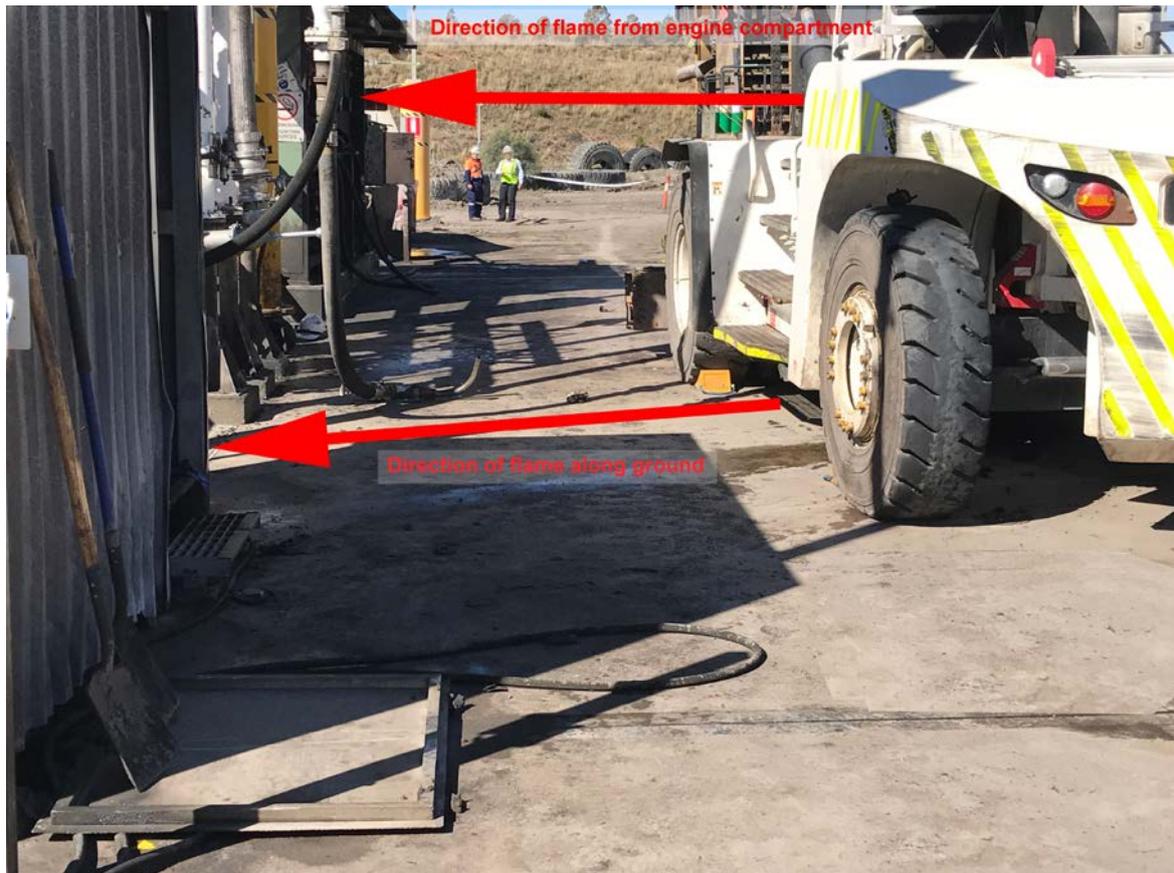
After the diesel ignited, a flame flashed back towards the worker and other areas that were affected by diesel, as shown in Image 3.9 below. They included the tyre handler's engine area and the ground between the tyre handler and the shed. The worker's hair and the sleeves of his long sleeve work shirt caught fire. The worker dropped the assembly and ran in an easterly direction to escape the fire.

Image 3.9 - Direction of flames.

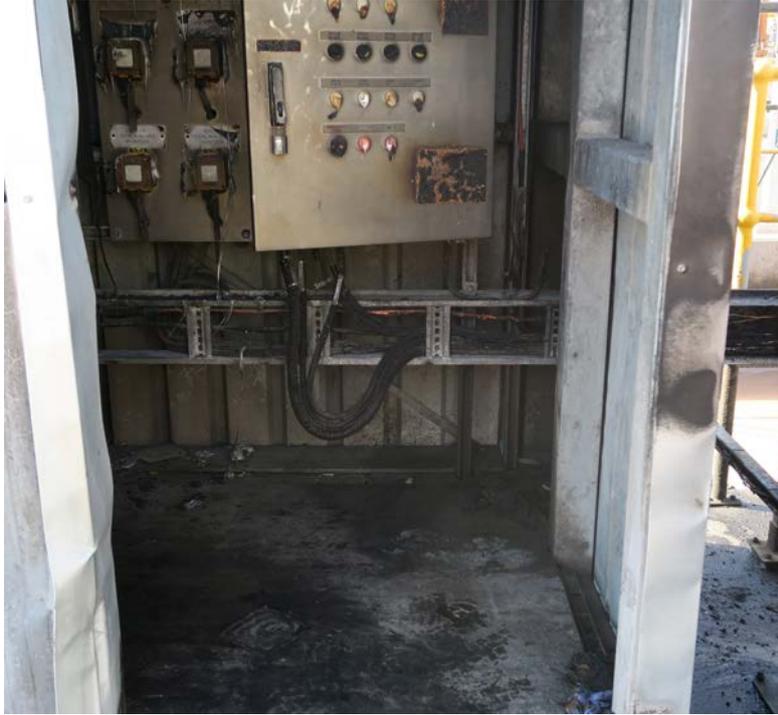
The fire burning in the engine area and on the ground became well established. The flames spread to cabling outside the shed, and through that cabling into the shed. Damage was occasioned to the following areas:

- engine area of the tyre handler
- interior of the shed, including the switchboard
- cabling connected to the switchboard; both outside and inside the area.

Image 3.11 Damage inside switchboard shed.

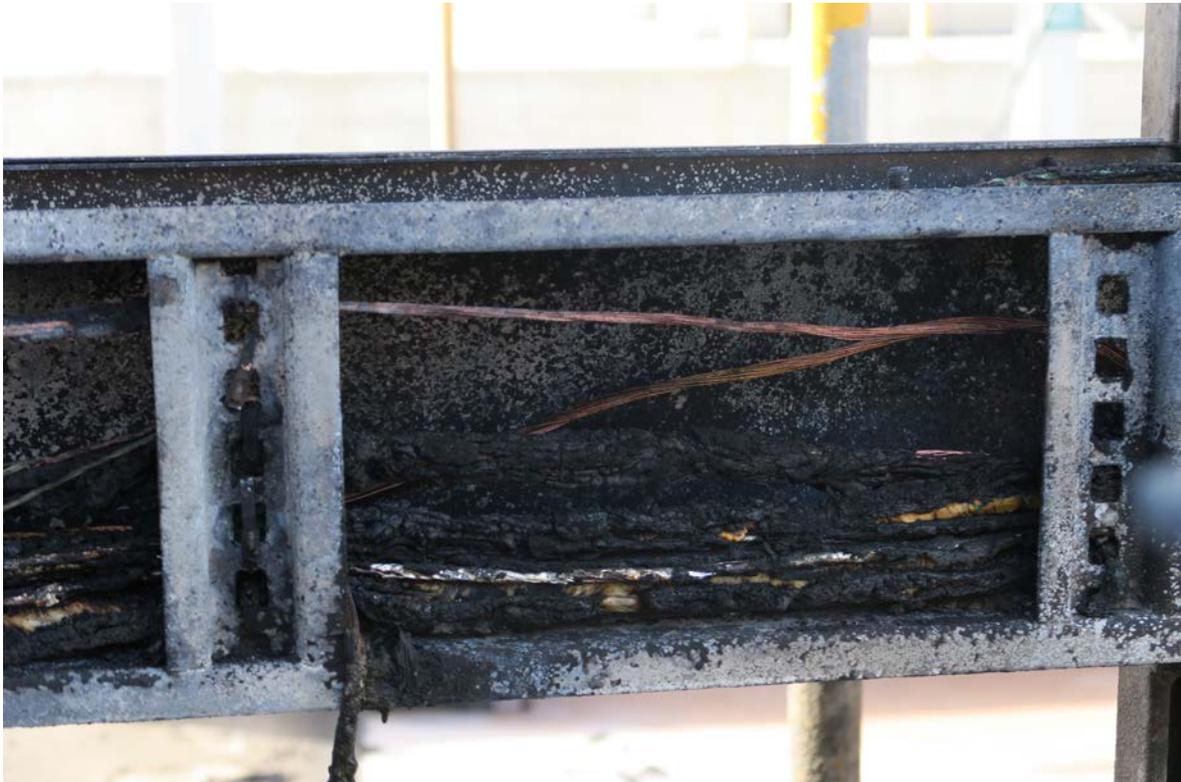
Image 3.12 - Damage to wiring leading into switchboard shed.

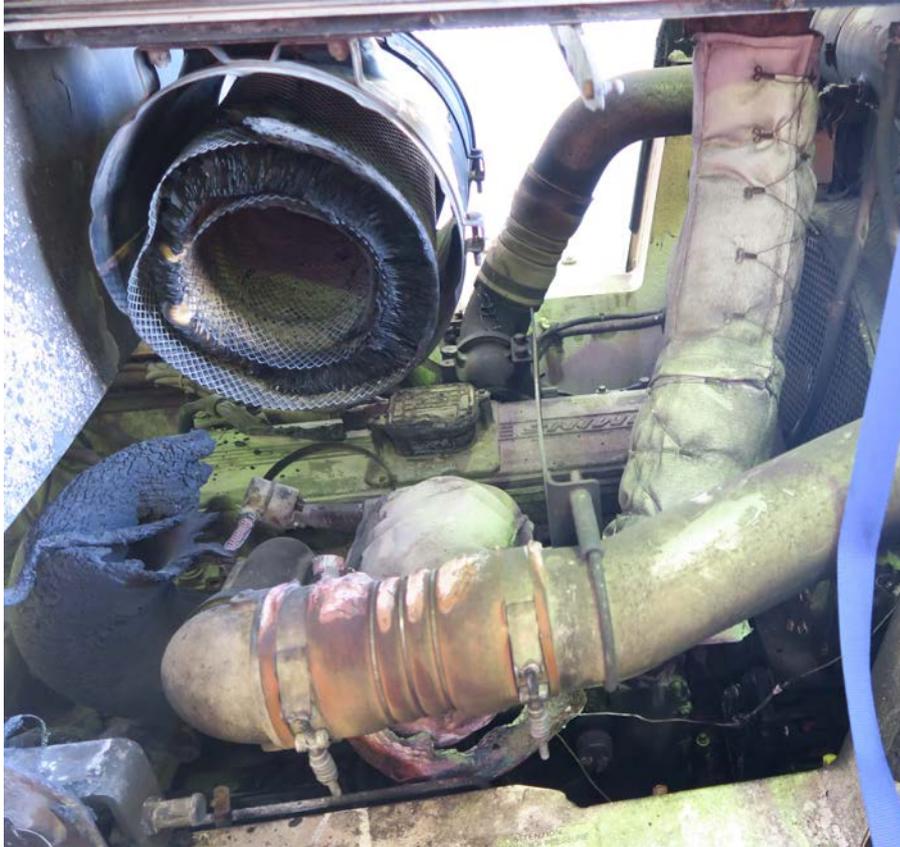
Image 3.13 - Damage inside left-hand engine bay of tyre handler.

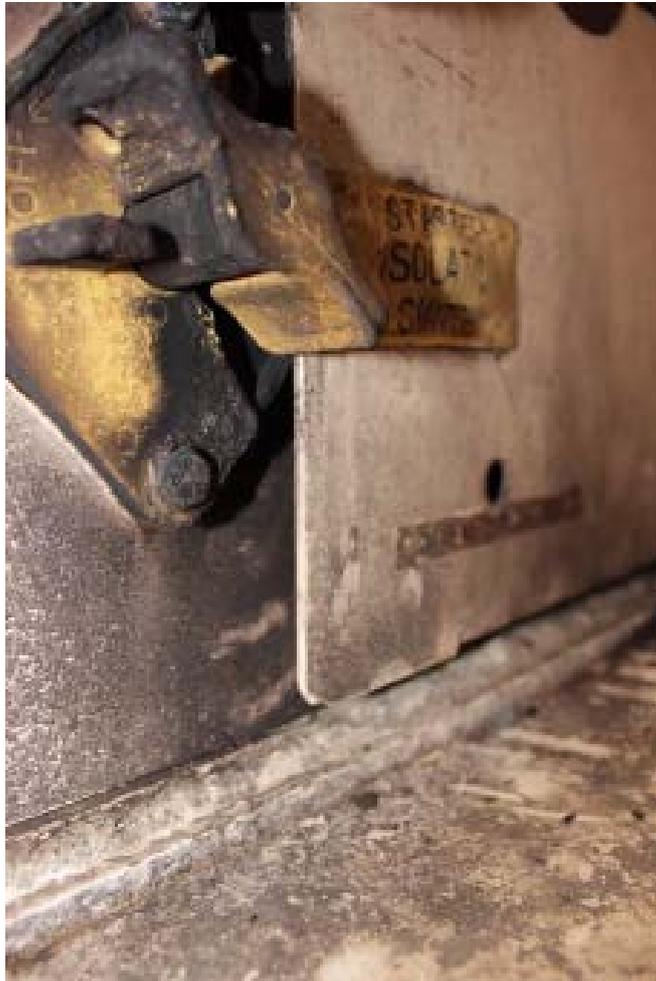
The Hyster 25-9 tyre handler is designed to have rubber seals fitted along the inside bottom edge of its engine covers, and on each side of the frame of the engine bay where the engine cover closes on it. Examinations showed that the rubber seal was missing from the inside edge of the left side engine cover of OT21 at the time of the incident. They also showed that the seals at each side of the left-hand engine bay did not make full contact with the engine cover frame. These seals are only designed to reduce noise and protect paint, and not to prevent liquids entering the tyre handler's engine bay. However, it is likely that if the engine cover had been better sealed, the amount of diesel that entered the engine bay during the incident would have been reduced.

Image 4.1 - Gap between the engine cover and the engine bay frame of OT21.

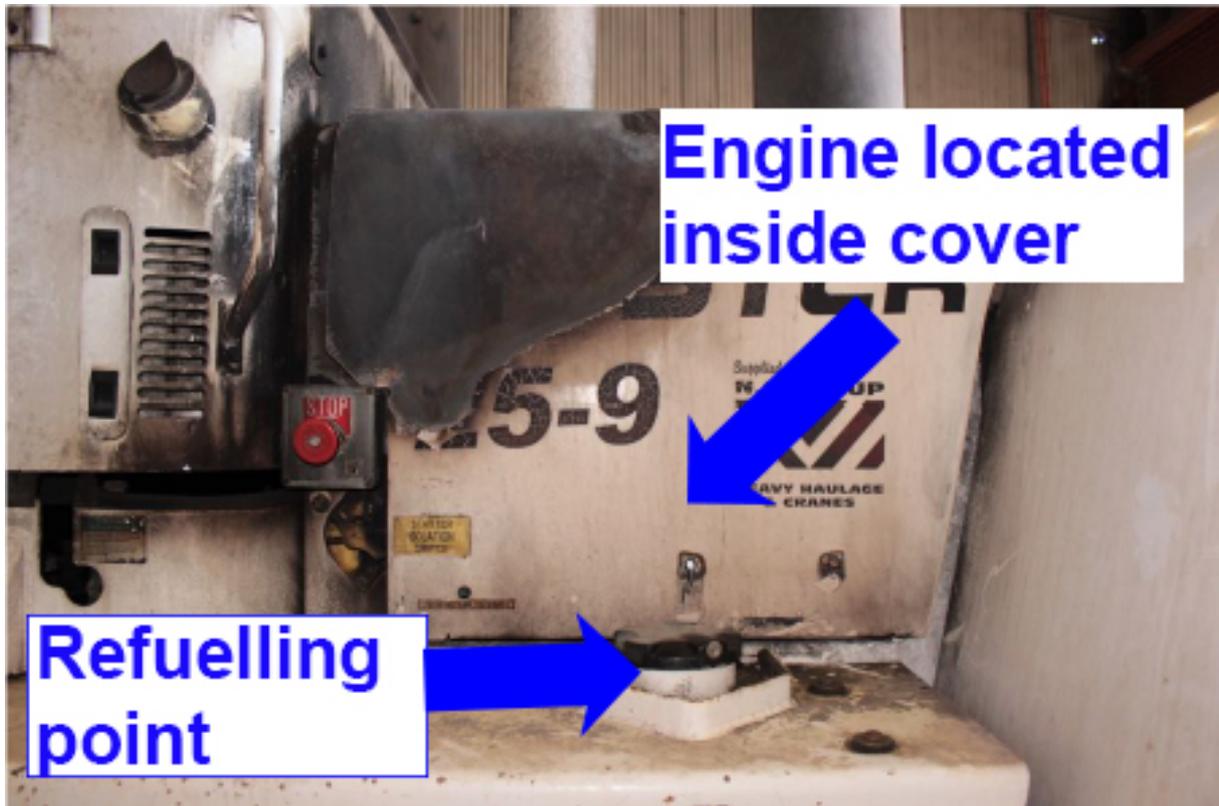
The proximity of the tyre handler's filling neck to its engine bay was examined during the investigation. Its design was found to meet the requirements of AS2359.6-2013 for 'Self-propelled industrial trucks, other than driverless trucks, variable-reach trucks and burden carrier trucks'. Part 4.5.2.1. provides that

It is highly unlikely that the above requirements in relation to the drainage of 'spillage or leakage' would extend to preventing high volume flows close to 800 litres per minute. With effective engine cover seals in place, it would be reasonable to expect that the raised lips beneath the engine cover and around the filling neck would be sufficient to prevent the ingress of spillage or leakage into the engine bay of the tyre handler.

Image 4.2 - Proximity of filling neck to left side of engine cover of OT21.

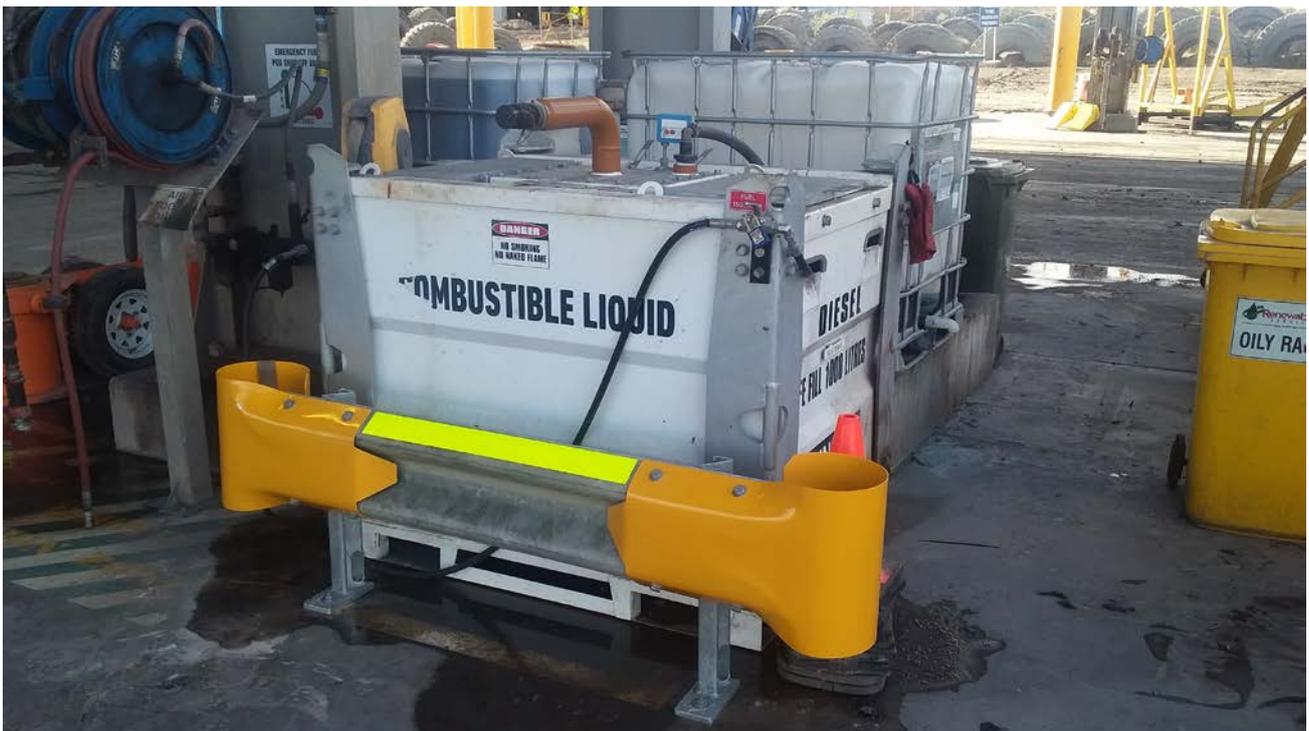
Image 9.1 Low flow refuelling pod installed by the contractor at its tyre bay to refuel tyre handlers.

- prohibit the use of adapters attached to quick flow nozzles
- issue an information bulletin detailing this prohibition and the risks associated with using adapters attached to quick flow nozzles
- conduct an audit across all its operations and confirmed that there were no other sites using the adaptor involved in this incident
- advise its clients of the risks associated with the use of adapters attached to quick flow nozzles
- install a 1000 litre fuel pod fitted with a low flow nozzle at the tyre bay used by the contractor for the refuelling of its tyre handlers.
