# MINE SAFETY INSPECTORATE

INVESTIGATION INFORMATION RELEASE

**Incident date** 19 August 2016  
**Event** Coalburst on longwall face  
**Location** Austar Coal Mine

# **Coal burst on longwall B2 face at Austar Coal Mine on 19 August 2016.**

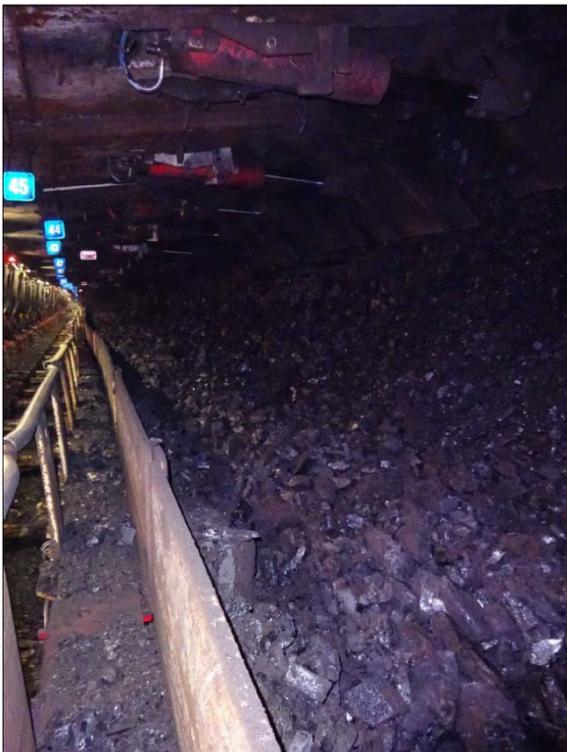
Figure 1: Broken coal on the face side of spill trays following the reported coal burst.<sup>i</sup>

It is estimated that about 11 to 12 tonnes of coal (in total) was projected from the face over an area covering approximately 50 m of face length with some 400 kg travelling up to 7 m into the walkway area of the powered supports.

1. Installation of coal burst conveyor mats between the coal face and the powered support walkway in addition to operating the roof support flipper bars at 90 degrees to the roof support canopy.
2. Reducing exposure of the workers on the coal face by limiting the number of workers during production and maintenance activities.
3. Providing direction as to the position of workers during production and maintenance activities.
4. Reviewing the cutting methods.
5. Ensuring all workers are trained in, and made aware of, the new operating procedures for longwall B2.

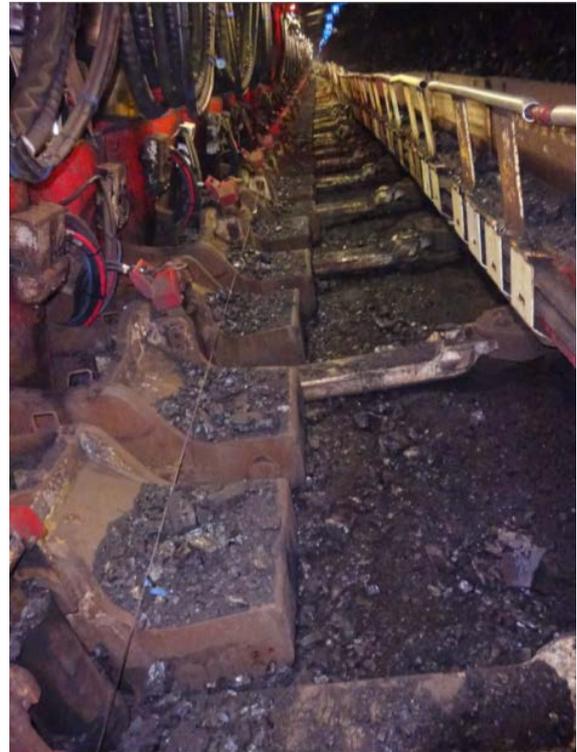
Figure 2: Ejected coal in the walkway as a result of the coal burst.<sup>ii</sup>

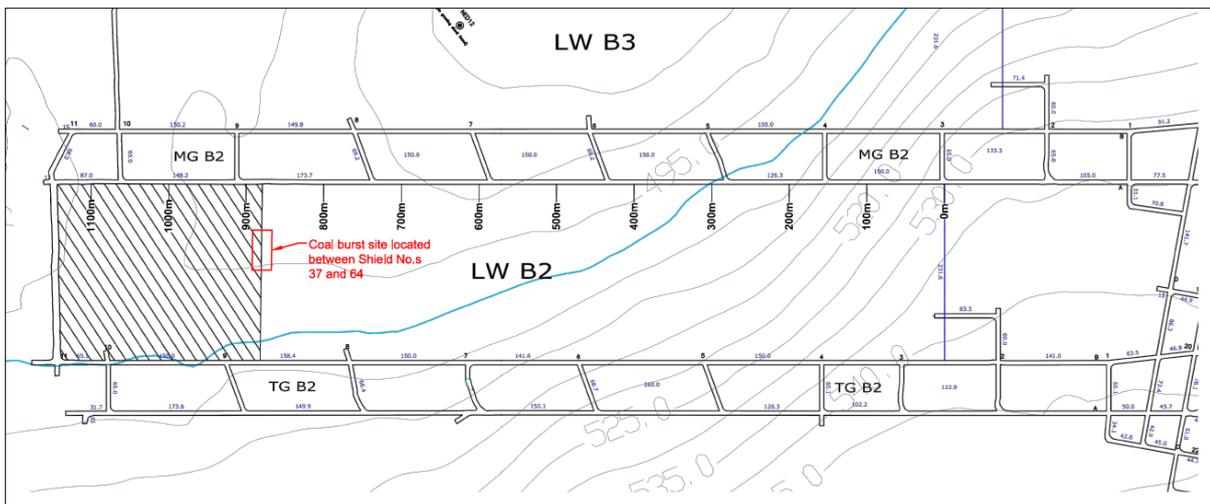
The incident site was on longwall B2 with the face at the 872 m mark as shown in Figure. 3. The longwall had retreated 260 m from the starting position, having just passed the “square” goaf position. The depth of cover at the incident site was approximately 495 m.

Figure 3: Location of the incident<sup>iv</sup>

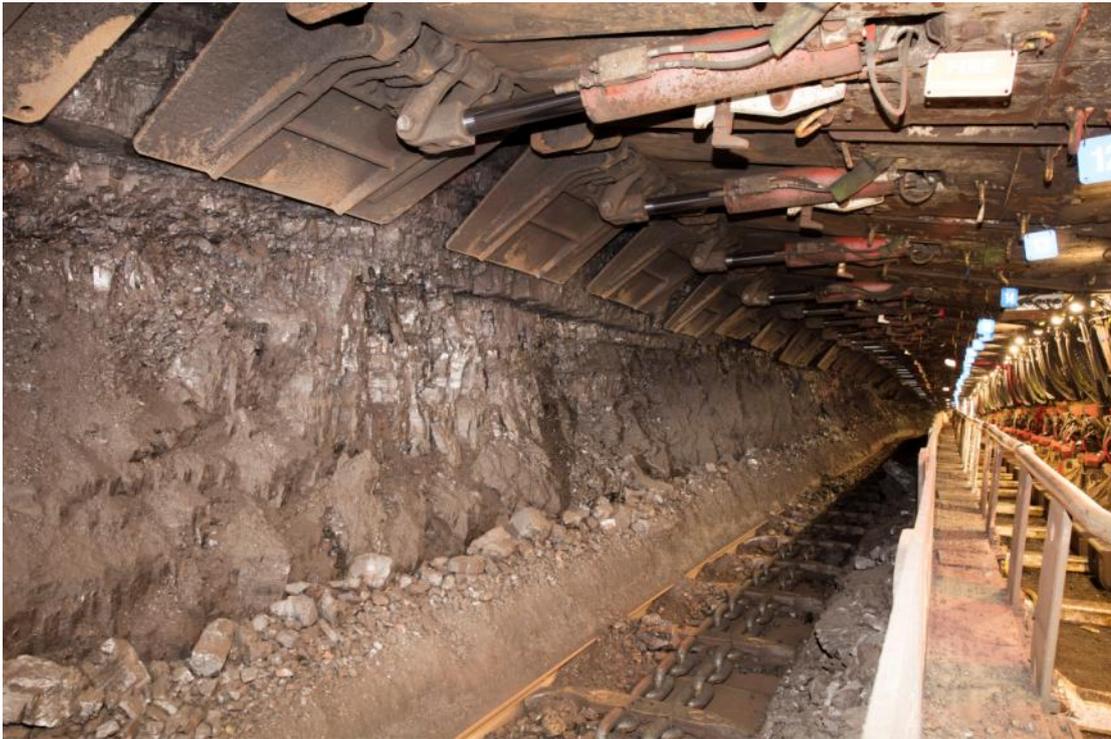
At the time of my site visit on 22 August 2016, some three days after the incident, the face and adjacent gate roads were very quiet. The longwall powered supports were not in yield or displaying signs of being subjected to a periodic weighting cycle, the face was not spalling and there was no noise emanating from the goaf or from the roof and floor strata. The face and gate road ribs did not display signs of excessive abutment stress.

Figure 1: Face condition towards maingate end showing minimal signs of high abutment stress and spalling and negligible debris on the walkway side of the AFC.

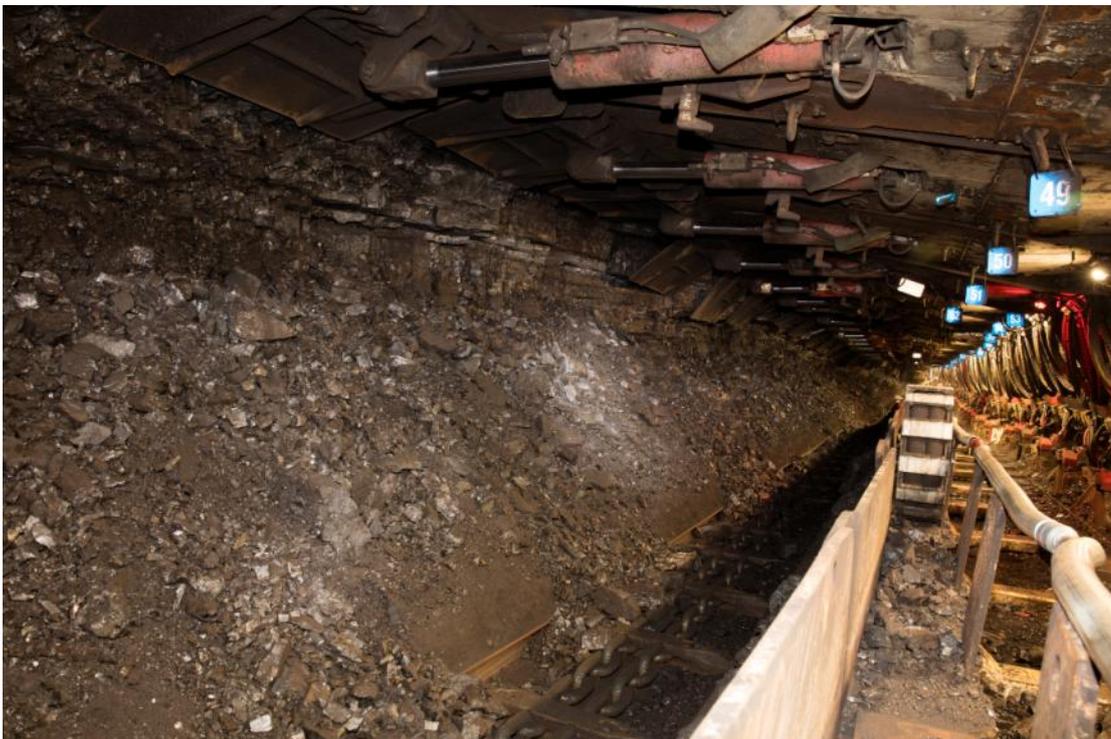
Figure 1 to Figure 3 show aspects of the longwall face. Coal was blown from the longwall face over a length of some 50 m and to a depth of about 1 to 1.5 m. According to analysis undertaken by the mine owner at the request of investigators after visiting the site on 22 August 2016, approximately 11 to 12 tonnes of broken coal was ejected from the face between powered supports #37 to 64 and, of this, around 0.4 tonnes had landed on the walkway side of the spill trays. Coal had been ejected some 6 to 7 m back from the face.

Figure 2: Face condition in burst area, showing the depth of rib blow out (note that the coal had already been run off the AFC).

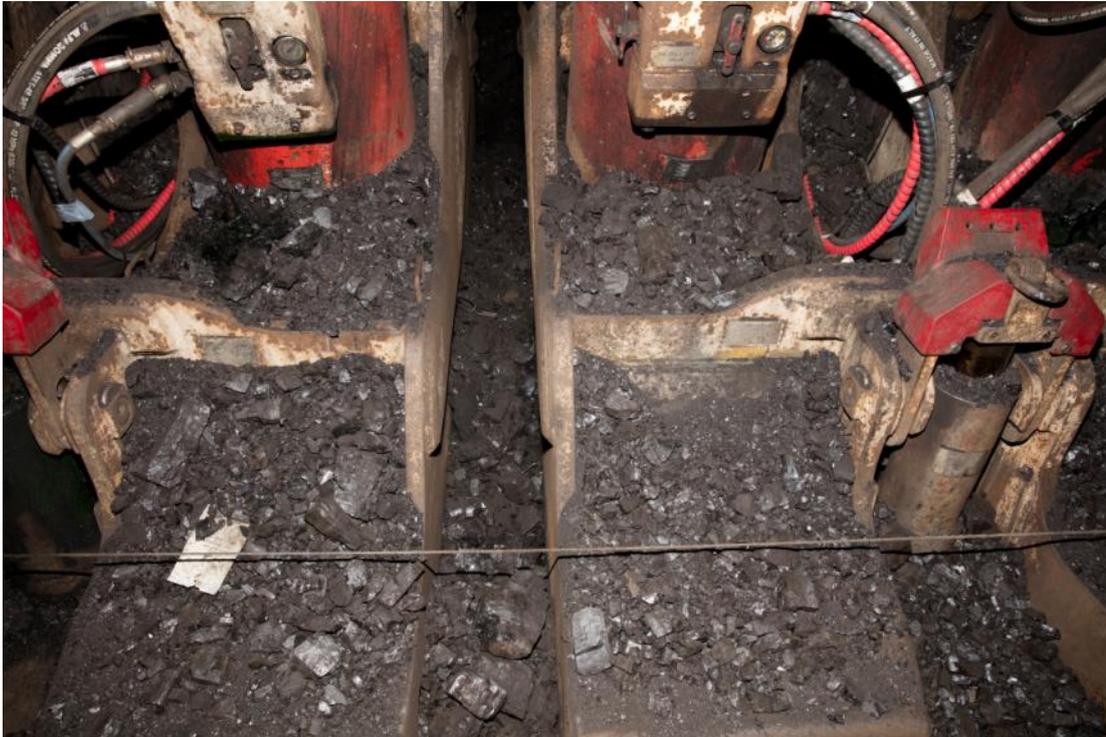
Figure 3: Ejected coal around and between the pontoons of #50 support.
