INVESTIGATION INFORMATION RELEASE

Worker injured while conducting repairs to mobile jaw crusher

Event: A worker was injured when struck by a failed lifting lug while conducting repairs to a mobile jaw crusher

Location: Hera Mine, Cobar region via Nymagee in NSW

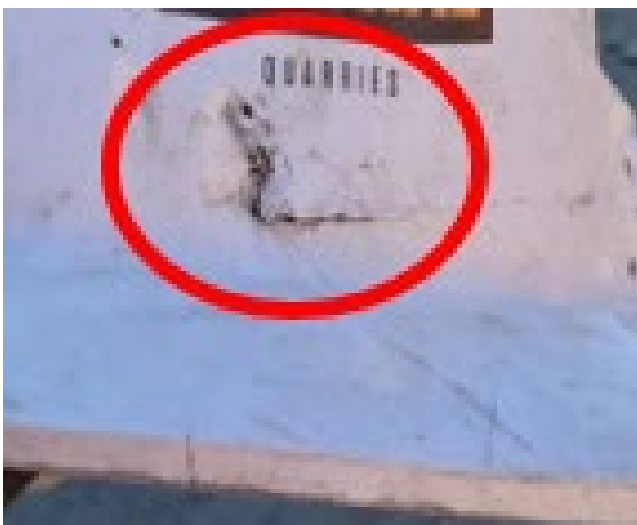
A contract worker sustained an injury during an attempt to rotate a fixed liner plate in a mobile jaw crusher. To remove the liner plate, a temporary lifting lug was welded to the plate. An excavator was then used to lift the plate, however the weld failed and the lug struck the worker's hard hat at speed. The hat was damaged, resulting in a laceration to the worker's forehead which required nine stitches.

Figure 1 Impact damage to hard hat

- Mine operators must ensure that personal protection equipment (PPE) is available and worn as determined in the mine safety management system.

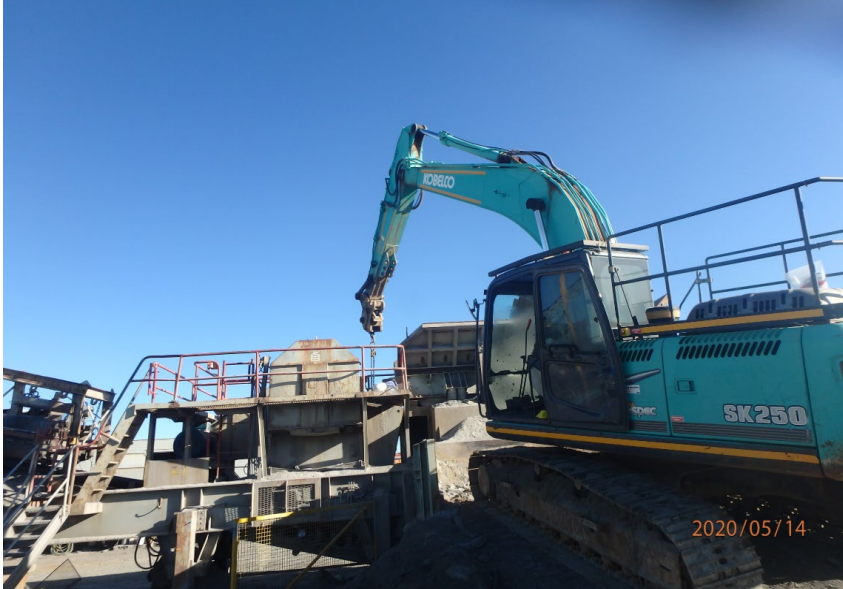
Figure 2 Crusher with excavator in position

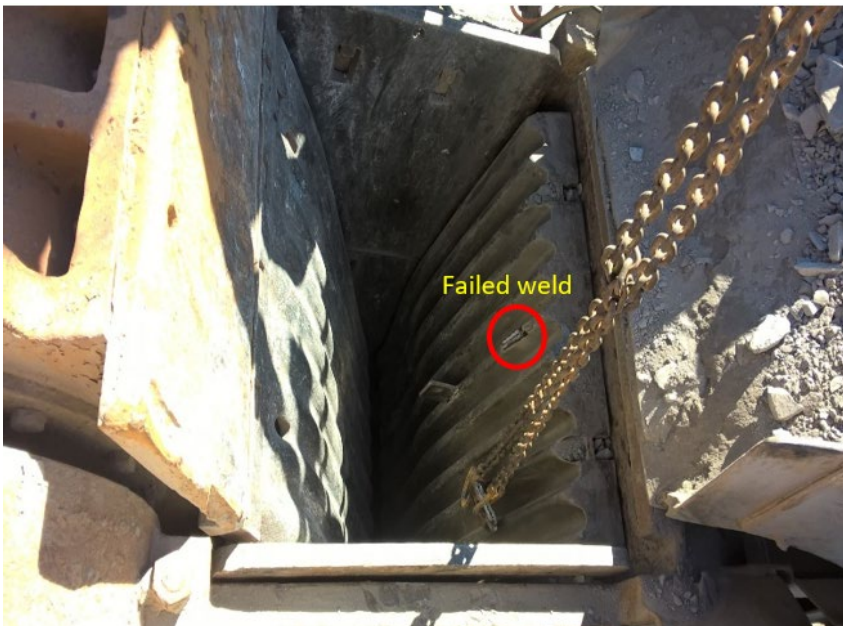
Figure 3 Fixed jaw liner plate

- The fixed jaw liner plate being removed did not have designated lifting points. A new fixed jaw plate observed on site had designated lifting points on both ends.

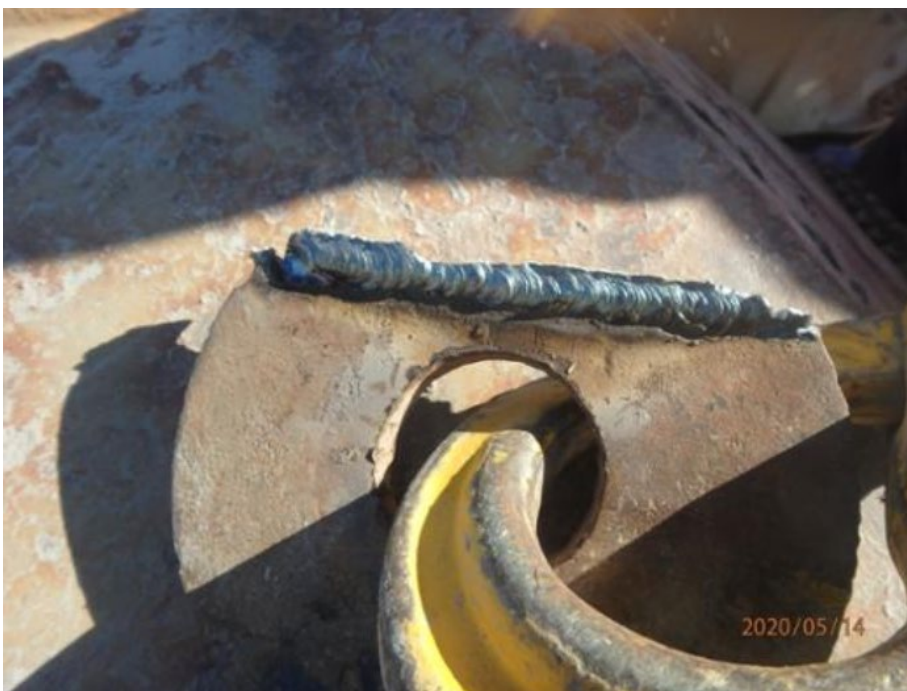
The excavator operator attempted to lift the fixed jaw plate with the side cheek plates still fixed in position. It then appeared to be jammed and the boilermaker stopped the lift. He then stood on the crusher platform, where he leaned over to see what was preventing the jaw plate from moving. The lifting assembly was still under tension due to the excavator not releasing the unknown additional load, caused by the jammed plate during the lift. The boilermaker had positioned himself so that he could visually communicate with the operator of the excavator. This placed him in direct line of fire should the lifting attachments fail. The weld on the lifting lug failed unexpectedly, which allowed a sudden release of stored energy in the lifting chain and lug which struck the boiler maker on his hard hat. Subsequently, he received an approximately 8-centimetre laceration to his forehead.

Figure 4 Failed lifting lug attached to lifting hook

- The excavator lift rating was 2,480 kilograms and the worn fixed jaw liner plate weighed approximately 750 to 800 kilograms.
- The 10-millimetre lifting chain assembly was rated at WLL of 3,200 kilograms.

- When planning a task involving lifting, the rating load of all components, including the connection points, must be considered in the design of the lifting plan.

- Mobile equipment used for lifting activities should be fit for purpose and be fitted with a load sensing device.
- Safe standing zones must be established to account for component failures within the system.
