INVESTIGATION INFORMATION RELEASE

Worker receives crush injury to foot from hydraulic stabilising jack on jumbo rig

Incident date: 15 September 2020

Location: CSA Mine, Cobar, NSW

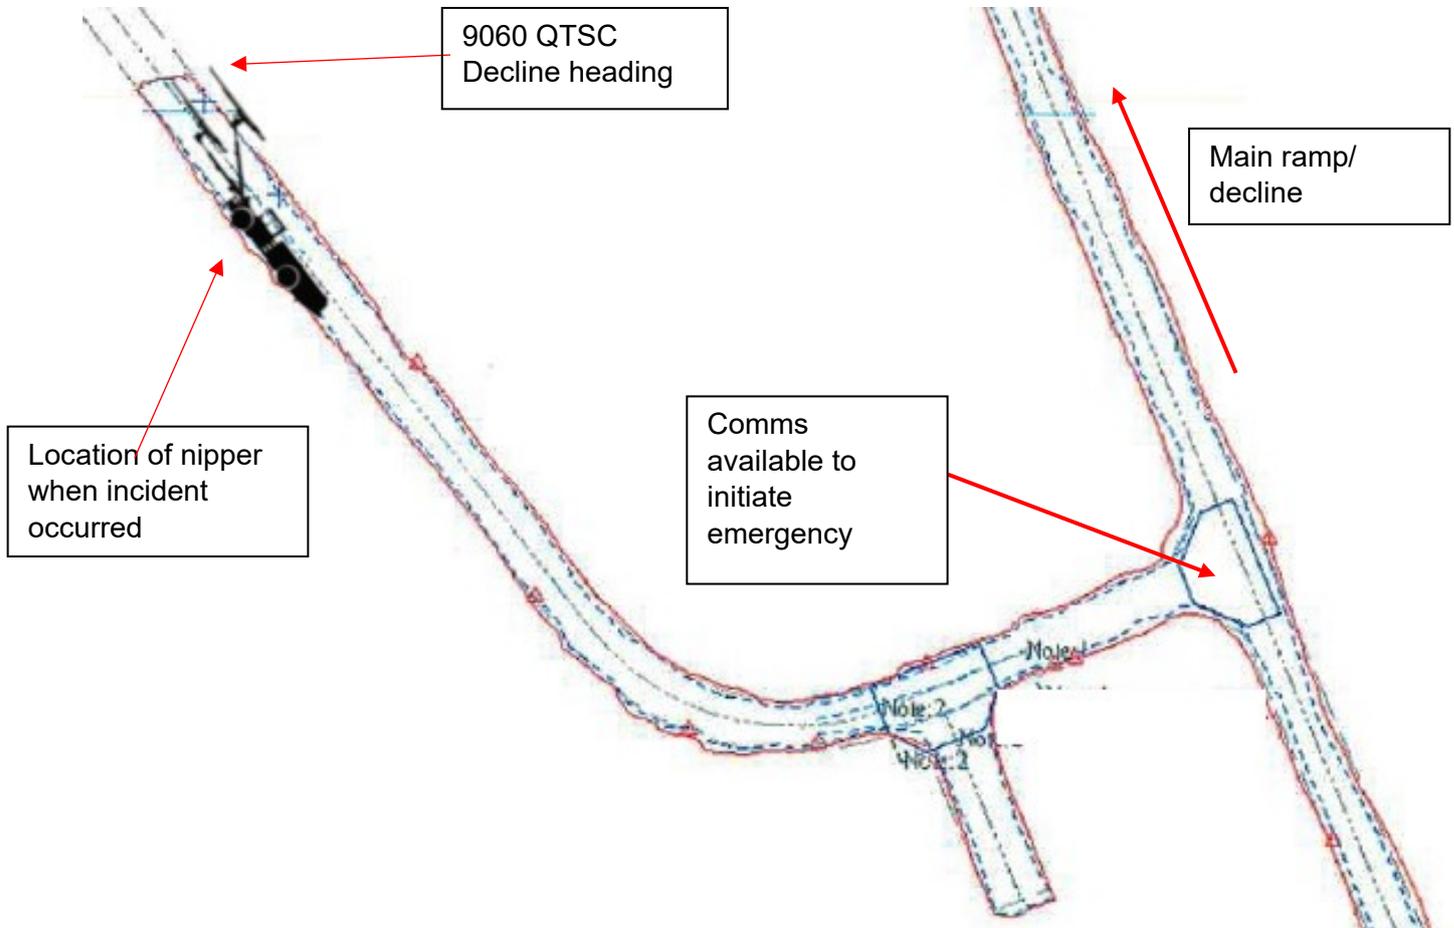
Figure 1. Level plan showing location of jumbo

On the morning of 14 September 2020, a Sandvik DD421 Twin Boom Development drill rig (jumbo) was installing ground support to enable progression of the 9060 QTSC Decline Heading (see figure 1). The task was being carried out by two contract workers, an experienced driller and a driller's offsider (nipper) with four months experience in the role. The jumbo was introduced to site from another mining operation and an inspection was conducted on the jumbo on 13 February 2020.

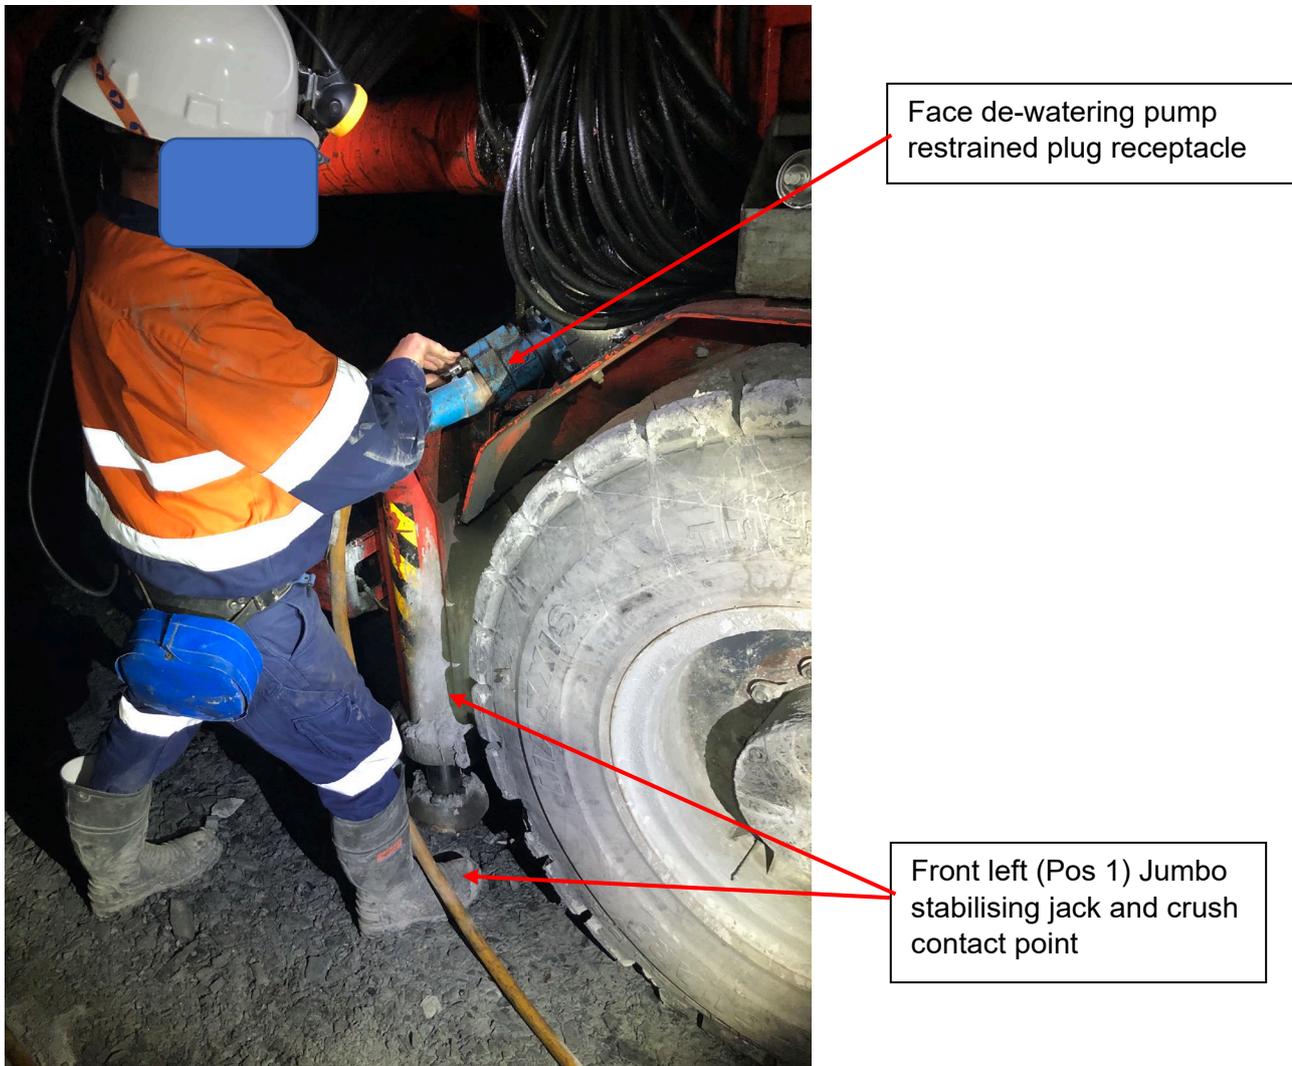
Figure 2. Re-enactment of nipper's positioning at the time of incident

The driller lowered the front left jack leg (Pos 1) when it contacted the nipper's right foot, crushing it. The driller heard the nipper yell and from his seated position observed the nipper's hand waving inside the jumbo's cabin. The driller immediately raised the jack leg which released the nipper's foot. A maintenance fitter in the vicinity was alerted to the incident and called an emergency over the radio. The nipper was transported to Cobar Base Hospital and transferred to Dubbo Base hospital. The resulting injury to the nipper was an amputation of the big toe and the fracture of his second toe. Figures 3 and 4 below show the boot worn by the nipper at the time of the incident.

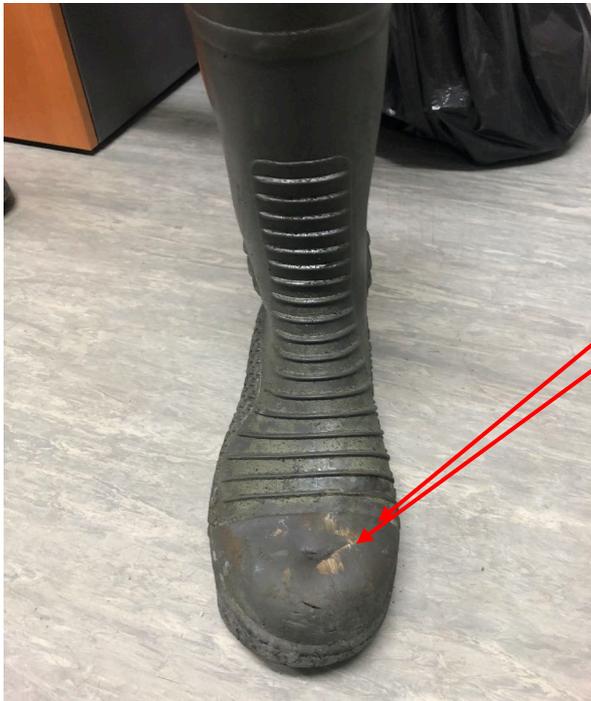
Figure 3. Top view of nipper's right boot

Indentation in nipper's boot

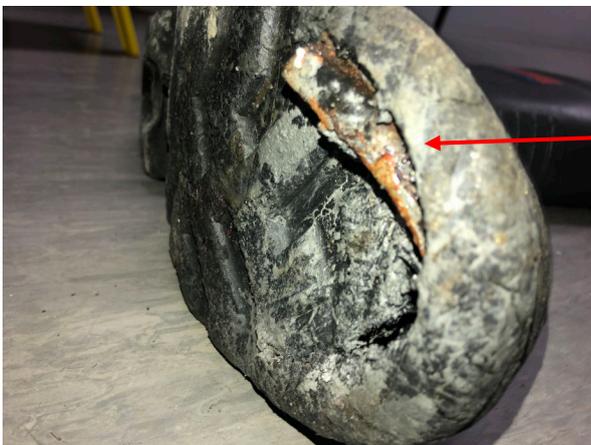
Figure 4. Sole view of the nipper's right boot

Steel cap protruding from the sole of the nipper's right boot

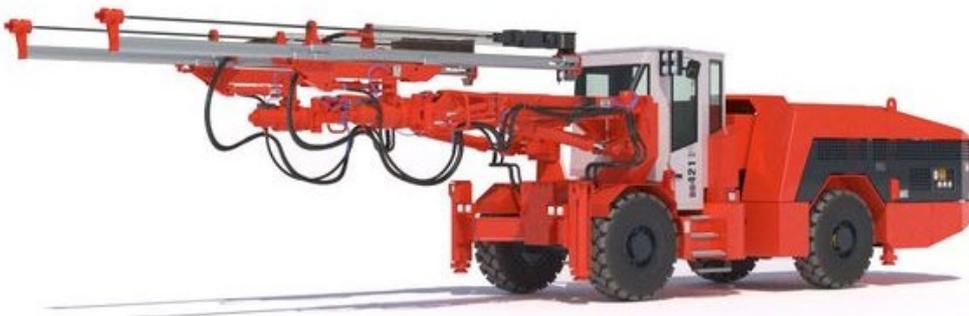
Figure 6. the DD421 development drill rig, colloquially known as a jumbo. (Renderhub/ ArqArt)

The original equipment manufacturer placement of the pump outlet / receptacle has changed with this version of the DD421 drill rig involved in the incident. The change in position was due to the positioning of the Telescopic Feed Extension (TFX) valving near the tombstone and mounting of the laser barrier (jumbo guard/ boom stop) devices at the rear of the front wheel arch, limiting real estate. Older versions of the DD421 drill rig had the pump outlet / receptacle nearer the cab, at the rear of the front wheel arch. Previous version positioning meant that workers were not exposed to the risk of crush injuries by the jack leg. Figure 6 shows an unmodified DD421 drill rig.

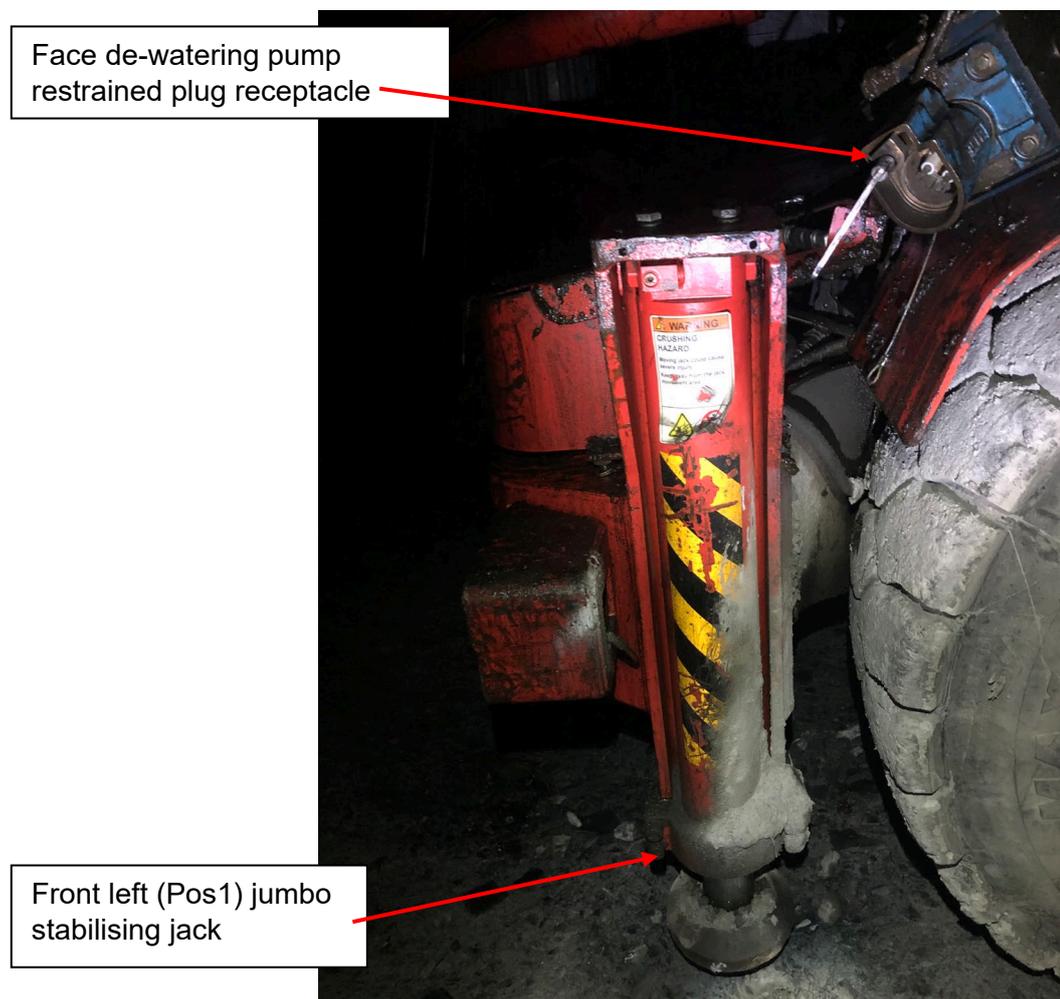
Figure 7. Position of pump receptacle above jack leg

Site based assessment of the jumbo as fit for purpose equipment (Introduction to site) had identified the fitment of a laser barrier (jumbo guard/ boom stop) safety system to prevent personnel movement beyond the rear of the wheel arch during boom operation. Introduction to site documentation required a risk assessment be conducted for any equipment modifications identified however, this risk assessment process was not carried out. The re-location of the pump receptacle, which placed personnel near the hydraulically actuated stabilising jack, introduced a potentially hazardous situation for any person connecting a pump to the receptacle.

- Relocation of 1000 volt outlets on affected plant to an area that does not introduce additional hazards.
