INVESTIGATION INFORMATION RELEASE

Worker seriously injured by ejected object

Event: Dangerous incident at a hard rock quarry

Location: Lynwood Quarry, Marulan NSW

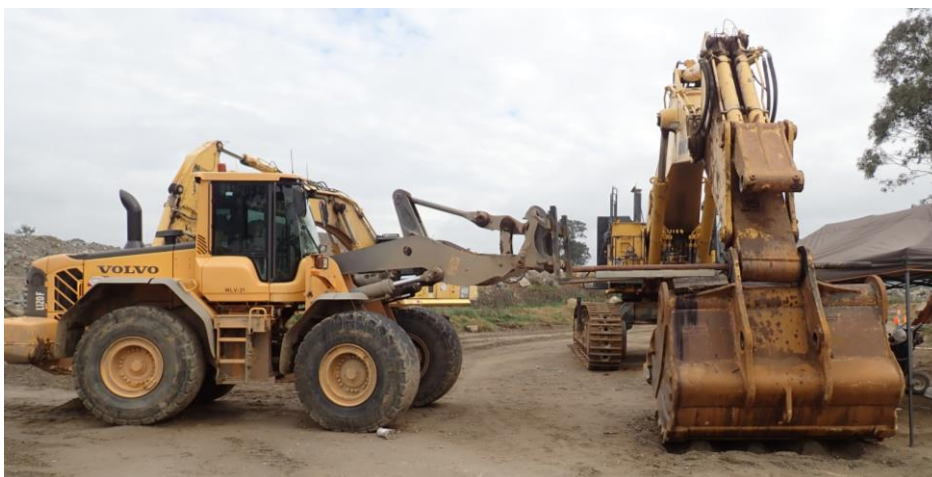
The process involved removing the retaining bolts and plate from the end of the pins then pressing the pins from their housing with a drill rod device. The drill rod was welded to a steel box section and slipped onto a fork tine on the wheel loader to provide horizontal force (refer figure 1 below). The task was expected to take three to four hours.

Figure 1 - Intended method to extract excavator pin

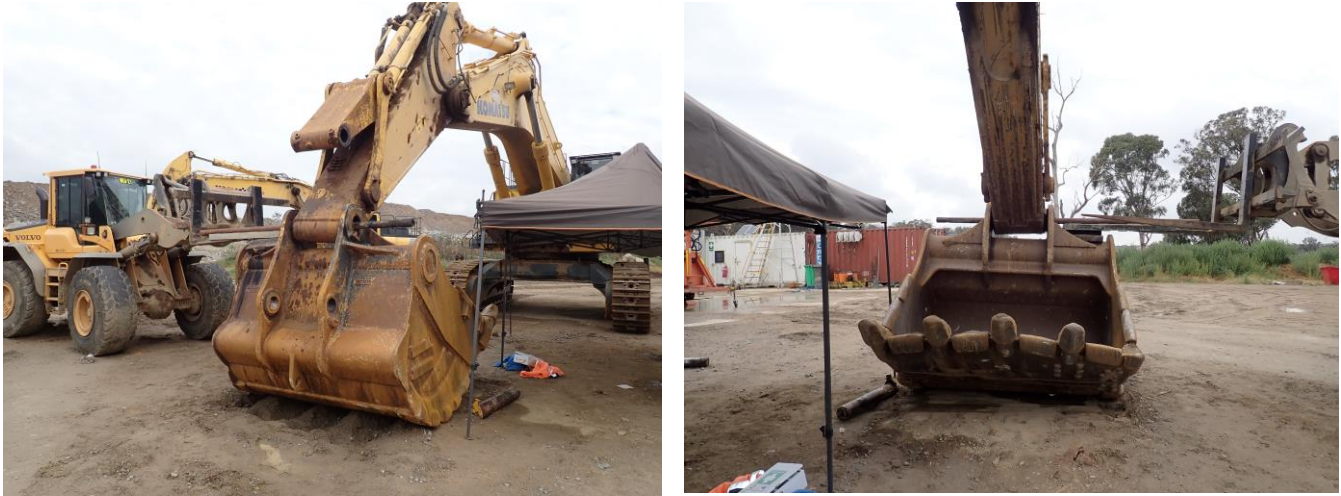
Following the second attempt, the pin was still stuck, the wheel loader reversed, and the spotter stepped towards the excavator bucket (a witness observed this to be towards the rear of the bucket to view the pins position and was out of the line of sight of wheel loader operator/supervisor). Not seeing the spotter, the supervisor drove the loader forward, again hitting the pin.⁹ The pin was ejected, deflecting off the bucket lip. It glanced the spotters shoulder knocking him over and landing on his right leg, causing a compound fracture of his right tibia. The supervisor administered first aid to the worker and contacted emergency personnel and an ambulance.¹⁰

Figure 2. The pin lying next to the bucket which deflected off the bucket lip and fell on the spotter.

- where a task cannot proceed as planned, ad hoc changes to procedures are avoided. Any changes in procedures should be subject to risk assessment and communicated to all workers affected by the change
- exclusion zones which provide for falling components should be identified, demarcated and managed to ensure workers are not exposed to falling components/equipment. There must be positive communication between all workers involved when any worker enters an exclusion zone

- there is appropriate supervision and monitoring of contractor's activities on the mine by the mine.
