Trade &
Investment
Mine Safety

Investigation report

Investigation into a fatal collision between a Caterpillar 793D haul dump truck and a Toyota Landcruiser at Ravensworth open cut mine on 30 November 2013

March 2015

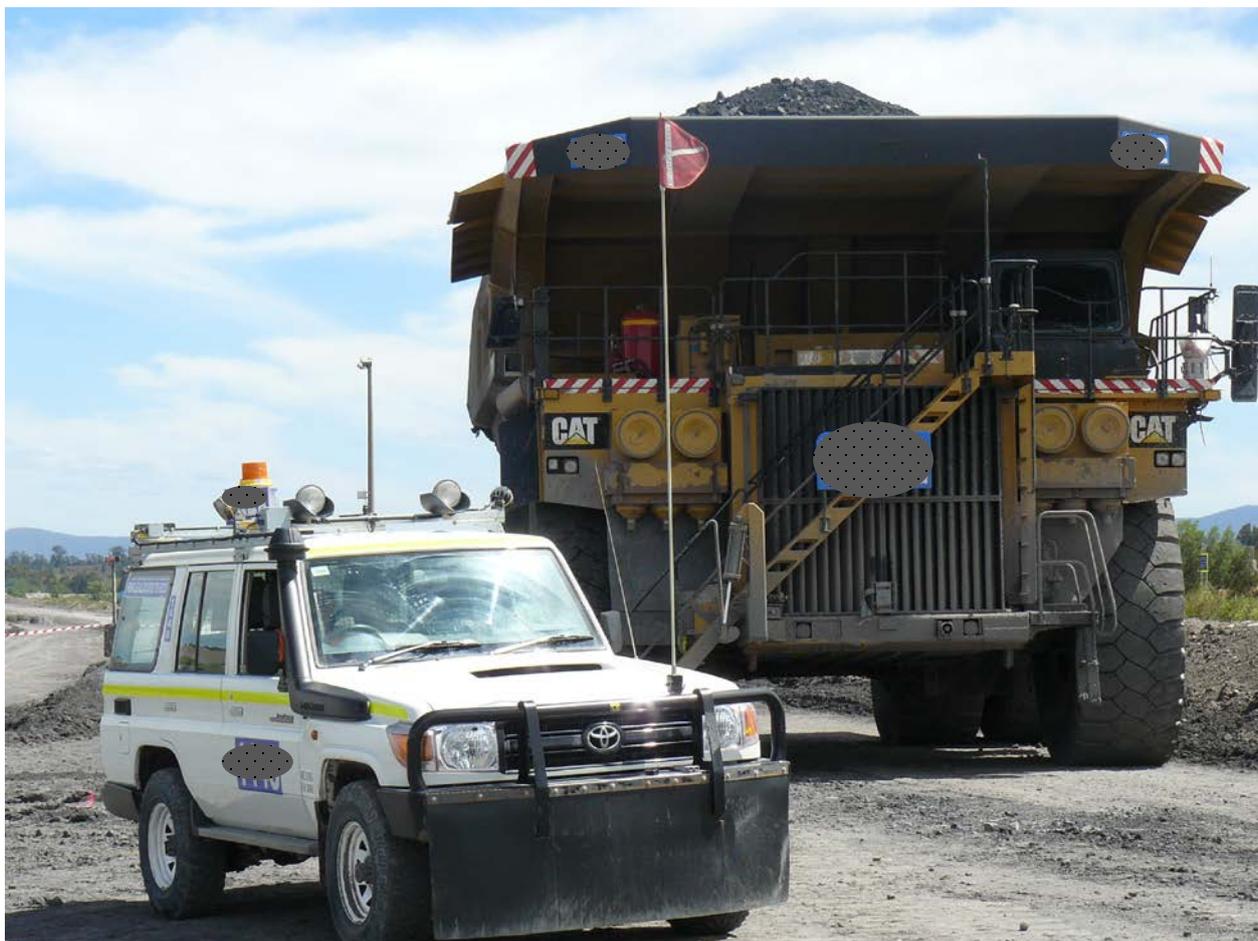
The Landcruiser driver turned right onto the 9th haul road into the path of the truck. The truck and Landcruiser collided and Ms Forshaw was crushed inside the Landcruiser and died immediately from multiple injuries.

Figure 1. Photograph of simulation taken by investigators at Ravensworth mine on 2 December 2013.

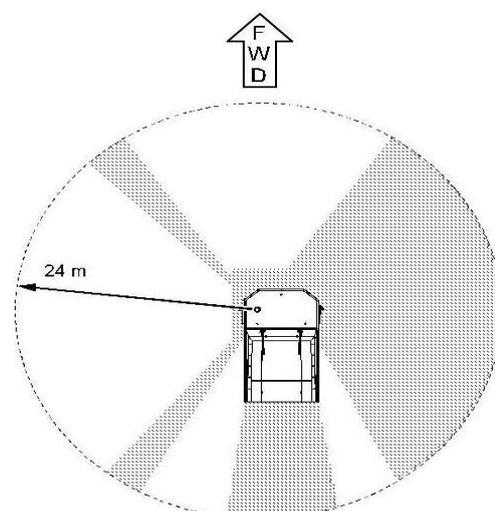
“The size and the configuration of this machine may result in areas that cannot be seen when the operator is seated. Illustration 1 provides an approximate visual indication of the areas of significant restricted visibility. Illustration 1 indicates the restricted visibility areas at ground level inside a radius of 24.00 m (78.74 ft) from the operator on a machine without the use of optional visual aids. This illustration does not provide areas of restricted visibility for distances outside a radius of 24.00 m (78.74 ft).”

Figure 6. Illustration 1, extracted from Operation and maintenance manual of Caterpillar 793D Note: The shaded areas of illustration 1 indicate the approximate locations with significant restricted visibility.

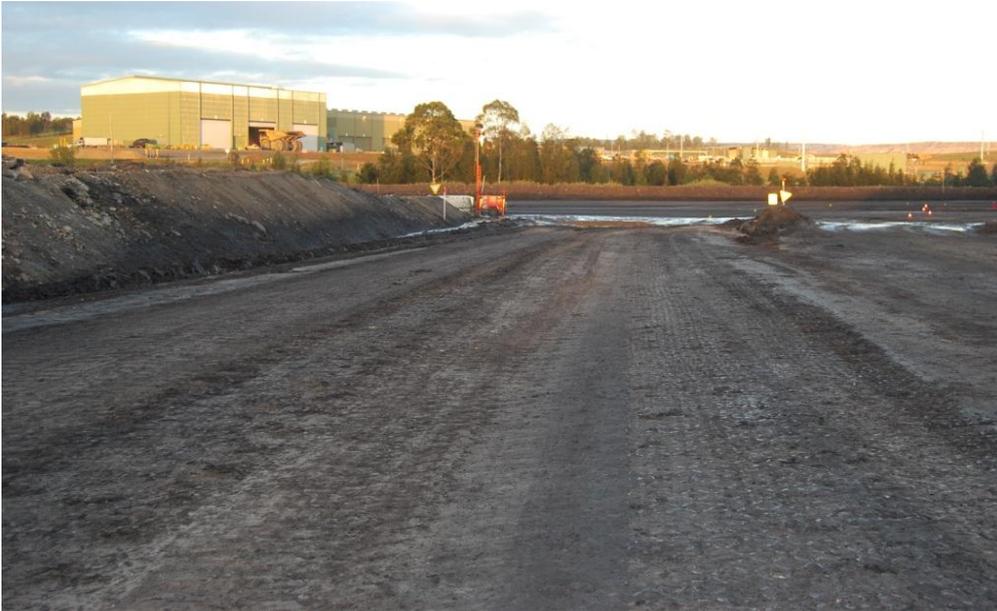
Figures 8 and 9 are photographs of the intersection (note: the orange mobile lighting tower in Figure 8 was put in that position following the incident, there were no lighting towers near the intersection at the time of the incident).

Figure 8. Photograph of the intersection from the 8th haul road taken by investigators on 1 December 2013.

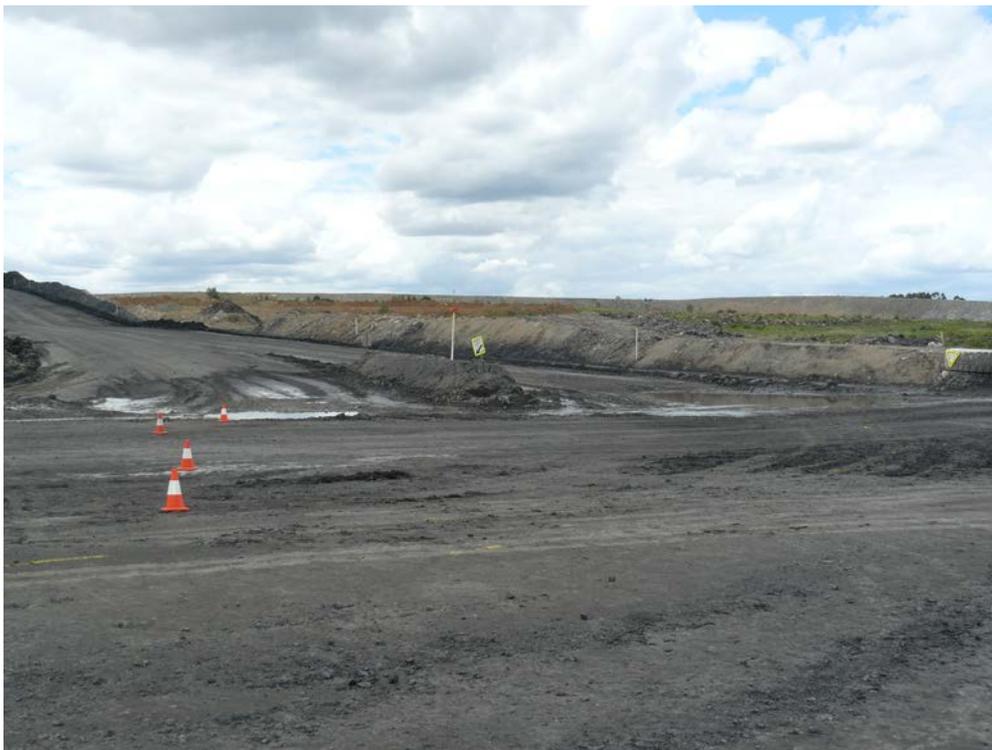
Figure 9. Photograph of the intersection from the 9th haul road taken by investigators on 1 December 2013.

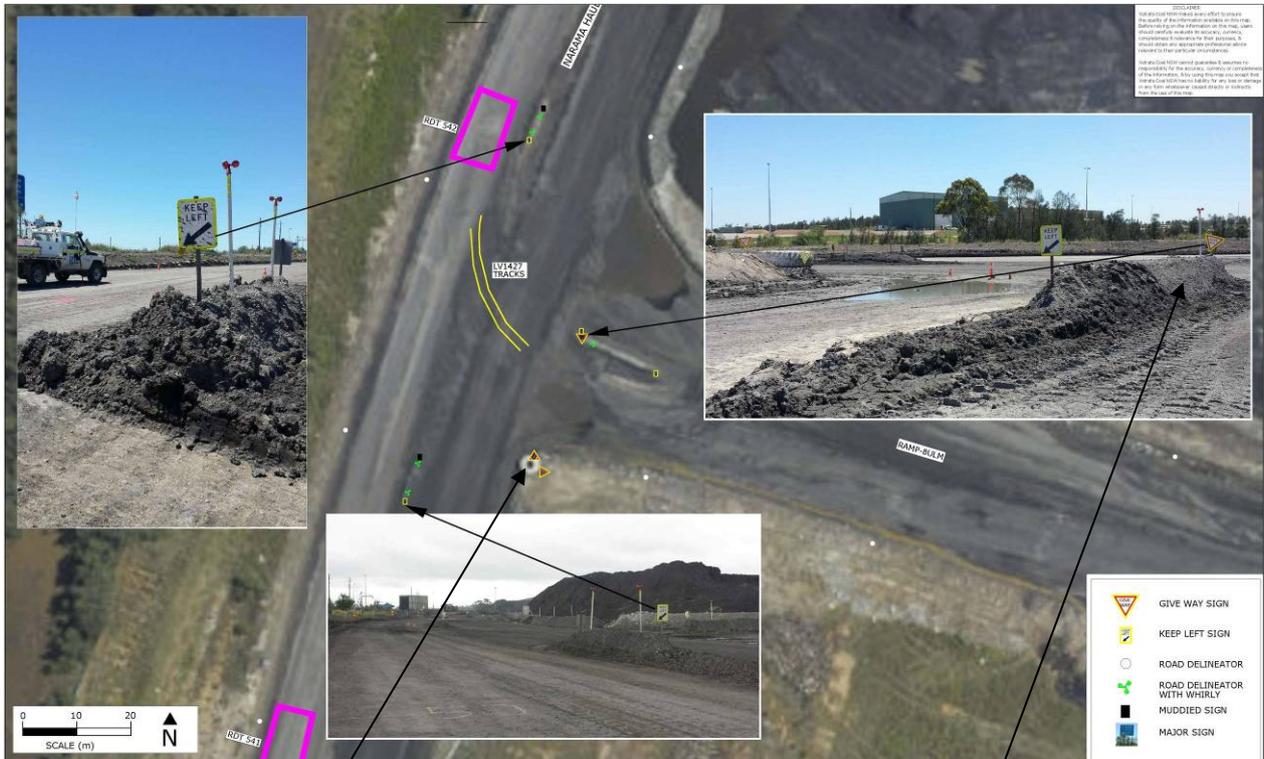
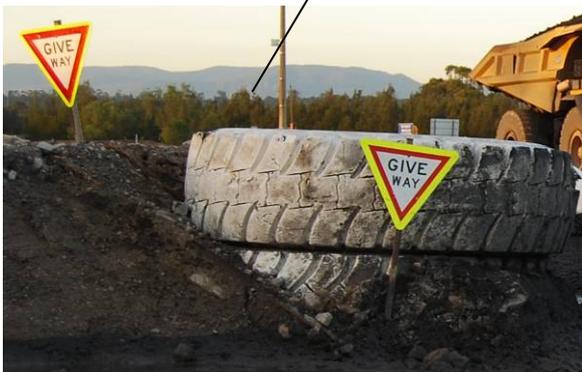
The intersection was controlled by the 8th ramp having to give way to the 9th haul road. Figures 10, 11 and 12, below depict the “GIVE WAY” signs located at the intersection on the 8th ramp and “KEEP LEFT” signs in the medians on the 9th haul road and the 8th ramp.

Figure 10. Plan of signs provided by Ravensworth mine (cropped for report).

Figure 10 (above) shows the position of delineators (guideposts) marked with white dots along the 9th haul road and the 8th ramp.

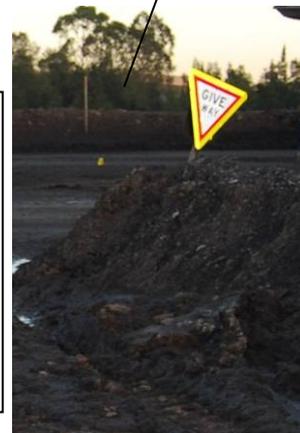
Figure 11 (left) and Figure 12 (right). Photographs taken by investigators on 1 December 2013

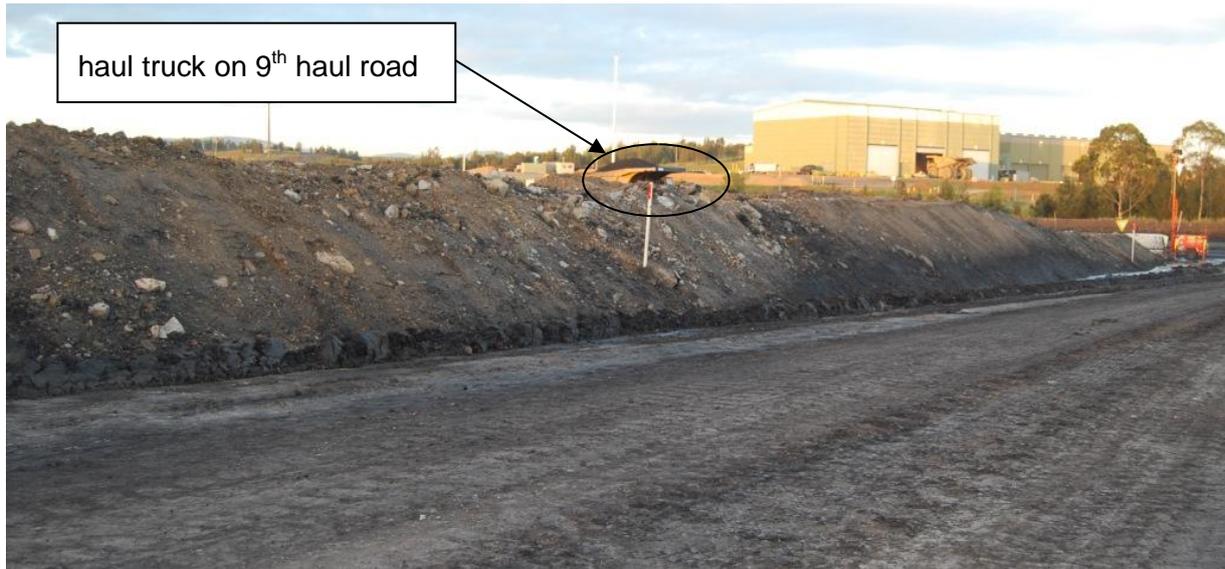
Figures 13 and 14 are photographs taken on the 8th ramp looking towards the windrow on the 8th ramp (note: the haul truck and mobile lighting plant in Figures 13 and 14 were not in that position at the time of the incident).

Figure 13. Photograph of windrow on 8th ramp taken by investigators at the mine on 1 December 2013.

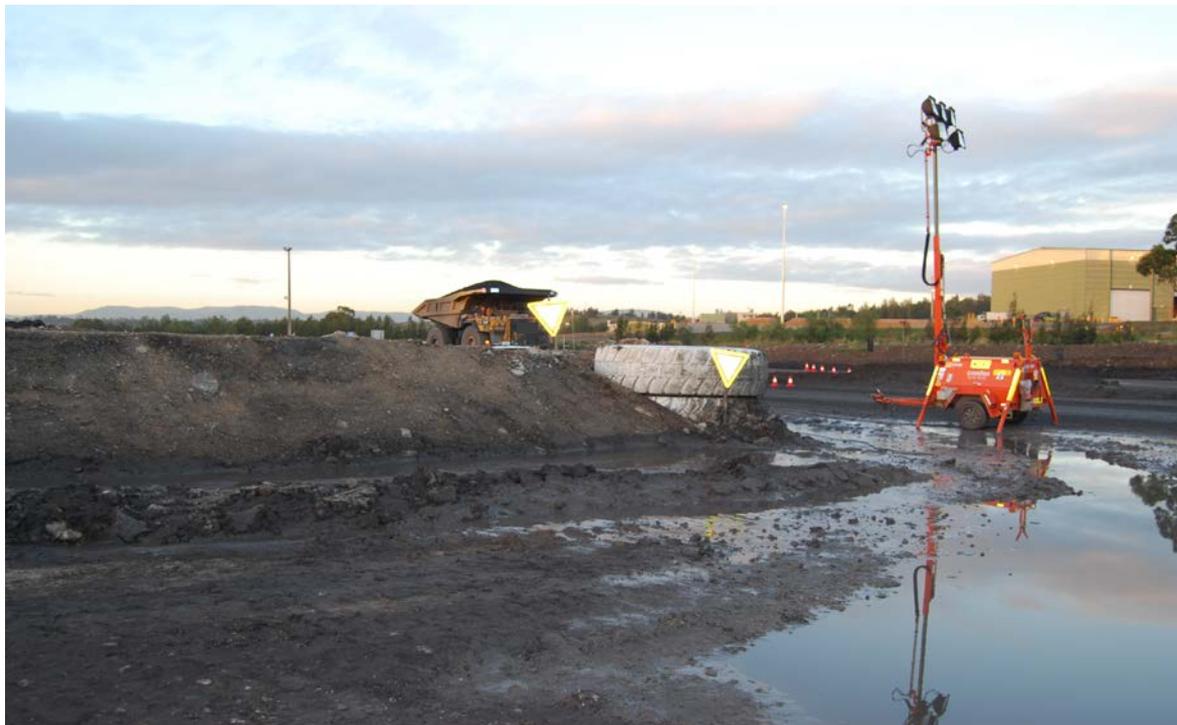
Figure 14. Photograph of windrow on 8th ramp taken by investigators on 1 December 2013.

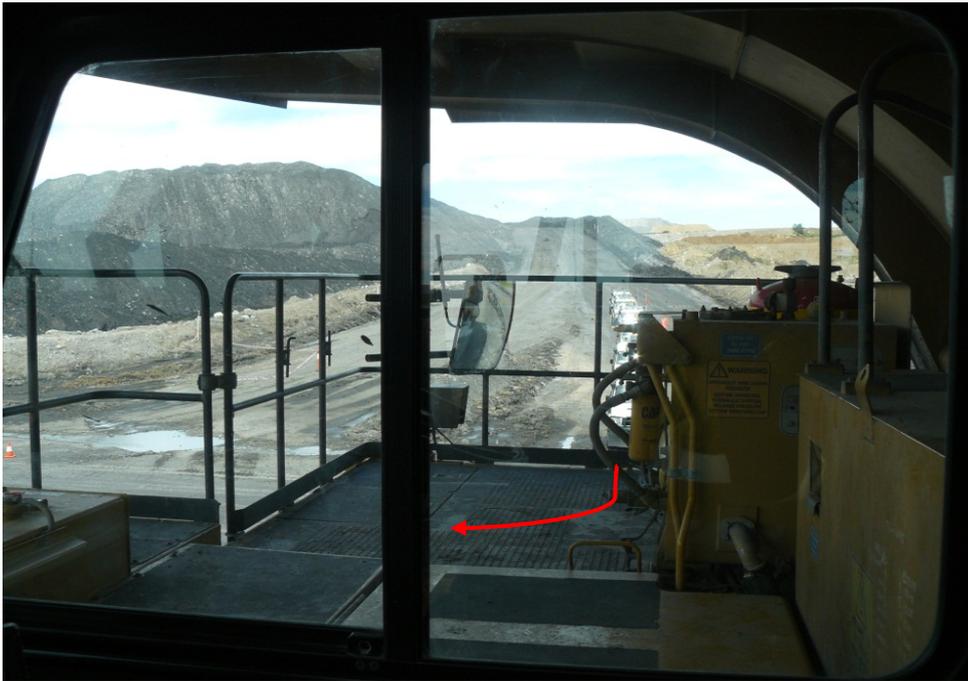
Figure 15. Photograph taken by investigators from truck operator's cabin (passenger seat) at Ravensworth mine on 2 December 2013. The truck was positioned at the center of the intersection. Note the significant blind spot on the right-hand side of the truck and the Landcruiser direction of travel (red arrow).

Investigators made the following observations during the simulations: The Landcruiser could not be seen when it was positioned in the truck's blind-spots. The lack of clearance/side lighting and reflective material on the truck made it difficult to detect at night. Lines of sight from the Landcruiser were obscured by the 8th ramp windrow in numerous places, making it difficult to see the truck on the haul road. The absence of direct artificial lighting and the impact of secondary (incidental) lighting from the mine infrastructure area (MIA) at the intersection caused background glare.

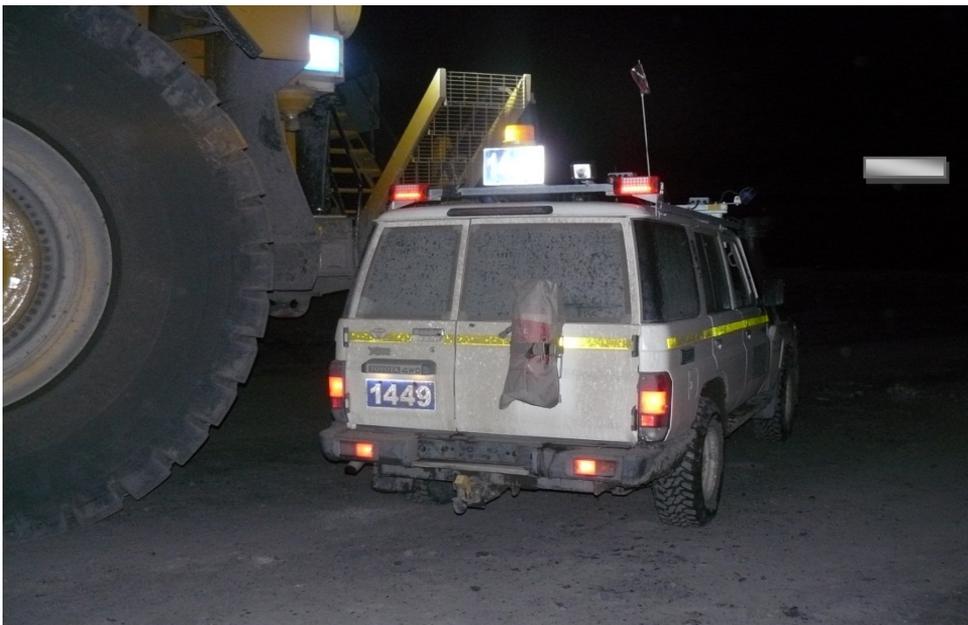
Figure 16. Photograph taken by investigators on 5 December 2013. The light vehicle is positioned in the truck's blind spot on the right-hand side of the truck simulating the right-hand turn made by Ms Forshaw.

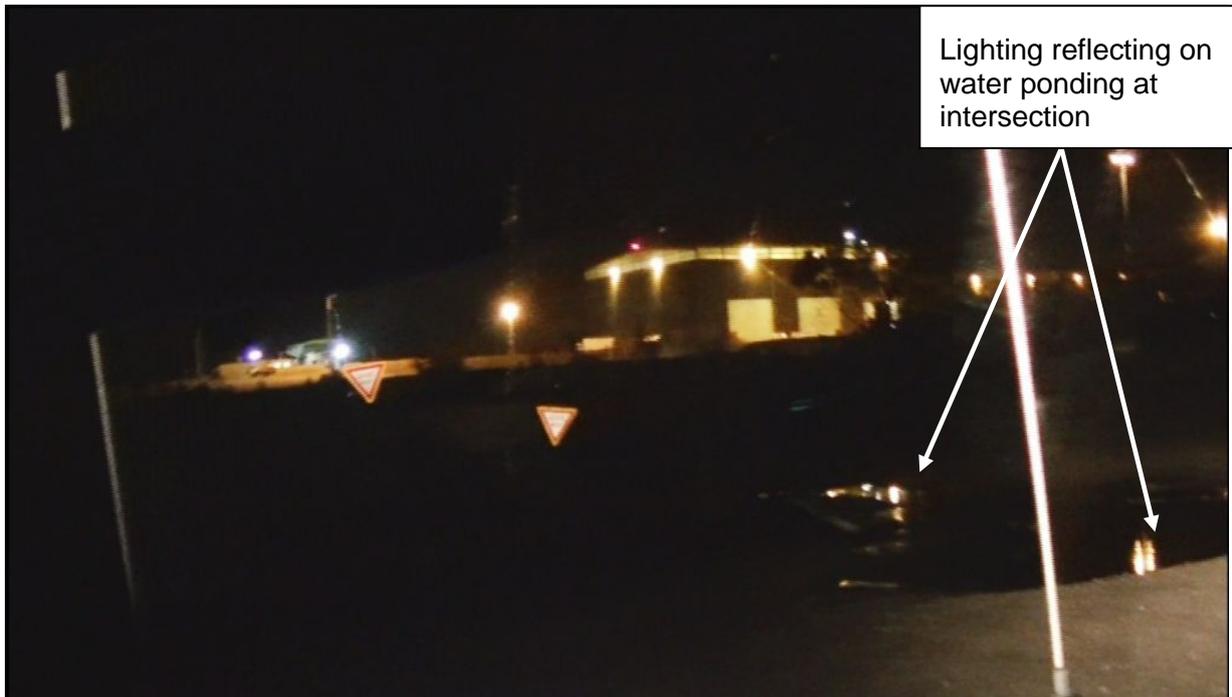
Figure 17. Screenshot from video taken by investigators on 5 December 2013. Taken from inside a light vehicle (passenger side) on the 8th ramp stockpile near the intersection.

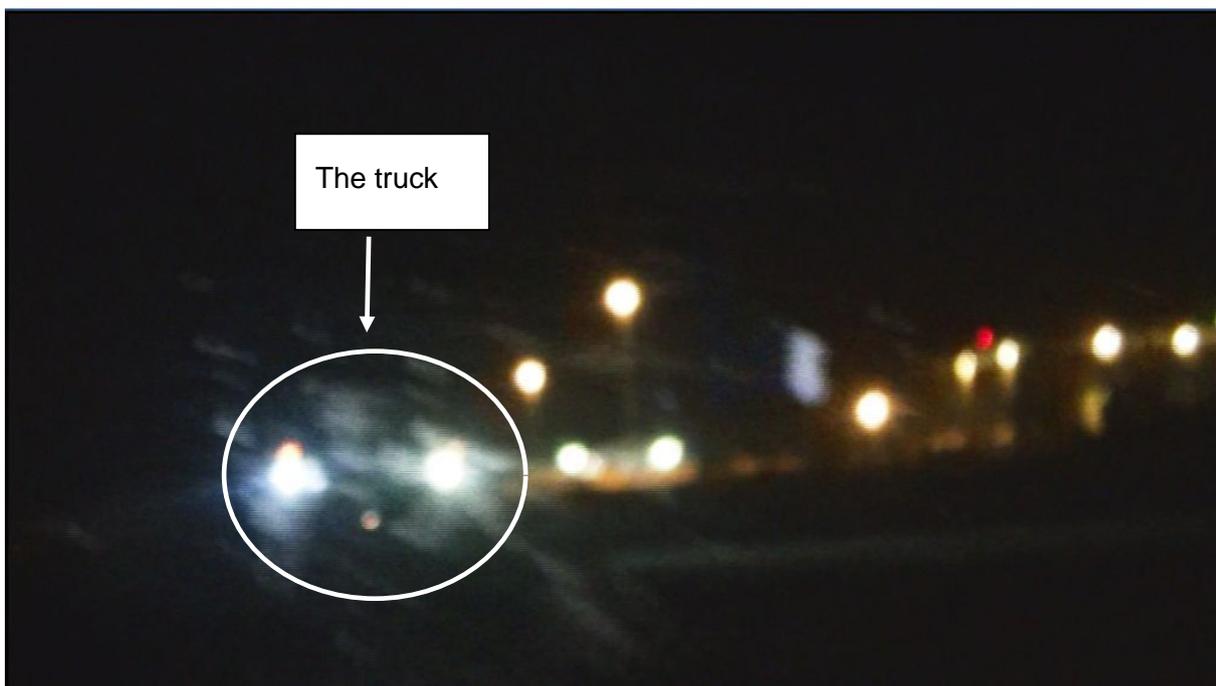
Figure 18. Screenshot from video taken by investigators on 5 December 2013 from inside a light vehicle travelling through the intersection. The truck was positioned on the haul road 50 metres from the intersection. Workshop lighting is visible in the back ground.

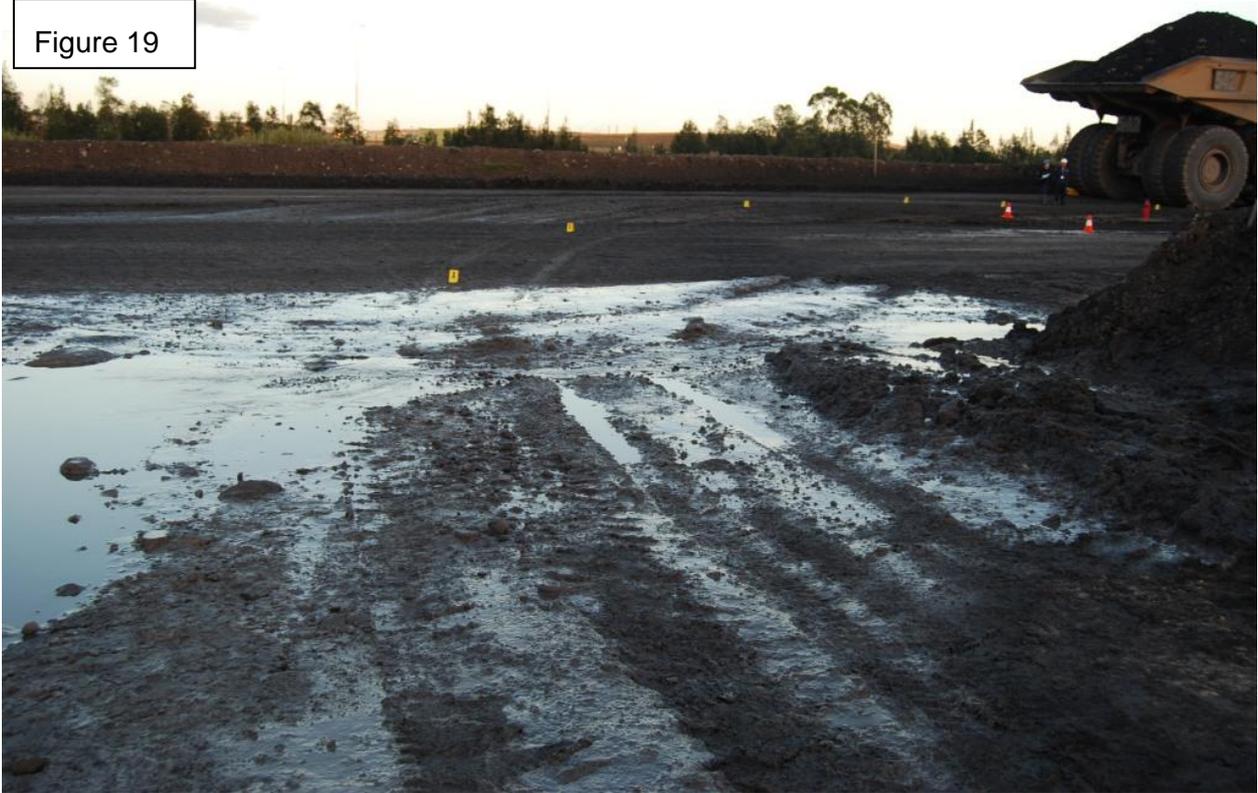
Figure 19

Figures 19, 20, and 21. Photographs of the tyre marks of the Landcruiser at the incident site taken by investigators at the mine on 1 December 2013.

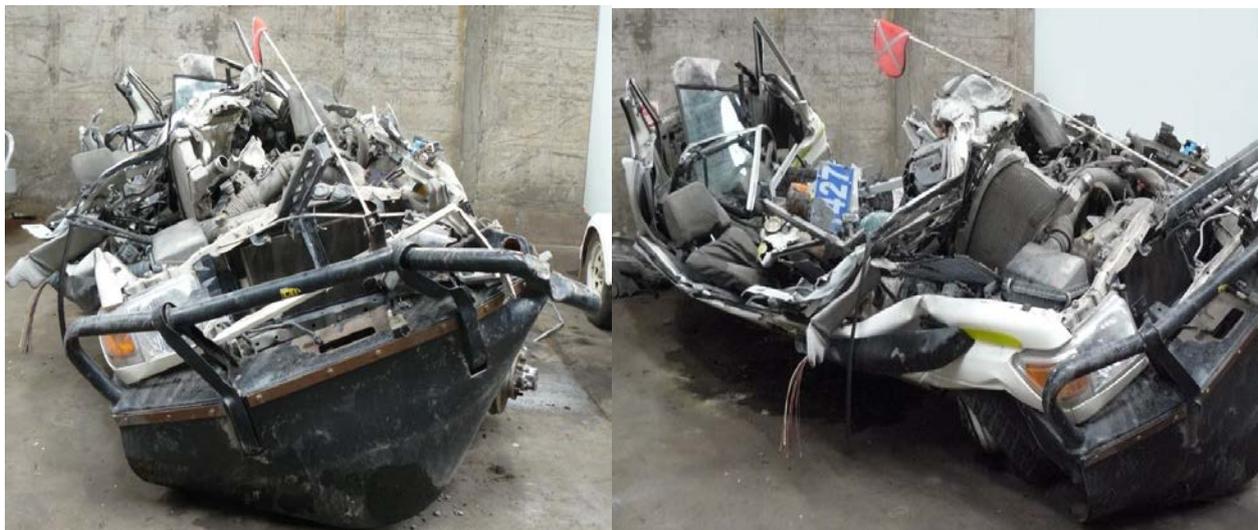
Figure 22. Photographs of the Landcruiser taken by investigators at the Newcastle Police holding yard on 8 January 2014.

The only window glass not broken was the pane from the right-hand rear door. Measurements of the distance from the window sills down into their door glass channel, which connects to the winder mechanism, implied that all four door windows were in the closed position.

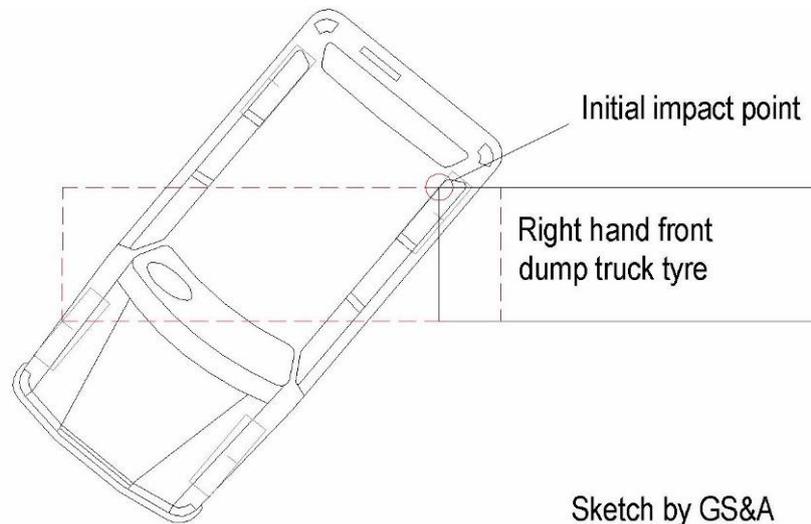
The most probable point of initial impact on the Landcruiser would have occurred near the turret seam just forward of the door pillar (rear passenger side). Figure 23, is an unscaled sketch of a plan view of the most probable point of impact.

Figure 23. Unscaled sketch of a plan view of the most probable impact point

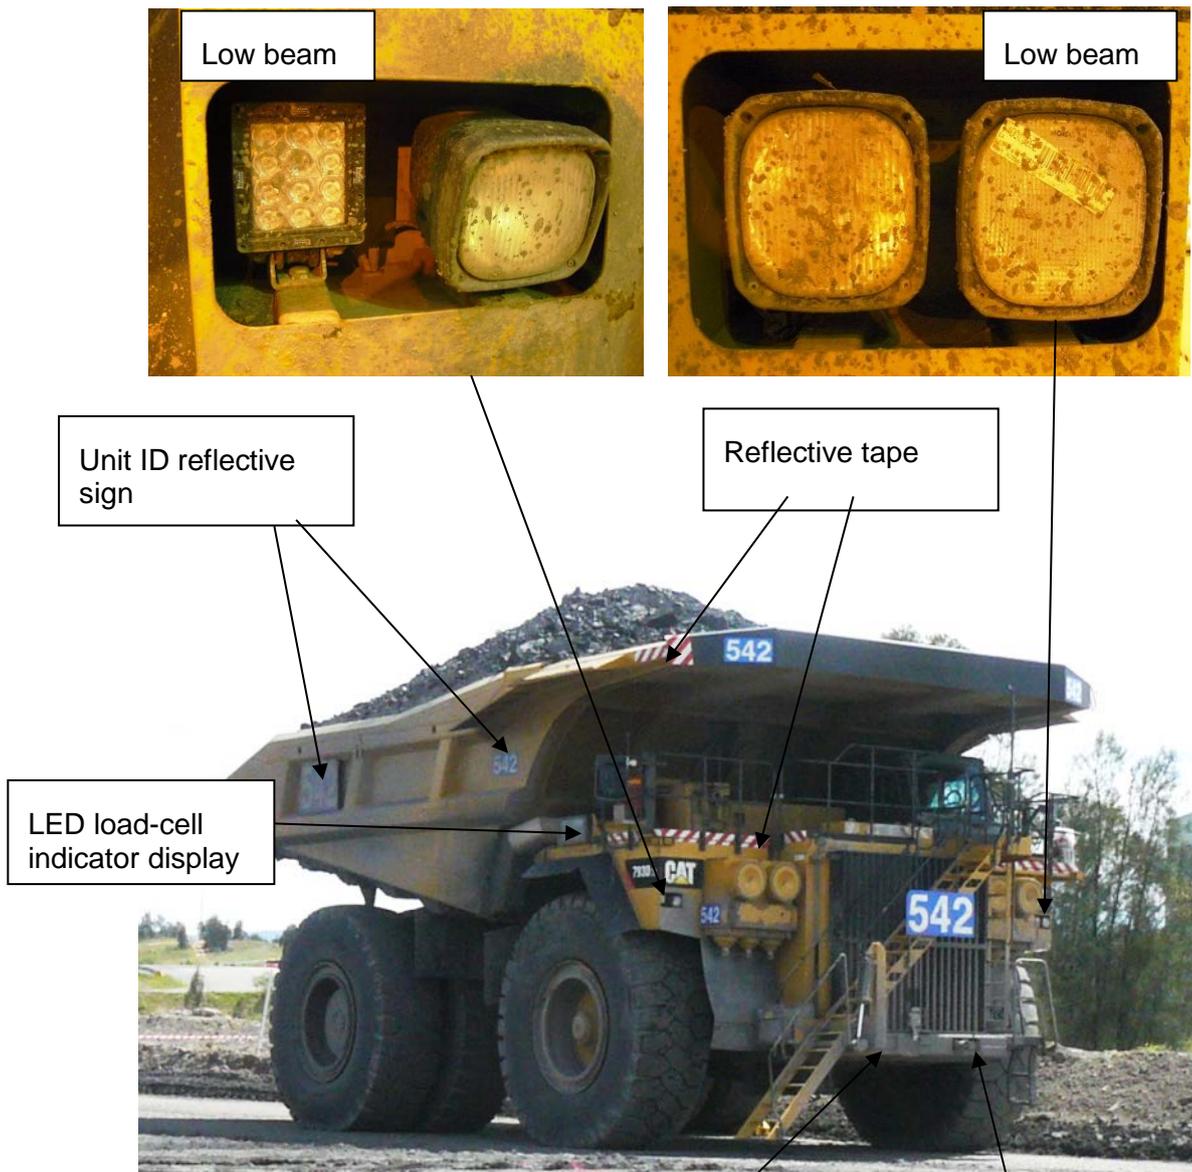
Figure 24. RHS (below left) and LHS (below right) front lighting (low beam and high beam) of truck. Photographs taken by investigators on 5 December 2013.

Investigators observed during the night time simulations of the incident on 5 December 2013 using the truck, that the recessed right hand side low beam light lens could not be seen from certain angles on the right-hand side of the truck.

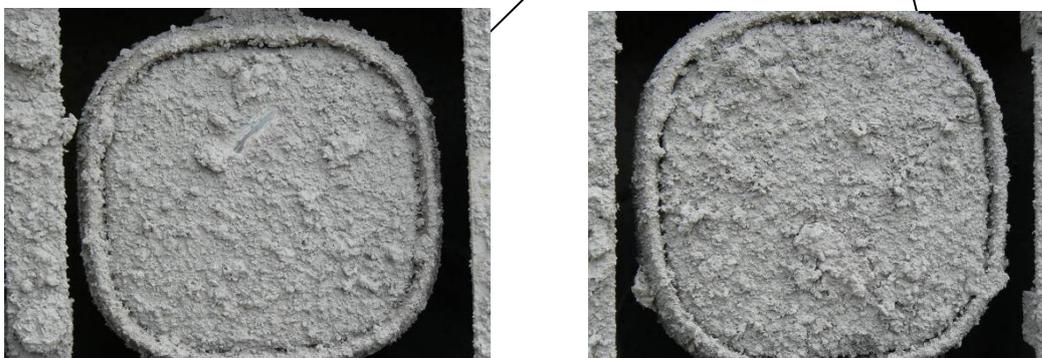
Figure 25. Photograph of truck taken by investigators at ROC on 2 December 2014.

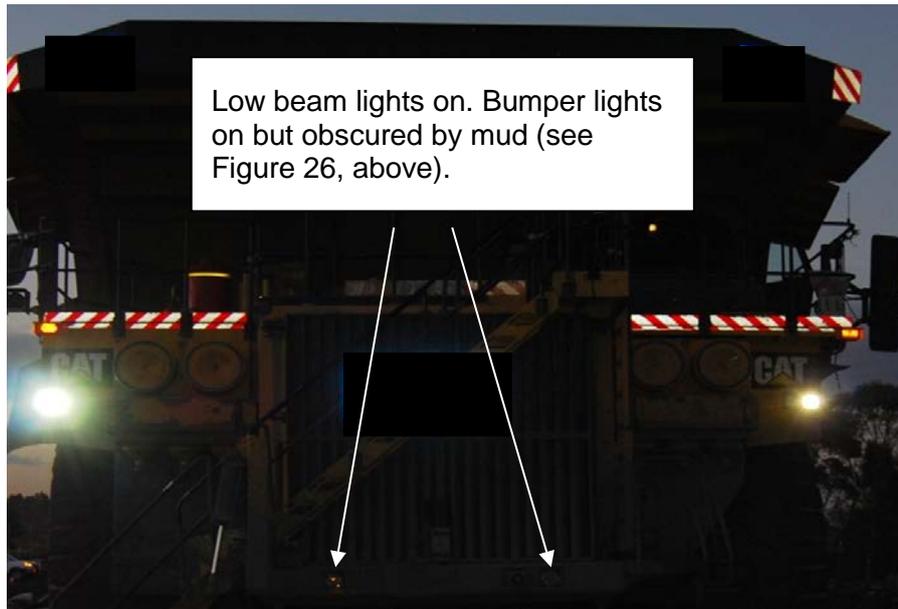
Figure 27. Photograph of the truck taken by investigators on 1 December 2013 at 5 am when the truck was first started after the incident. Low beam lights and bumper lights were on.

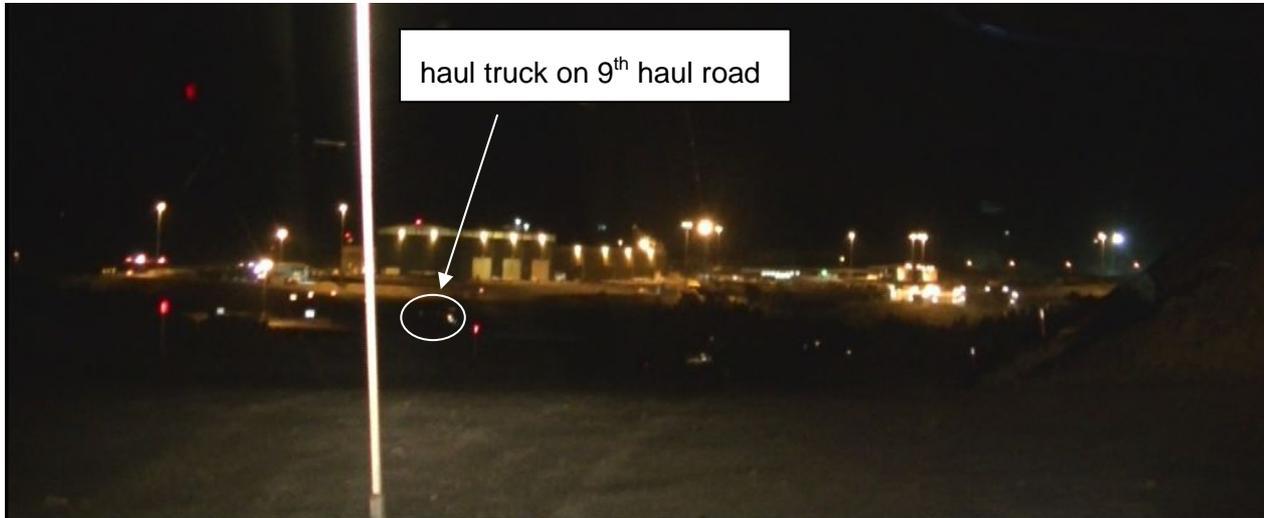
The incident occurred in the hours of darkness and as mentioned above no direct artificial lighting was provided at the intersection. There was secondary (background) lighting from the mine infrastructure area (MIA) in the vicinity of the intersection (see Figure 28, below).

Figure 28. Screenshot from video taken by the investigators on 5 December 2013, Taken from inside a light vehicle (passenger side) on the 8th ramp stockpile looking west toward the MIA.

Information from operators indicated that the background lighting of the intersection had the potential to disorientate or confuse drivers approaching the intersection on the 8th ramp, which may in turn adversely affect a driver's ability to detect a moving vehicle on the 9th haul road with accuracy and certainty. Reference was made to taking additional care at the intersection to detect whether the lights in vision were stationary or moving, as per a vehicle.

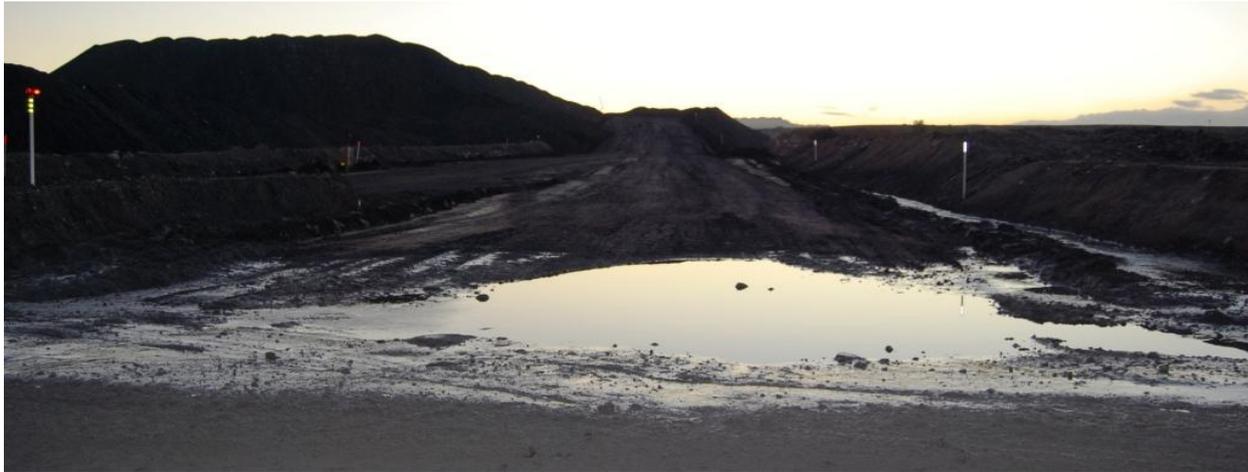
Management of the mine indicated that water across the intersection was an anticipated occurrence, such as during and after rain events and the road had a spoon drain across the intersection, requiring all vehicles to slow down on their approach. The water ponding remained unresolved at the time of the incident. This appears to be inconsistent with the local standard for haul road maintenance which stated '*Repairs to any defective section of roadway shall take place as soon as practical [sic]*' (ref. Section 6.1 of RDCG).

Figure 29. Photograph taken of incident site by investigators on 1 December 2013.

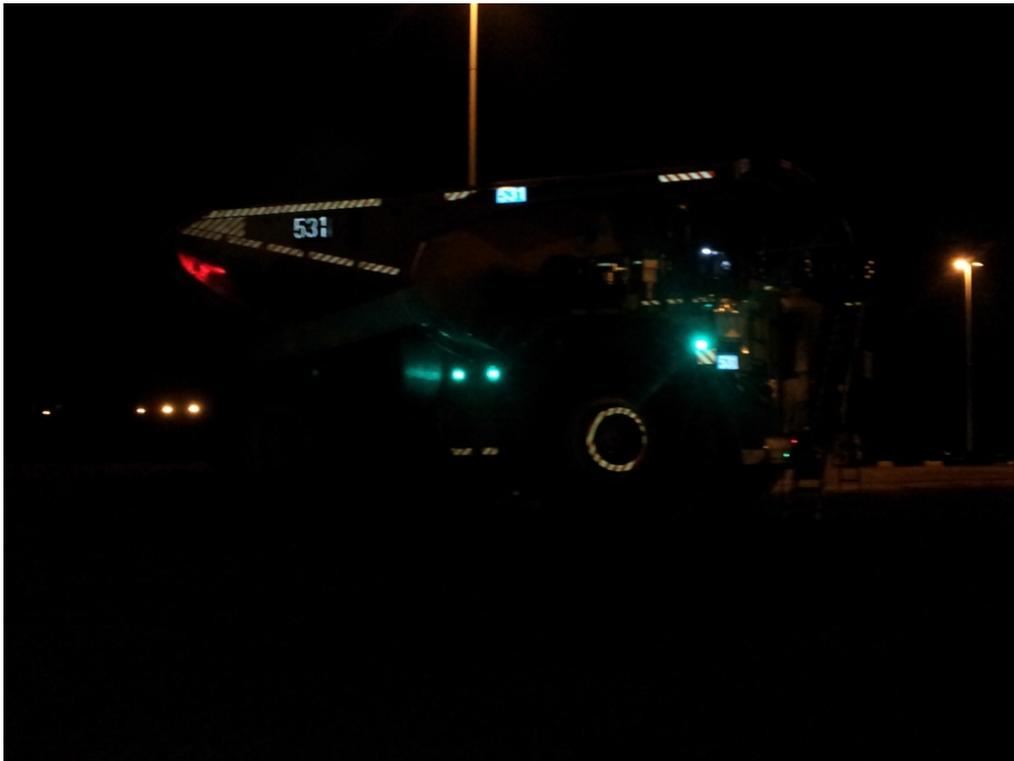
There was a trial of green clearance lights, luminescent paint, and reflective tape on certain haul trucks to attempt to improve truck visibility (see Figure 31, below).

Figure 31. Dump truck visibility trial.
