# SAFETY ALERT

**DATE:** August 2019

## Flight bar ejects - hitting worker while installing a conveyor chain

This safety alert provides safety advice for the NSW mining industry.

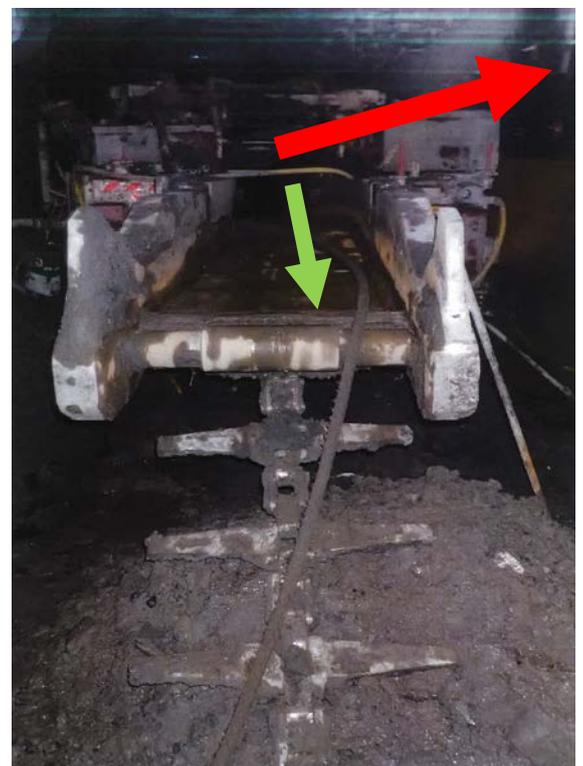
One side of the flight bar failed and was ejected from the tensioned sling towards the worker who was standing near the rib bolter controls on the right hand side of the continuous miner.

*Figure 1 The red arrow shows the trajectory of the broken flight bar. The green arrow shows the pull direction of the 22 millimetre rope pulling the conveyor chain around the sprocket underneath the head of the miner.*

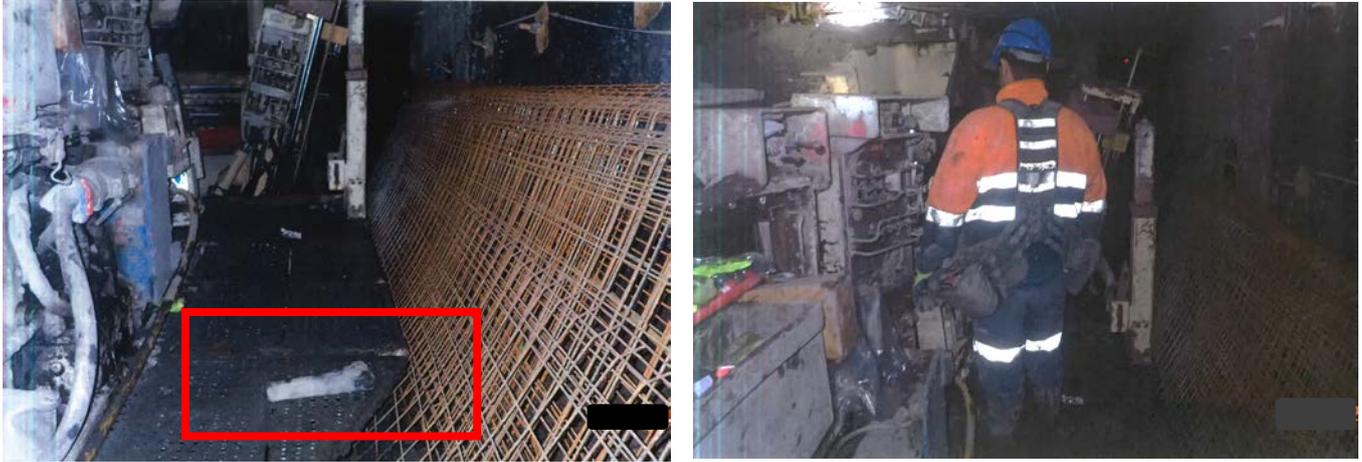
Figure 2 (left) The broken half of the flight bar on the platform of the continuous miner and Figure 3 (right) A simulation of where the injured worker was reportedly positioned when the flight bar hit him

3. Mine operators should review safe standing zones when pulling continuous miner conveyor chains. If the elimination of a spotter, standing in the line of fire during the pulling task cannot be achieved, then suitable protection for a spotter must be put in place such as a mobile hard barrier guard.

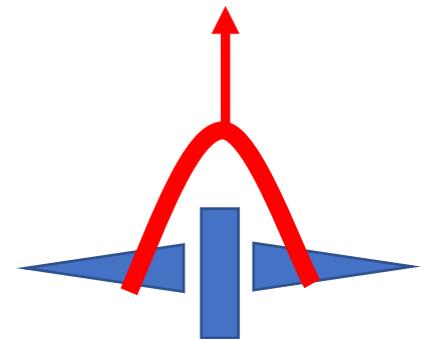
- **Pulling connection point failed:** The workers used a sling and rope that they considered would be 'fail to safe' (a slow release of energy on failure). They did not consider that the sling reeving method, which was looped around the flight bar, may cause the failure of the flight bar.

Figure 4 Diagram of the sling looped around both sides of the flight bar

1. Mine operators should review lifting and towing plans and procedures and provide safe work procedures for systems of connecting to, and pulling, conveyor chains.
