Investigation information release

Worker suffers serious burns using an angle grinder

Event: Worker suffers serious burns using an angle grinder to cut an IBC

Location: Northparkes Mines – Processing plant

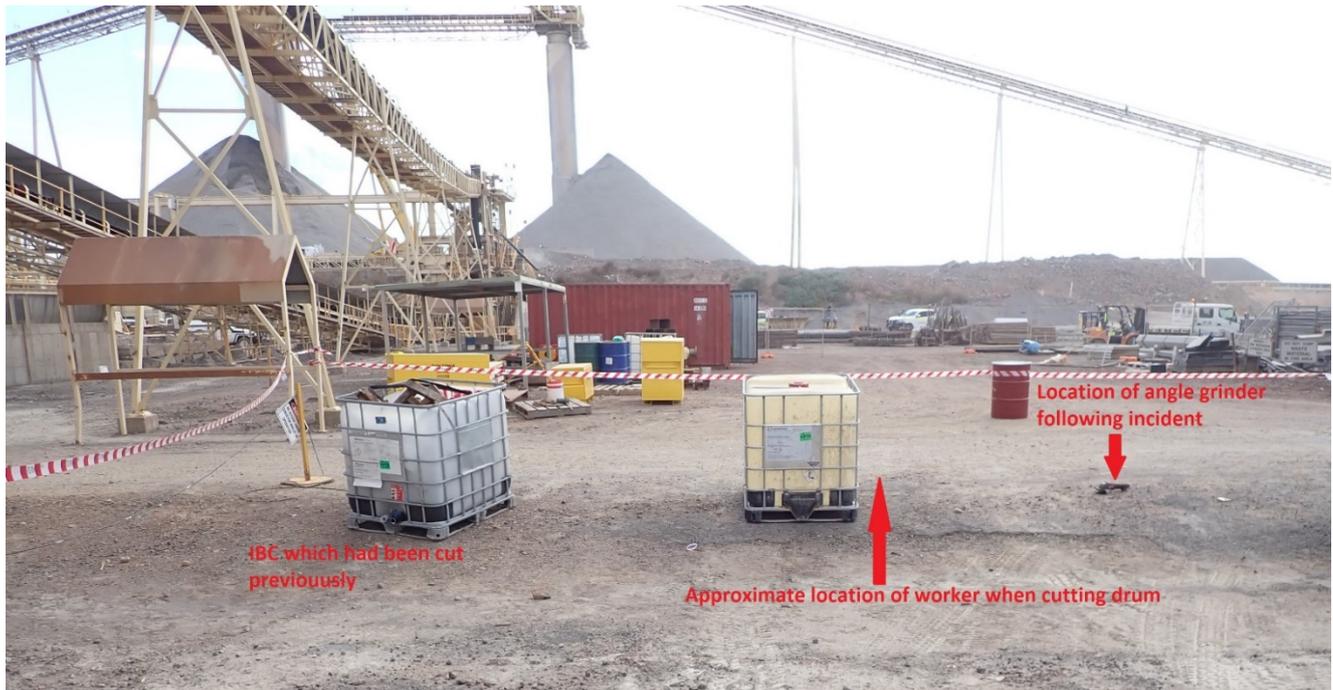
Figure 1 - Location of incident

A forklift operator retrieved a 1000 litre plastic IBC, which was supported by an external aluminium cage like frame, from a nearby storage area and placed it in an open area outside the processing plant. It had not been cut and appeared to be empty.

A crane operator involved in the maintenance work obtained an angle grinder and began cutting the top of the IBC. A short time later workers in the area reported hearing a rush of air and a loud bang. They observed the worker laying on the ground several metres from the IBC. The angle grinder that the worker had been using was also on the ground a short distance from him. The worker was pulling at his shirt, which was smouldering. Several nearby workers removed the worker's shirt and requested assistance.

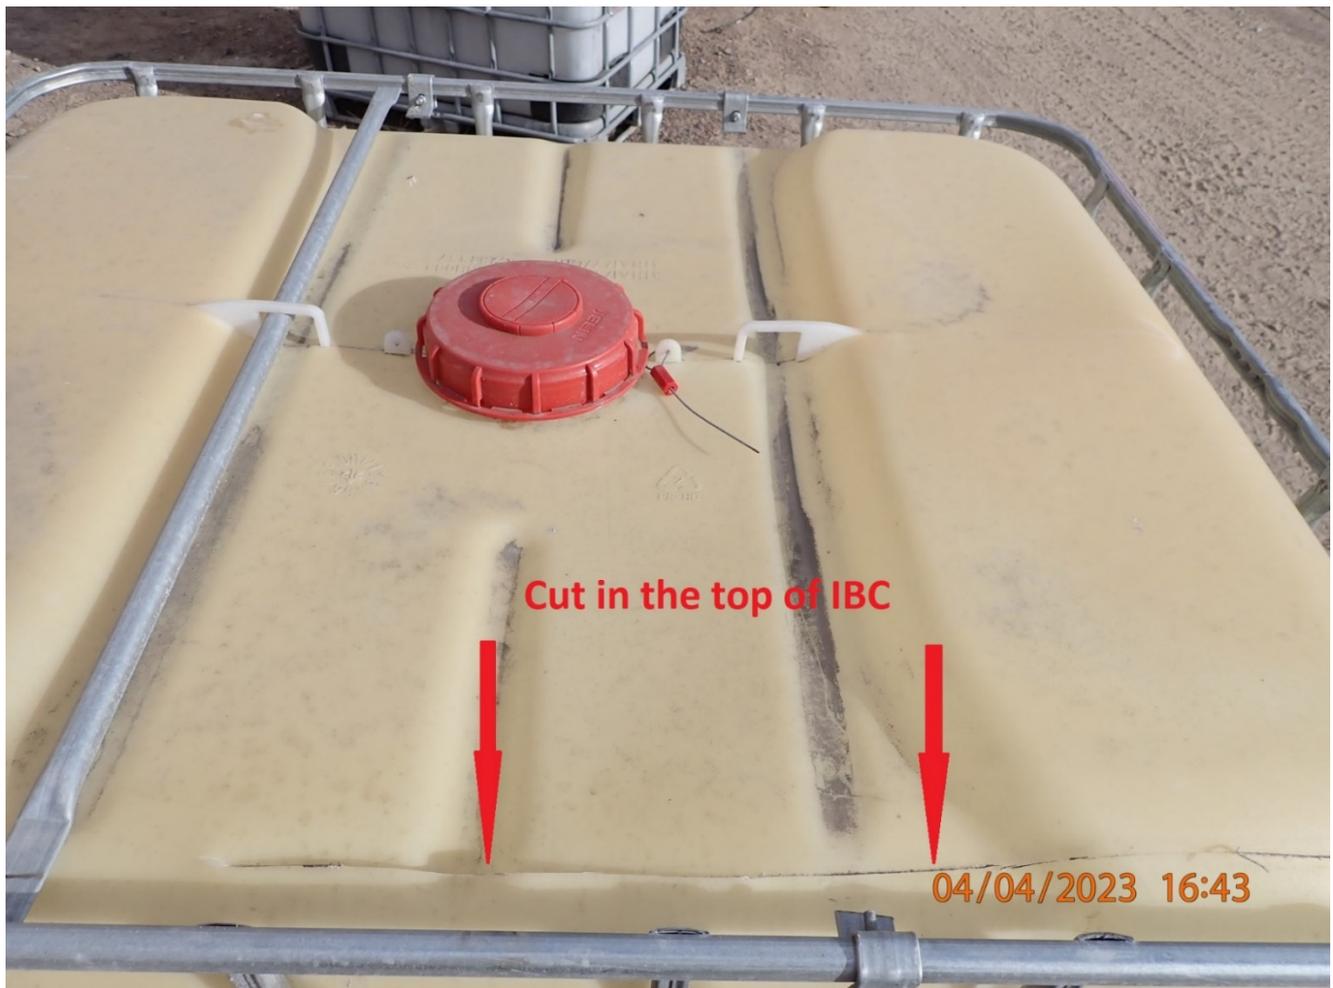
Figure 2 - Top of IBC

A worker was using an angle grinder to cut the top section off a 1,000 litre plastic intermediate bulk container (IBC) near the processing plant at Northparkes Mines on 4 April 2023. It is believed that chemical vapours contained within the IBC escaped during the cutting process causing serious burns to the worker's arms and face.

- implement a hot work permit system which requires all potential hazards associated with cutting containers and drums to be identified and controlled
- identify and control all risks of physical or chemical reaction in relation to the use, handling and storage of hazardous chemicals, having regard to the products safety data sheets
- ensure that containers previously used for the handling and storage of hazardous chemicals are appropriately cleaned and are free of such chemicals (including residues and vapours) when they cease being used for that purpose.

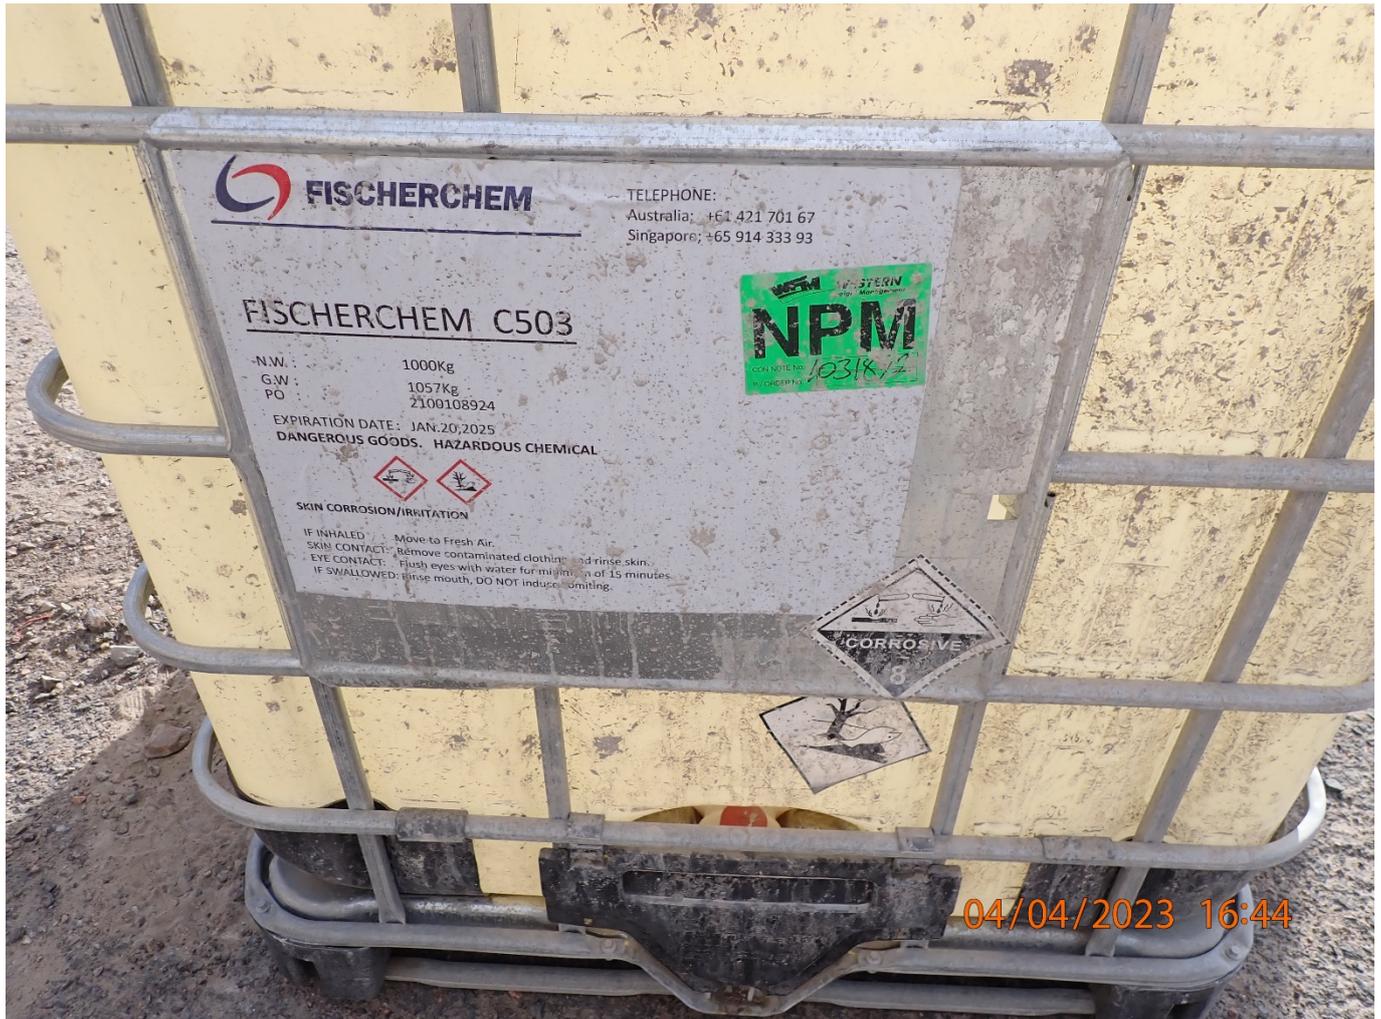
Figure 3 - Label on IBC

The IBC bore a label indicating the product that had been stored in it was Fisherchem C503, a caustic alkali liquid used as a flotation reagent. The product is classified as dangerous goods and is a hazardous chemical in accordance with the Globally Harmonised System of Classification and Labelling of Chemicals (GHS). The product's label contained GHS pictograms indicating that the product was an environmental and corrosive hazard.

- refer to and consider product safety data sheets when undertaking tasks involving the use, handling or storage of hazardous chemicals, including the repurposing of chemical storage containers
- be aware that liquids and vapours not classified as flammable, may ignite upon contact with a heat source
- ensure they comply with mine operators' hot work procedures, hazard identification and risk management processes, and inform supervisors whenever hazardous conditions are encountered or task procedures have changed from those originally planned.
